Subject: Buncombe County Landfill – Permit # 11-07
MW-3 Gas Issue – Construction Certification

CDM Smith Construction Inspection Daily Reports

PROJECT: BUNCOMBE COUNTY SOLID WASTE FACILITY LANDFILL GAS TRENCH

AS-BUILT SURVEY
BUNCOMBE COUNTY SOLID WASTE FACILITY

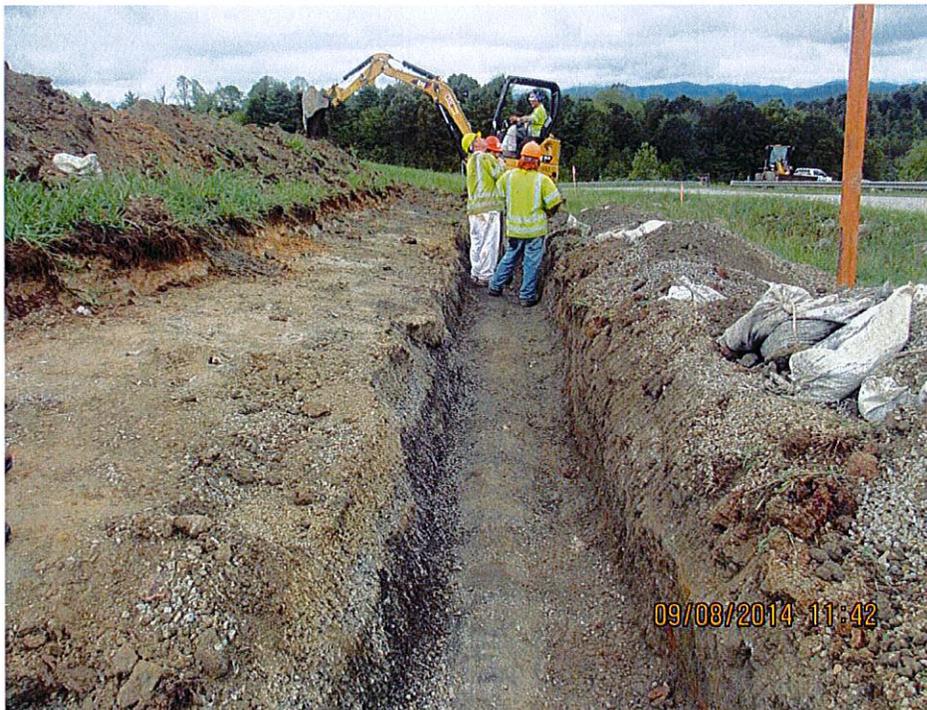
Advanced pipe trench is being cut from east working west, looking west from east. Soil is stacked up slope from cut, rock and old sandbags.

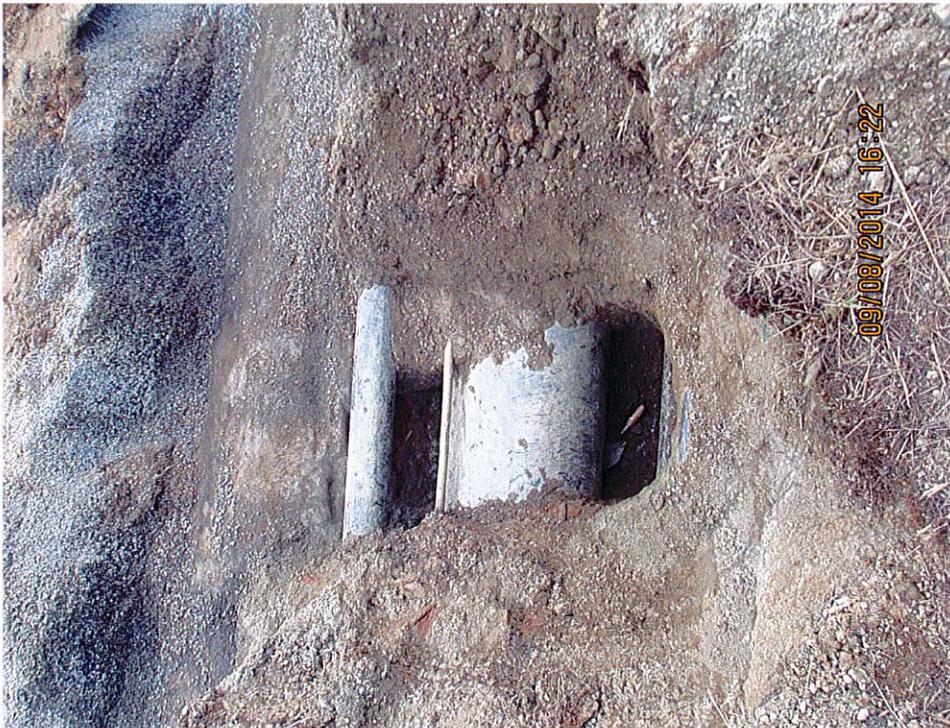
Looking down at 24" header, 1" airline adjacent to 24" and 6" force main near liner edge, west pipe saddle location prepared for saddle.

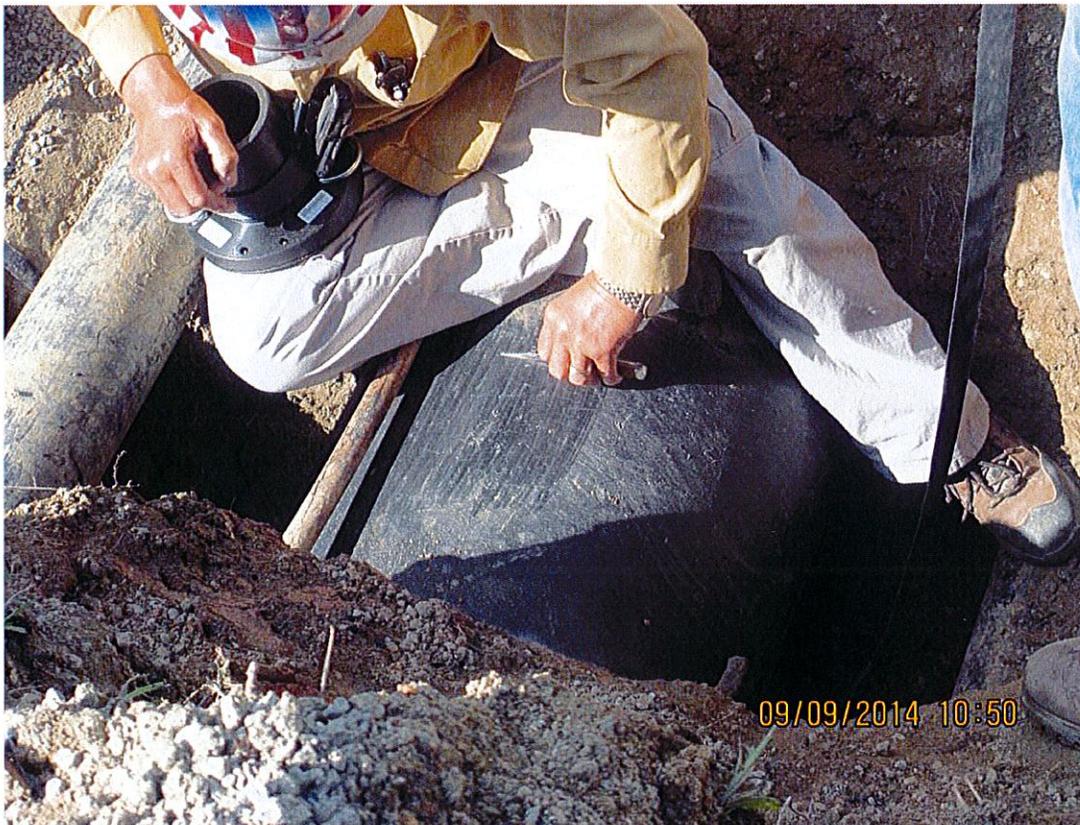
Doyle scrapes the 24" HDPE pipe clean where the saddle is to be installed, looking down and west.

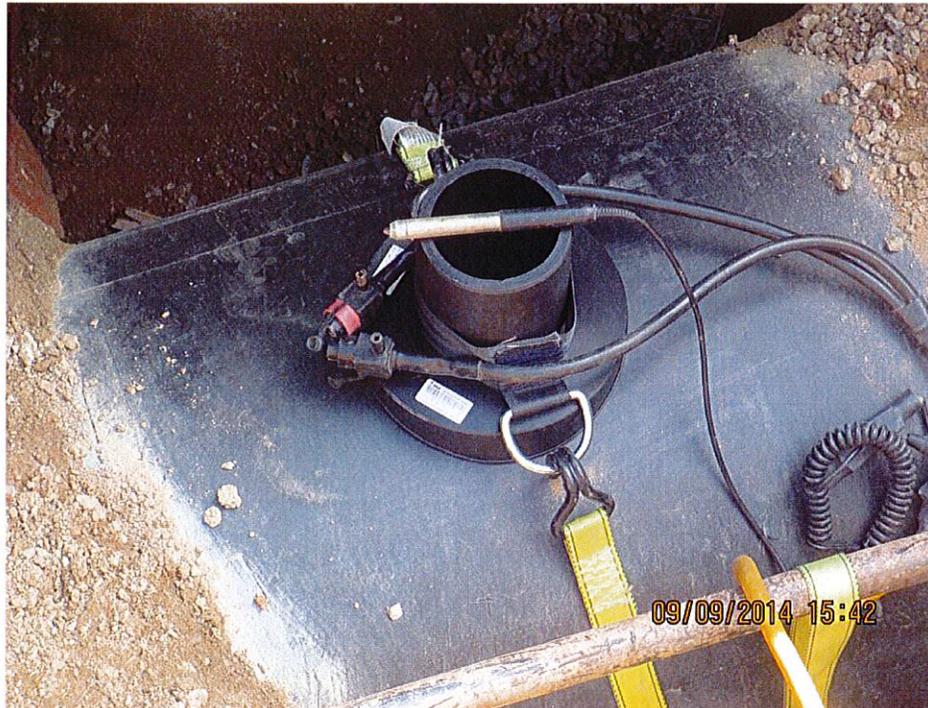
Electro fusion saddle is welded onto 24" header, looking down and south.

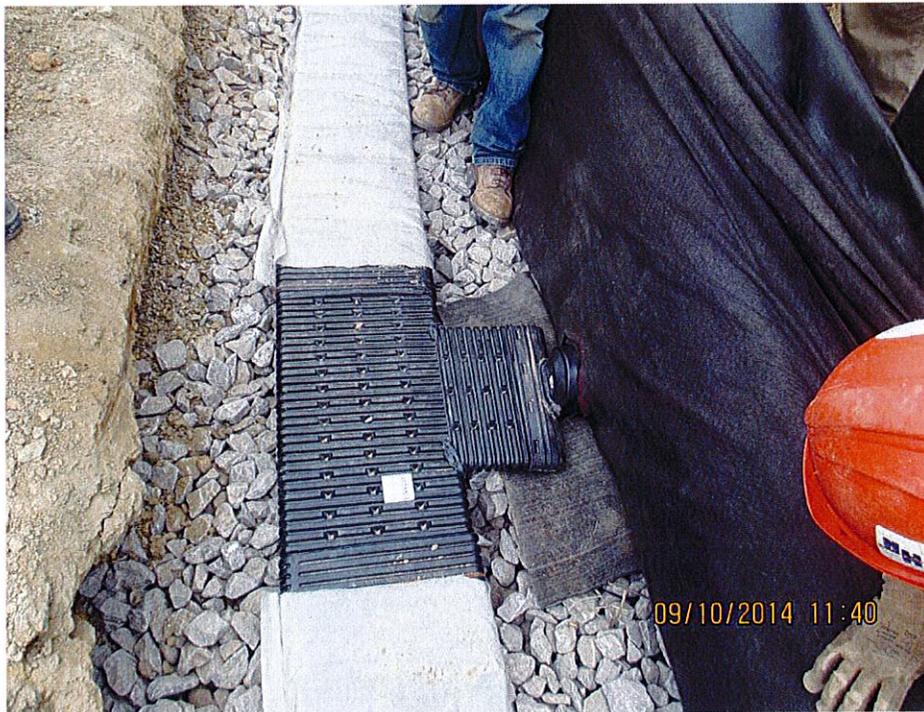
Advantage pipe is clipped to "tees" at gas collection locations, fitting to the right takes Advantage pipe to 4" round, looking down and west. The "Tee" is not slotted so it does not have textile cover like the pipe.

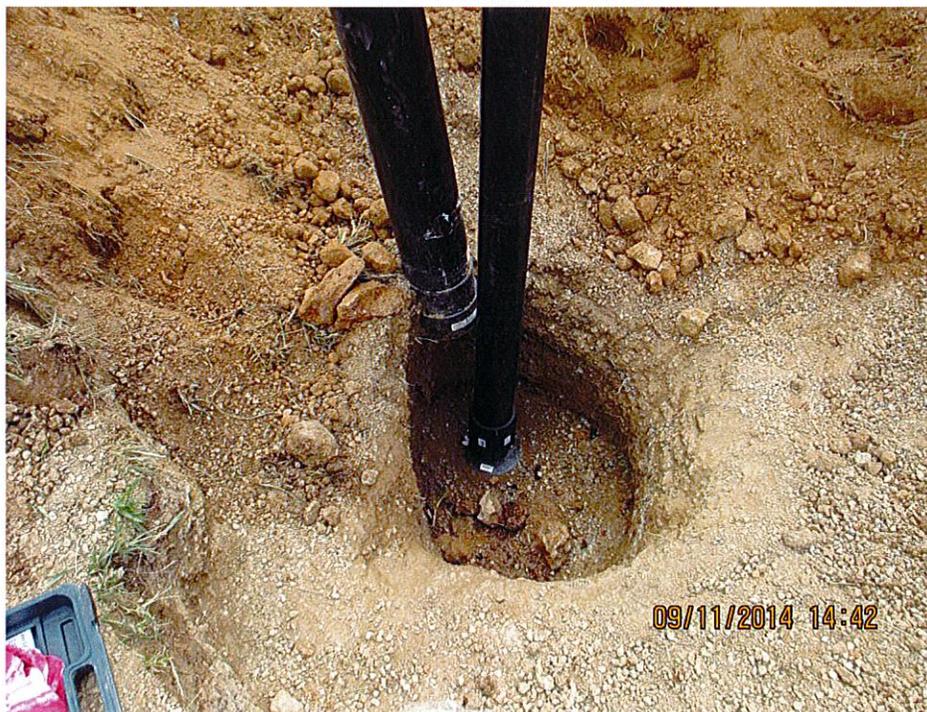
Electro-fusion coupling welds 4" riser to saddle on gas header, looking down at east location.

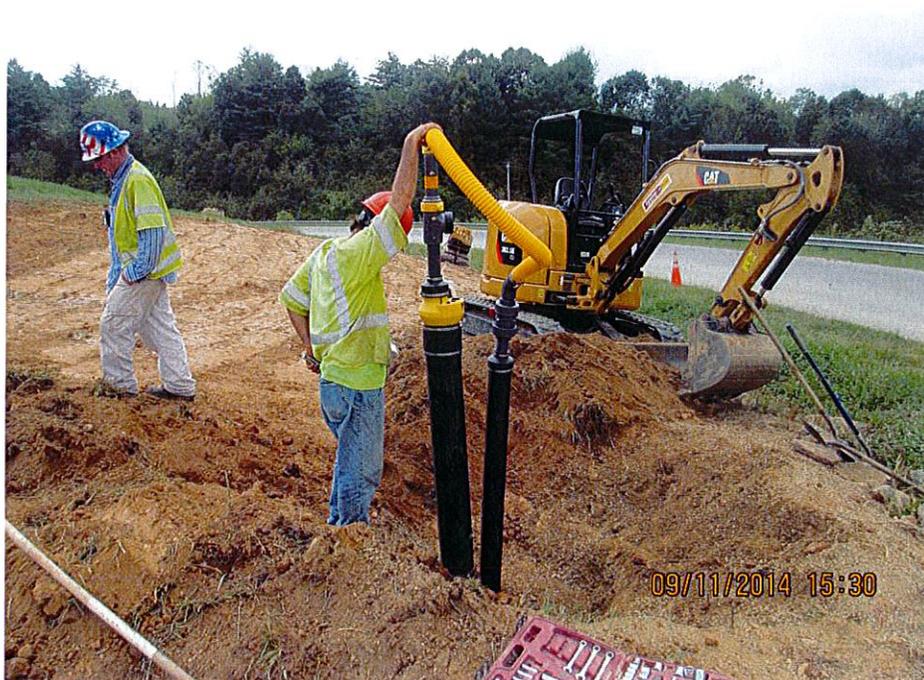
Gas Wellhead assembly is put together on the risers at the west location, looking west. Valves are opened partially to remove gas making the trench operational.

Deficiencies and Corrective Actions: The west well location has the 6" and 4" pipes within inches so the well head is set up in a "U" shape.

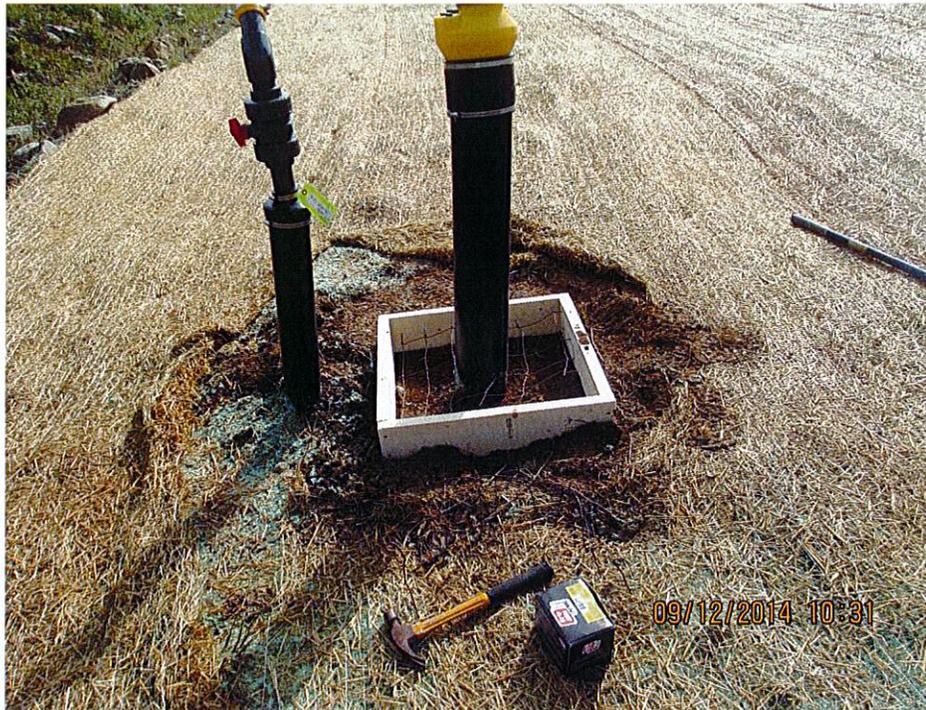
The housekeeping pad around the east gas collection riser has wire prior to sack concrete placement, looking east.

Deficiencies and Corrective Actions: Forms on housekeeping pads will be stripped in the PM and the matting dressed up.
