**FACILITY COMPLIANCE INSPECTION REPORT**  
**Division of Waste Management**  
**Solid Waste Section**

**Date of Site Inspection:** 7/24/2014

Evergreen Packaging Industrial Landfill  
 State Road 1550  
 Canton, NC 28716

Comprehensive Inspection; Complaint Investigation

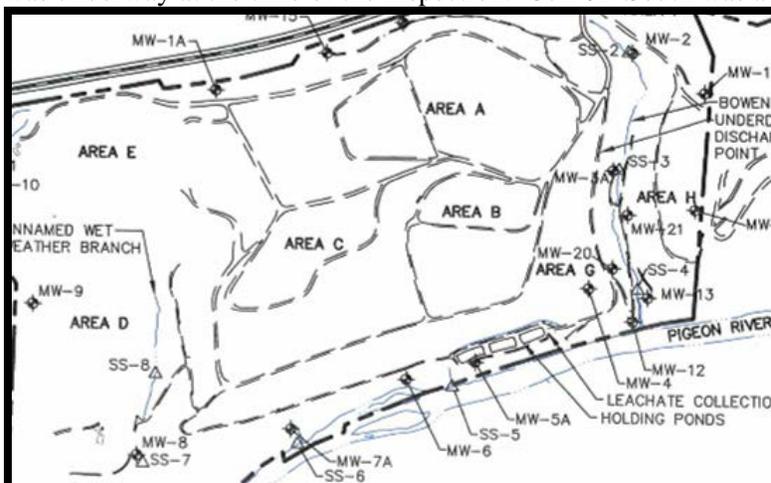
General Site Map

1. On site July 24<sup>th</sup>, 2014, to conduct comprehensive inspection of facility and to respond to facility complaint. Weather was partly cloudy (rain earlier in the morning), mid-70's. Construction of the new 6D North and 6E was underway at the time of the inspection. Cell 6D South was active and receiving waste.
