**FACILITY COMPLIANCE AUDIT REPORT**  
**Division of Waste Management**  
**Solid Waste Section**

<b>UNIT TYPE:</b>											
Lined MSWLF		LCID		YW		Transfer		Compost		SLAS	<b>COUNTY: HENDERSON</b> <b>PERMIT NO.: 45-01</b> <b>FILE TYPE: COMPLIANCE</b>
Closed MSWLF	<b>X</b>	HHW		White goods		Incin		T&P		FIRM	
Closed CDLF	<b>X</b>	Closed CDLF atop Closed MSWLF	<b>X</b>	Asbestos Disposal Area(s)	<b>X</b>	TVA Industrial Landfill	<b>X</b>	DEMO	<b>X</b>	SDTF

**Date of Audit:** 03/10/2010

Henderson County Solid Waste Landfill

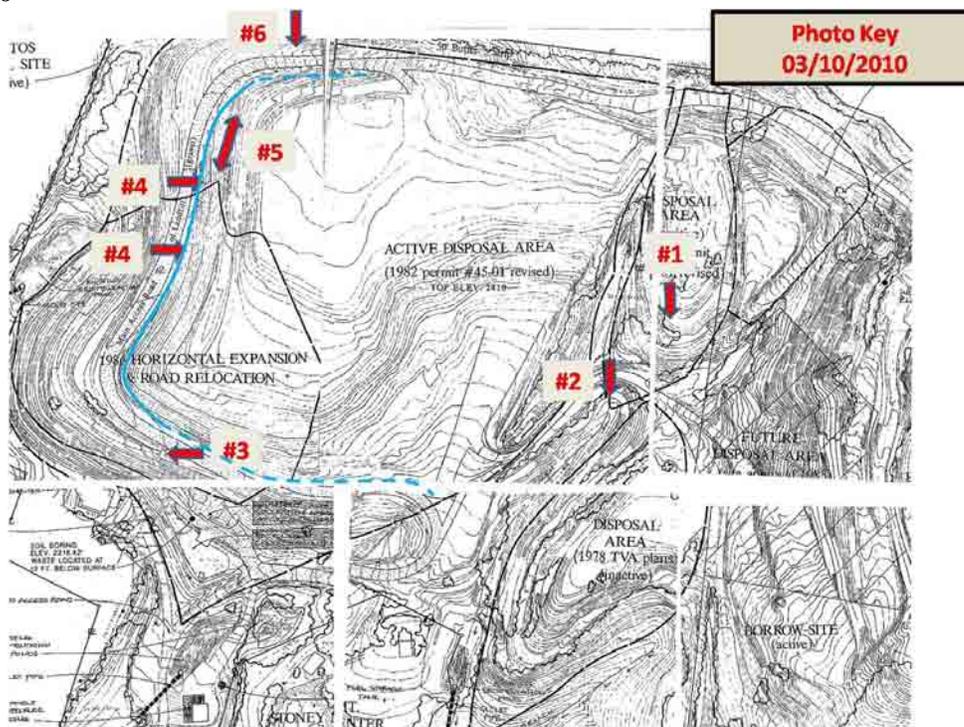
03/10/2010 photos #1: painted block, rebar, porcelain and some plastics were noted.

While most of the material noted at the site conforms with the above-stated definition, **this area is not considered a disposal site for solid waste and thus all non-conforming materials must be sorted and removed from this fill area for proper disposal.**
