FACILITY COMPLIANCE AUDIT REPORT
Division of Waste Management
Solid Waste Section

Date of Audit: 04/25/11

Grandfather Golf & Country Club Landfill, Newland
 Tax Parcel No. 1837 2082 7248
 Hickory Gap Road
 Newland, NC
 (Approximately 4-miles north of Newland, on the right, past Hickory Estates Lane.)

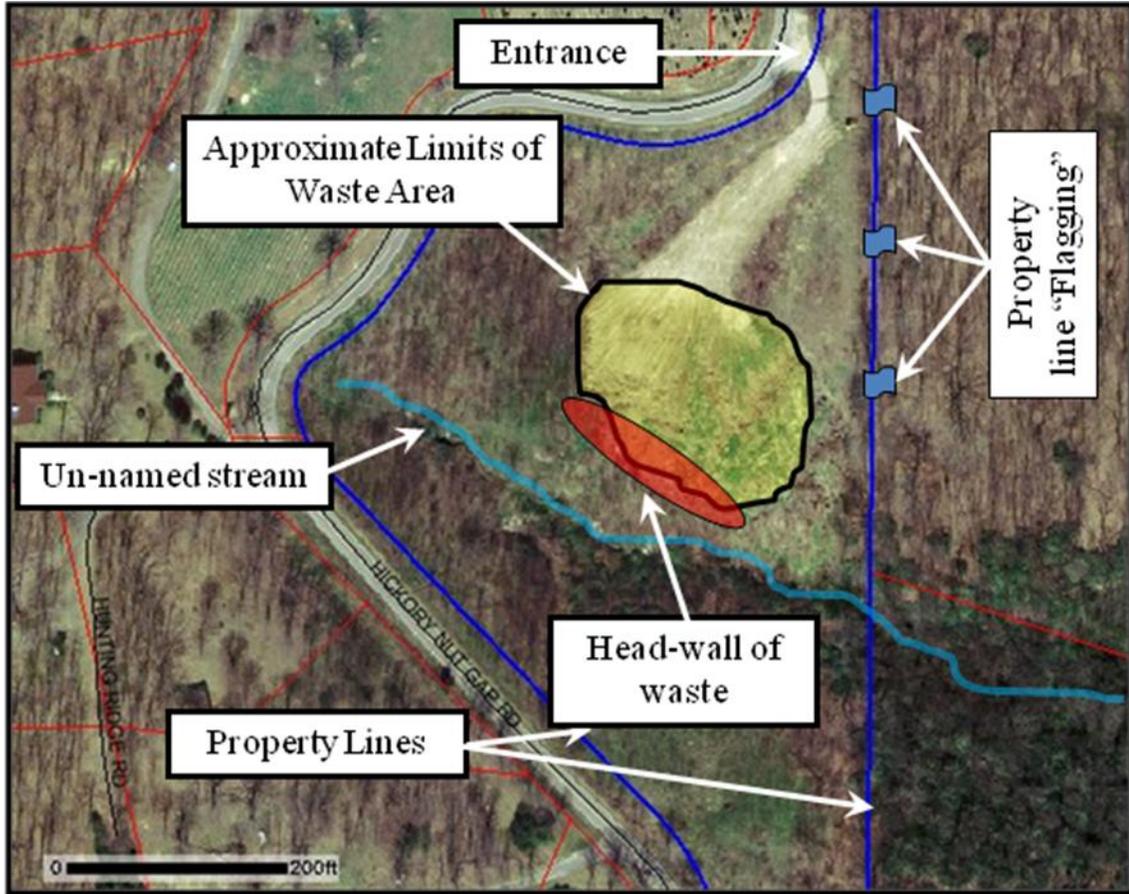
1. Follow-up site inspection to determine if facility has performed any of the actions recommended in the last audit report (2/02/11).
2. Access to the site is properly controlled with a locked gate.
3. The waste area appeared to have been recently compacted & graded. (Photo #1)
4. The northern portion of the eastern property line was “flagged” in three places. (Photos #2 - #4)
5. **Based the “flagging” of the eastern property line and the observed areas of waste, it appears that the required 100-ft. buffer from waste disposal areas to property lines is not being maintained on the eastern side of the facility.**

Figure 1. Avery County GIS Aerial of Tax Parcel No. 1837 2082 7248
Approximate Limits Area of Waste

6. As stated in the previous inspection report of 2/2/11, it is difficult to determine if 100-ft. buffer requirement is being adhered to without first knowing where the edge of waste and the property lines are located. **Within 30-days of your receipt of this report, identify and mark the entire length of the eastern property line as well as entire limits of waste.**

Any waste that is determined to be inside of the required 100-ft. buffer must be moved out of the buffer and into the permitted limits of waste.
