Re: LF Condensate Spill at the City of Durham Closed MSW Sanitary Landfill
Attn: Ervin Lane
Compliance Hydrogeologist
NC Department of Environment and Natural Resources
Division of Waste Management - Solid Waste Section
1646 Mail Service Center
Raleigh, NC 27699-1646
919-707-8288 (phone/fax)

Date: April 13, 2012

City of Durham Landfill

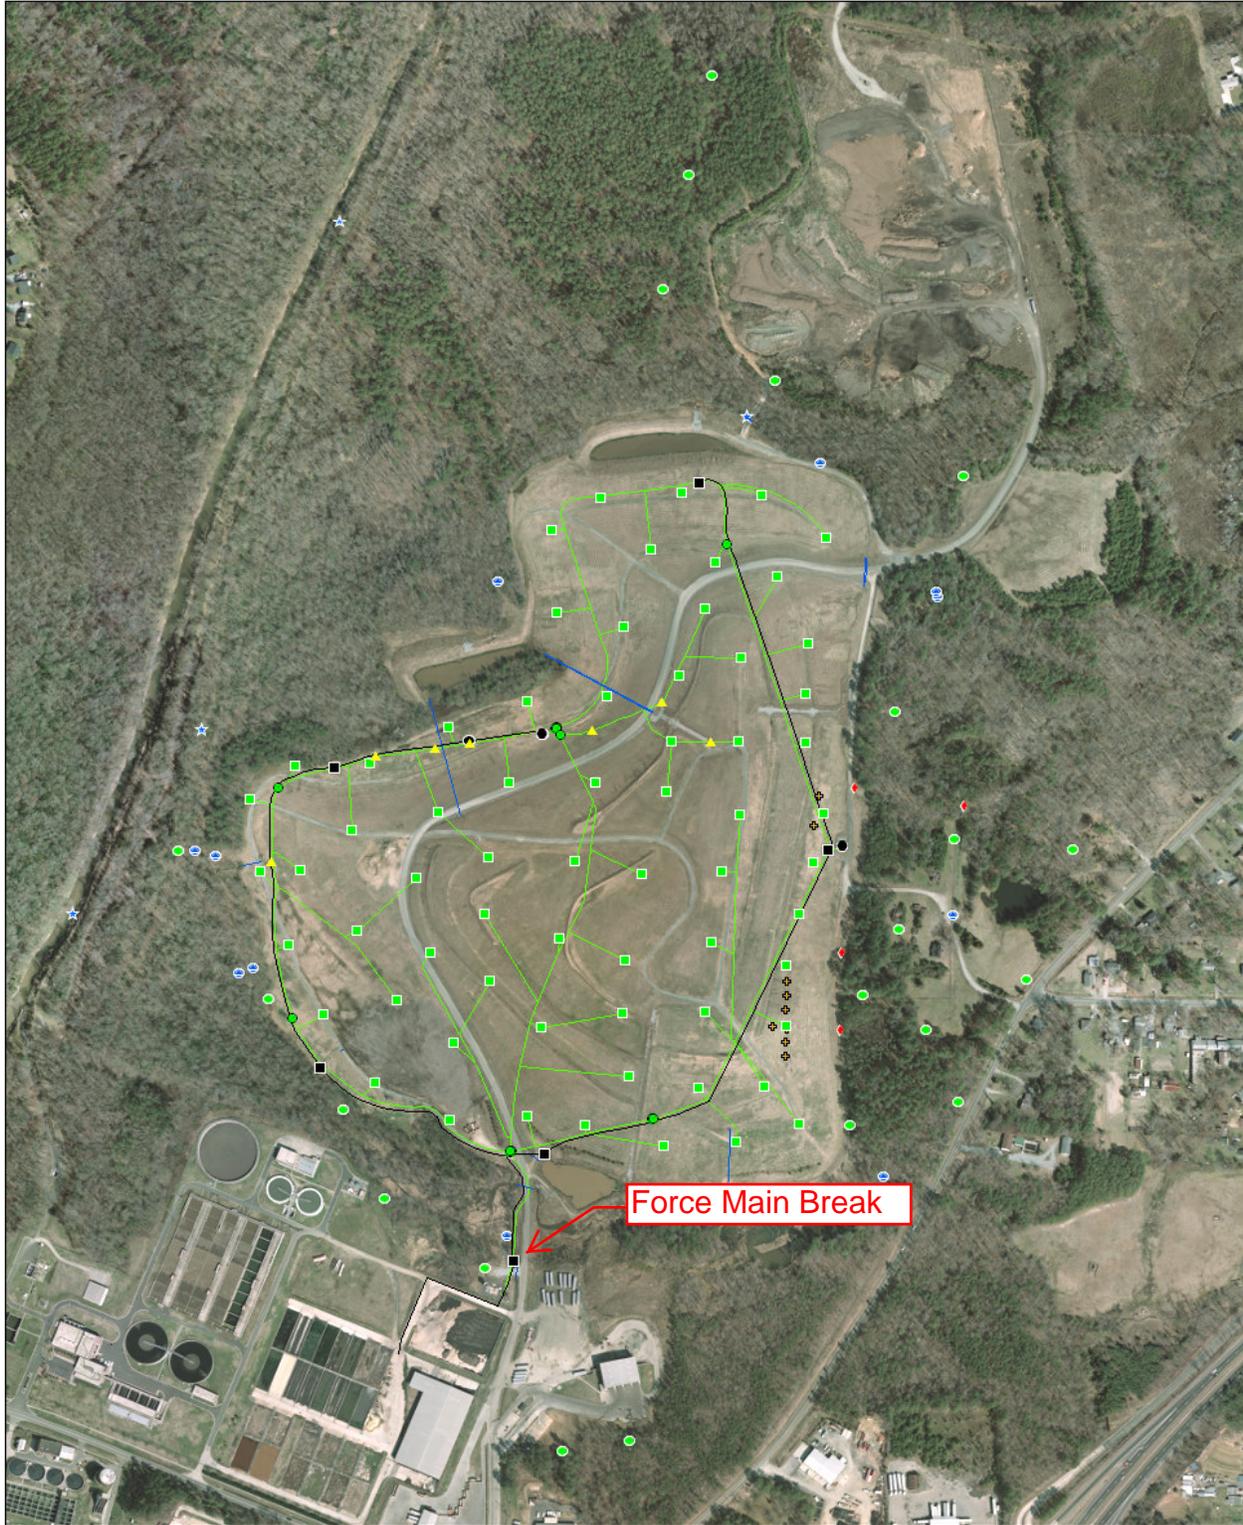
The attached figures show the location of the spill relative to the landfill, the temporary line and the section of pipe that was believed to be plugged. No root cause has been determined for the plugging of the original line. The City is going to abandon the old line in place and rely on the new line. A second report will follow shortly describing the reroute and the commissioning of the new stretch of line. Golder Associates are currently under contract to perform soil sampling and assessment services at the site of the spill.
