Solid Waste Management Facility Cell 6 Construction Quality Assurance Report

Volume 1

January 2006

Subject: Buncombe County, North Carolina
Buncombe County Solid Waste Management Facility
Cell 6 Construction Quality Assurance Report
Permit No. 11-07

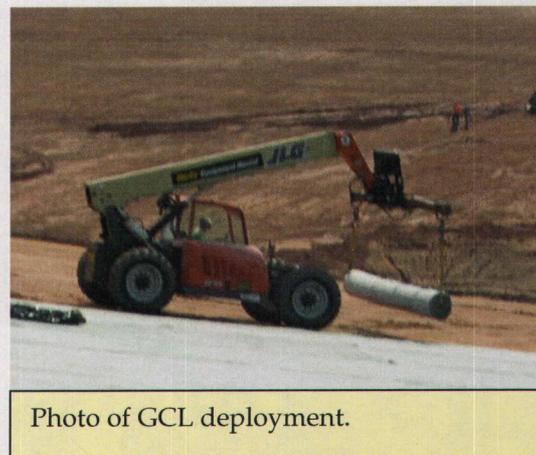
Photo of GCL deployment.

remained parallel with the landfill slope and avoided sharp turns when possible to minimize rutting of the low permeability soil liner surface. Significant rutting was repaired immediately by the Contractor to the satisfaction of the Engineer.

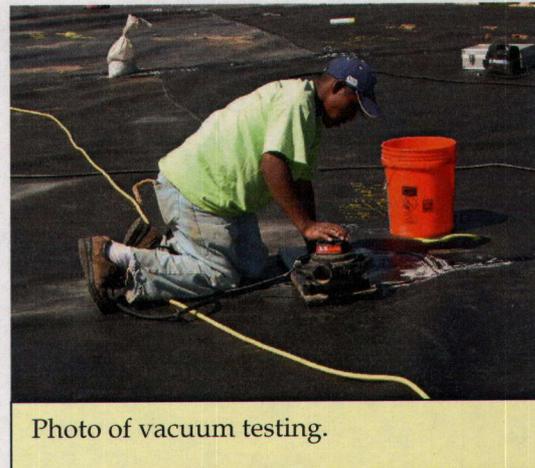
of the seam to be tested. Then a rectangular plexiglass-faced vacuum box was placed on the seam and a 5-psi vacuum was pulled in the box for a period of not less than 10 seconds. The seam was observed through the viewing window for the presence of soap bubbles. The presence of no bubbles indicated a good seam. CDM observed the vacuum testing and recorded the information on the appropriate forms included in Appendix C-13a (Phase 1) and C-13b (Phase 2). All vacuum tests yielded passing results.

Photo of vacuum testing.

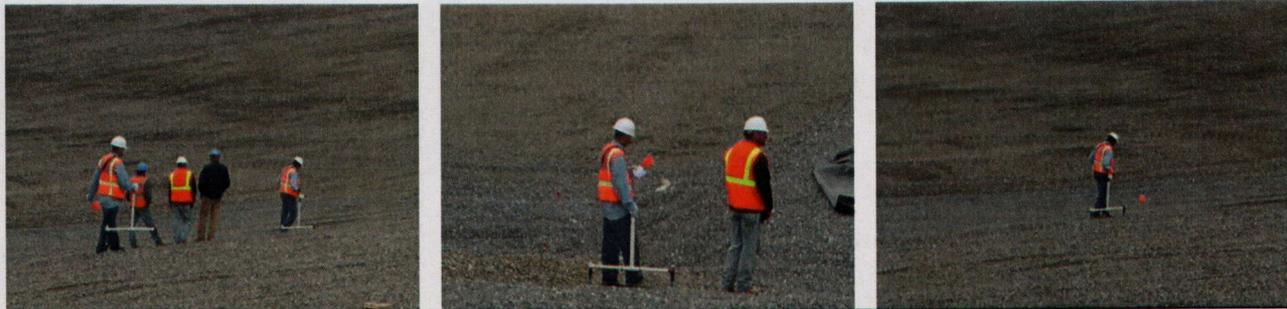
Once stone was in place above the fabric cushion, electrical resistivity testing was performed to locate any possible liner leaks. Page 7 of this section shows a few pictures of leaks that were detected and repaired.

One leak was detected. The leak was an approximate 4-foot long gash, which appeared to result from contact with the blade of the dozer used to deploy the protective cover. Hallaton exposed the area, performed vacuum testing and patched the area using an extrusion weld. Leak Location Services, Inc. provided a follow-up test on the patched area which resulted in a no leak response. The Phase 1 report prepared by Leak Location Services, Inc. is provided in Appendix C-14a.

Following placement of protective cover rock, CDM directed the Contractor to perform leak location detection in areas that received traffic during the remediation. Using electro leak location detection, one additional damage to the HDPE liner was

located and subsequently repaired in accordance with the Contract Documents. Appendix C-14b includes the documentation for the six HDPE liner damages and includes damage locations, repair logs, and the certified leak detection report.

Typical electro leak detection operations.
