FACILITY COMPLIANCE INSPECTION REPORT
Division of Waste Management
Solid Waste Section

Date of Site Inspection: 05/14/14

Duke Energy, Allen Steam Station – Retired Ash Basin (RAB)
 253 Plant Allen Road
 Belmont, NC 28012

Comprehensive Compliance Inspection

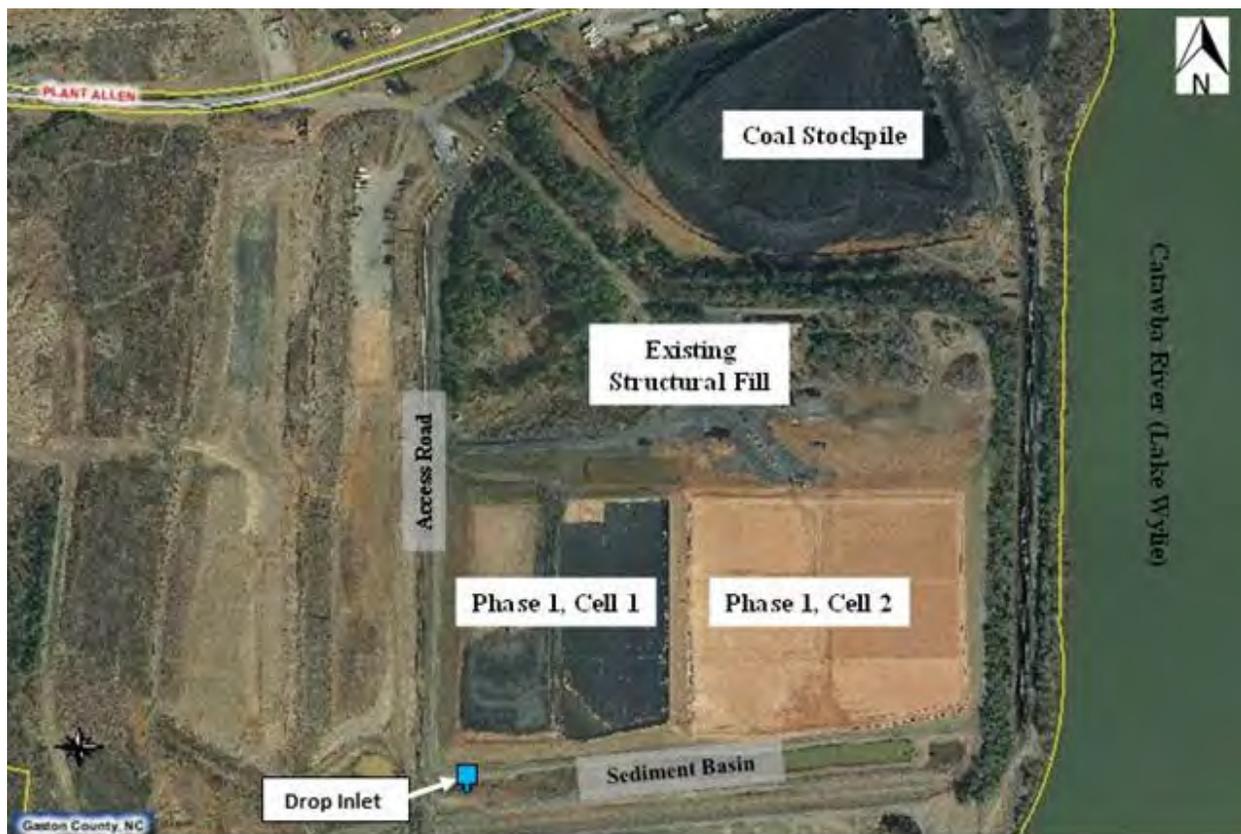
Figure 1.

11. There are three 'chimney drains' in Cell 2 of Phase 1 that collect and direct storm water that contacts the coal ash to the leachate collection system. (Photo #1)
12. Both the edge of waste and the edge of liner are identified with white PVC markers.
13. The side slopes of the landfill had well sloped and have an established vegetative cover. (Photos 1 &2).
