# SITE VISIT REPORT

**Project:** Dunn Erwin Landfill CAP Projects

| <b>Job No.:</b> 3002B | <b>Date:</b> August 20, 2013 |

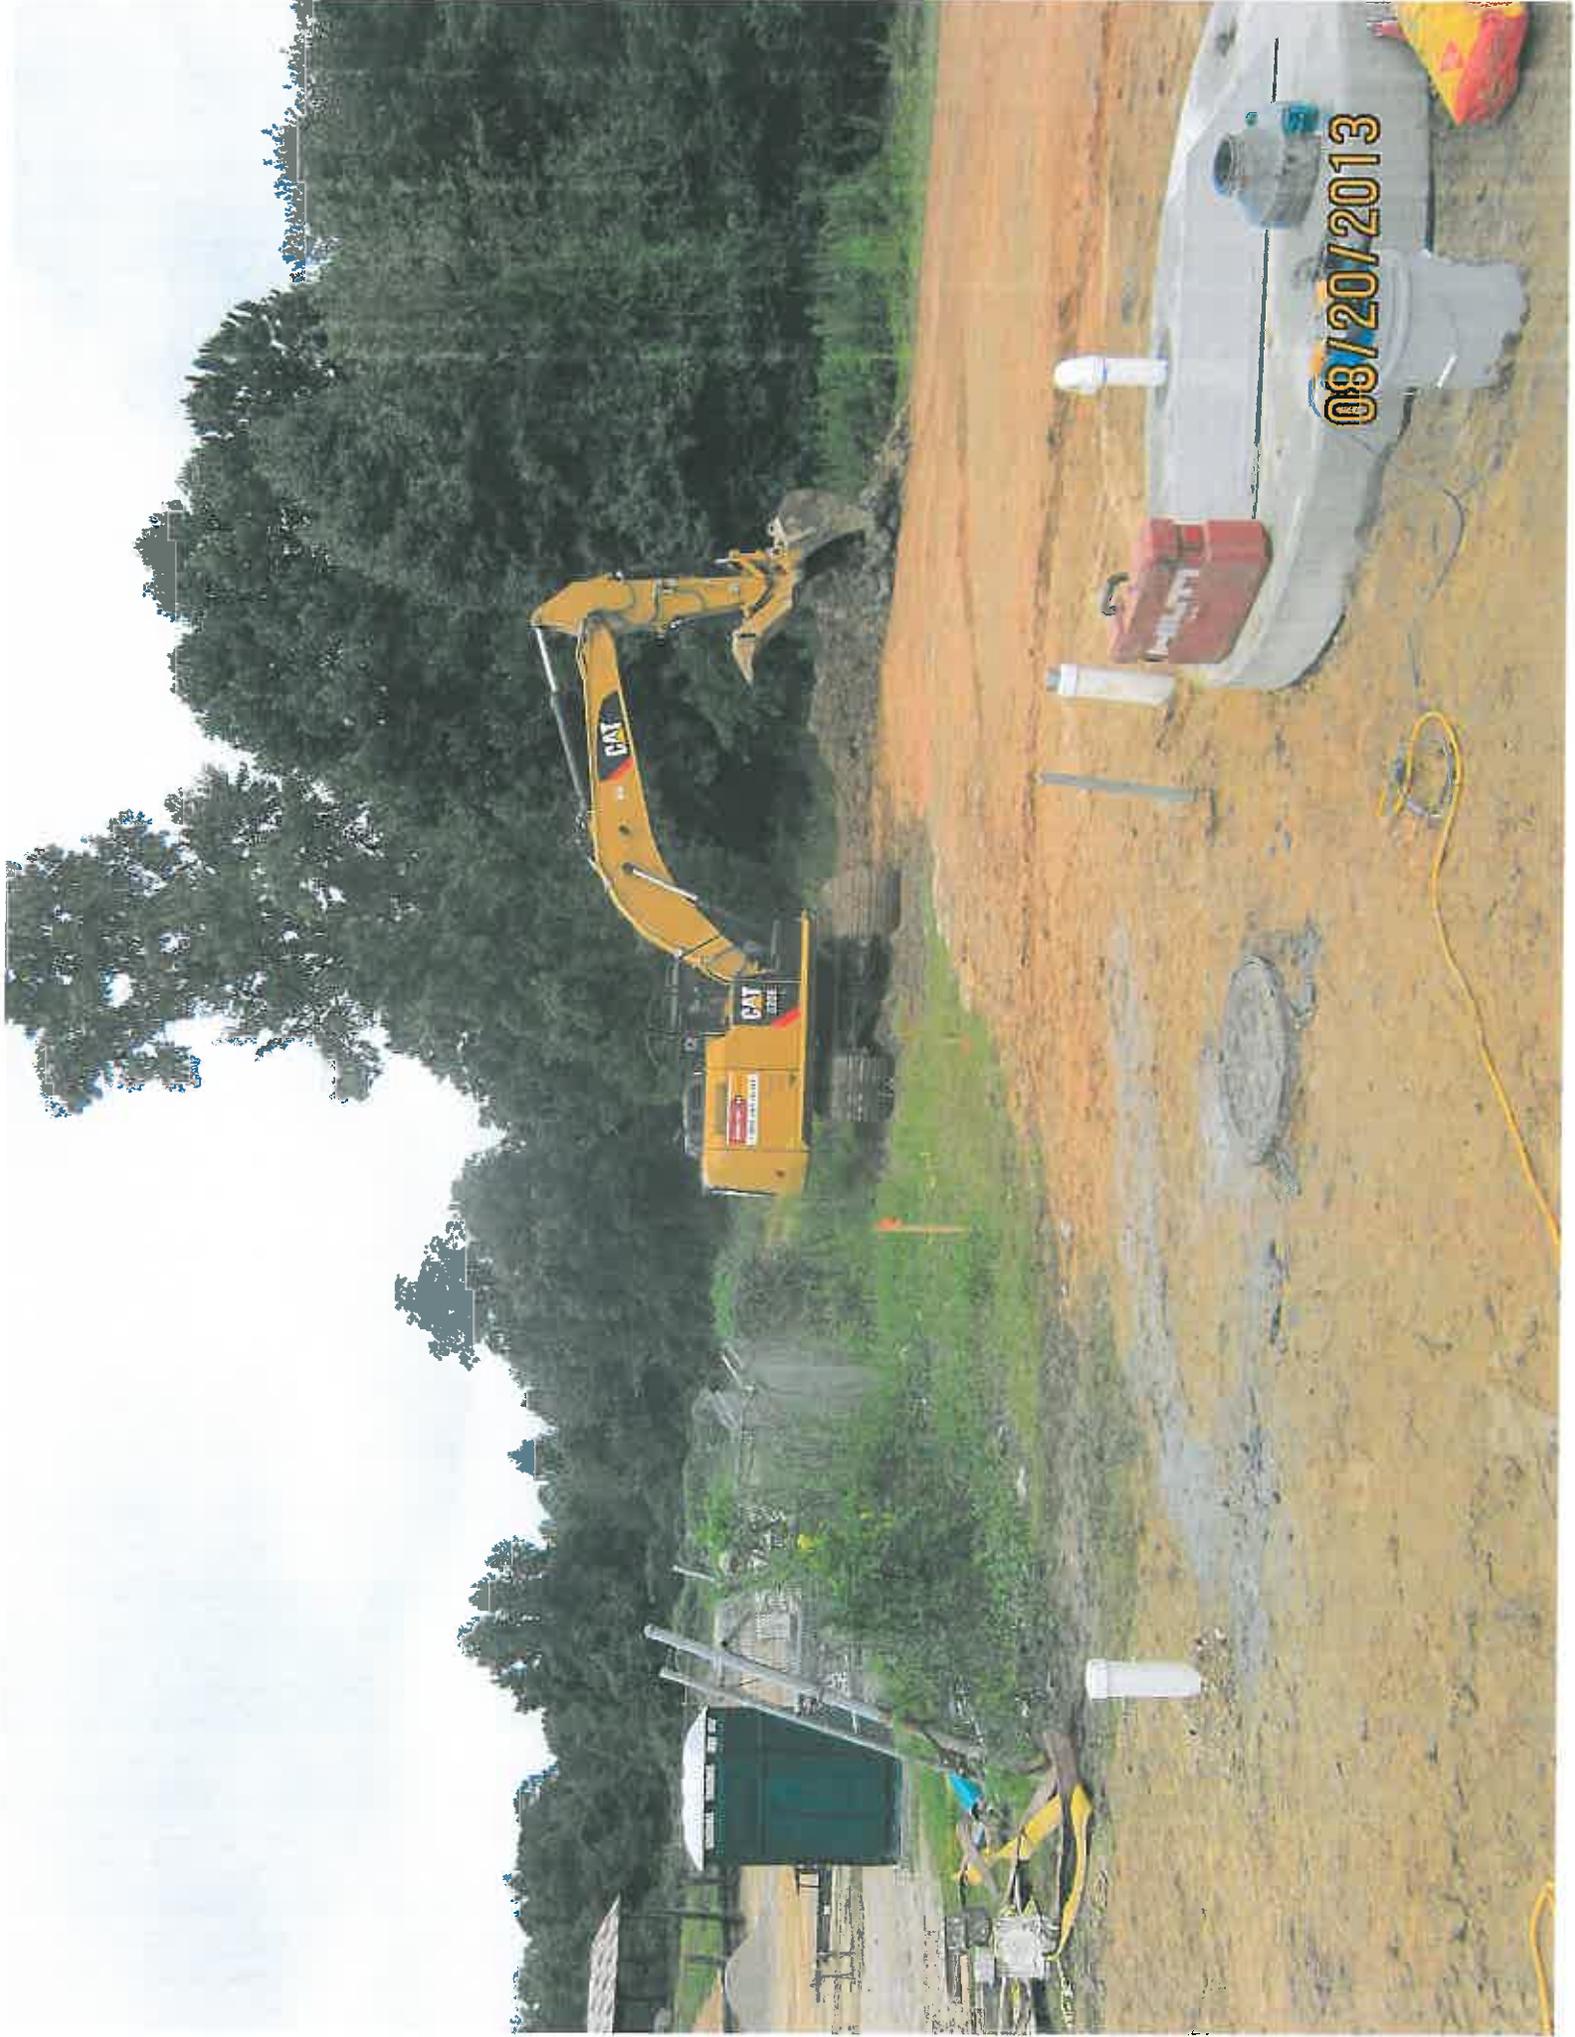
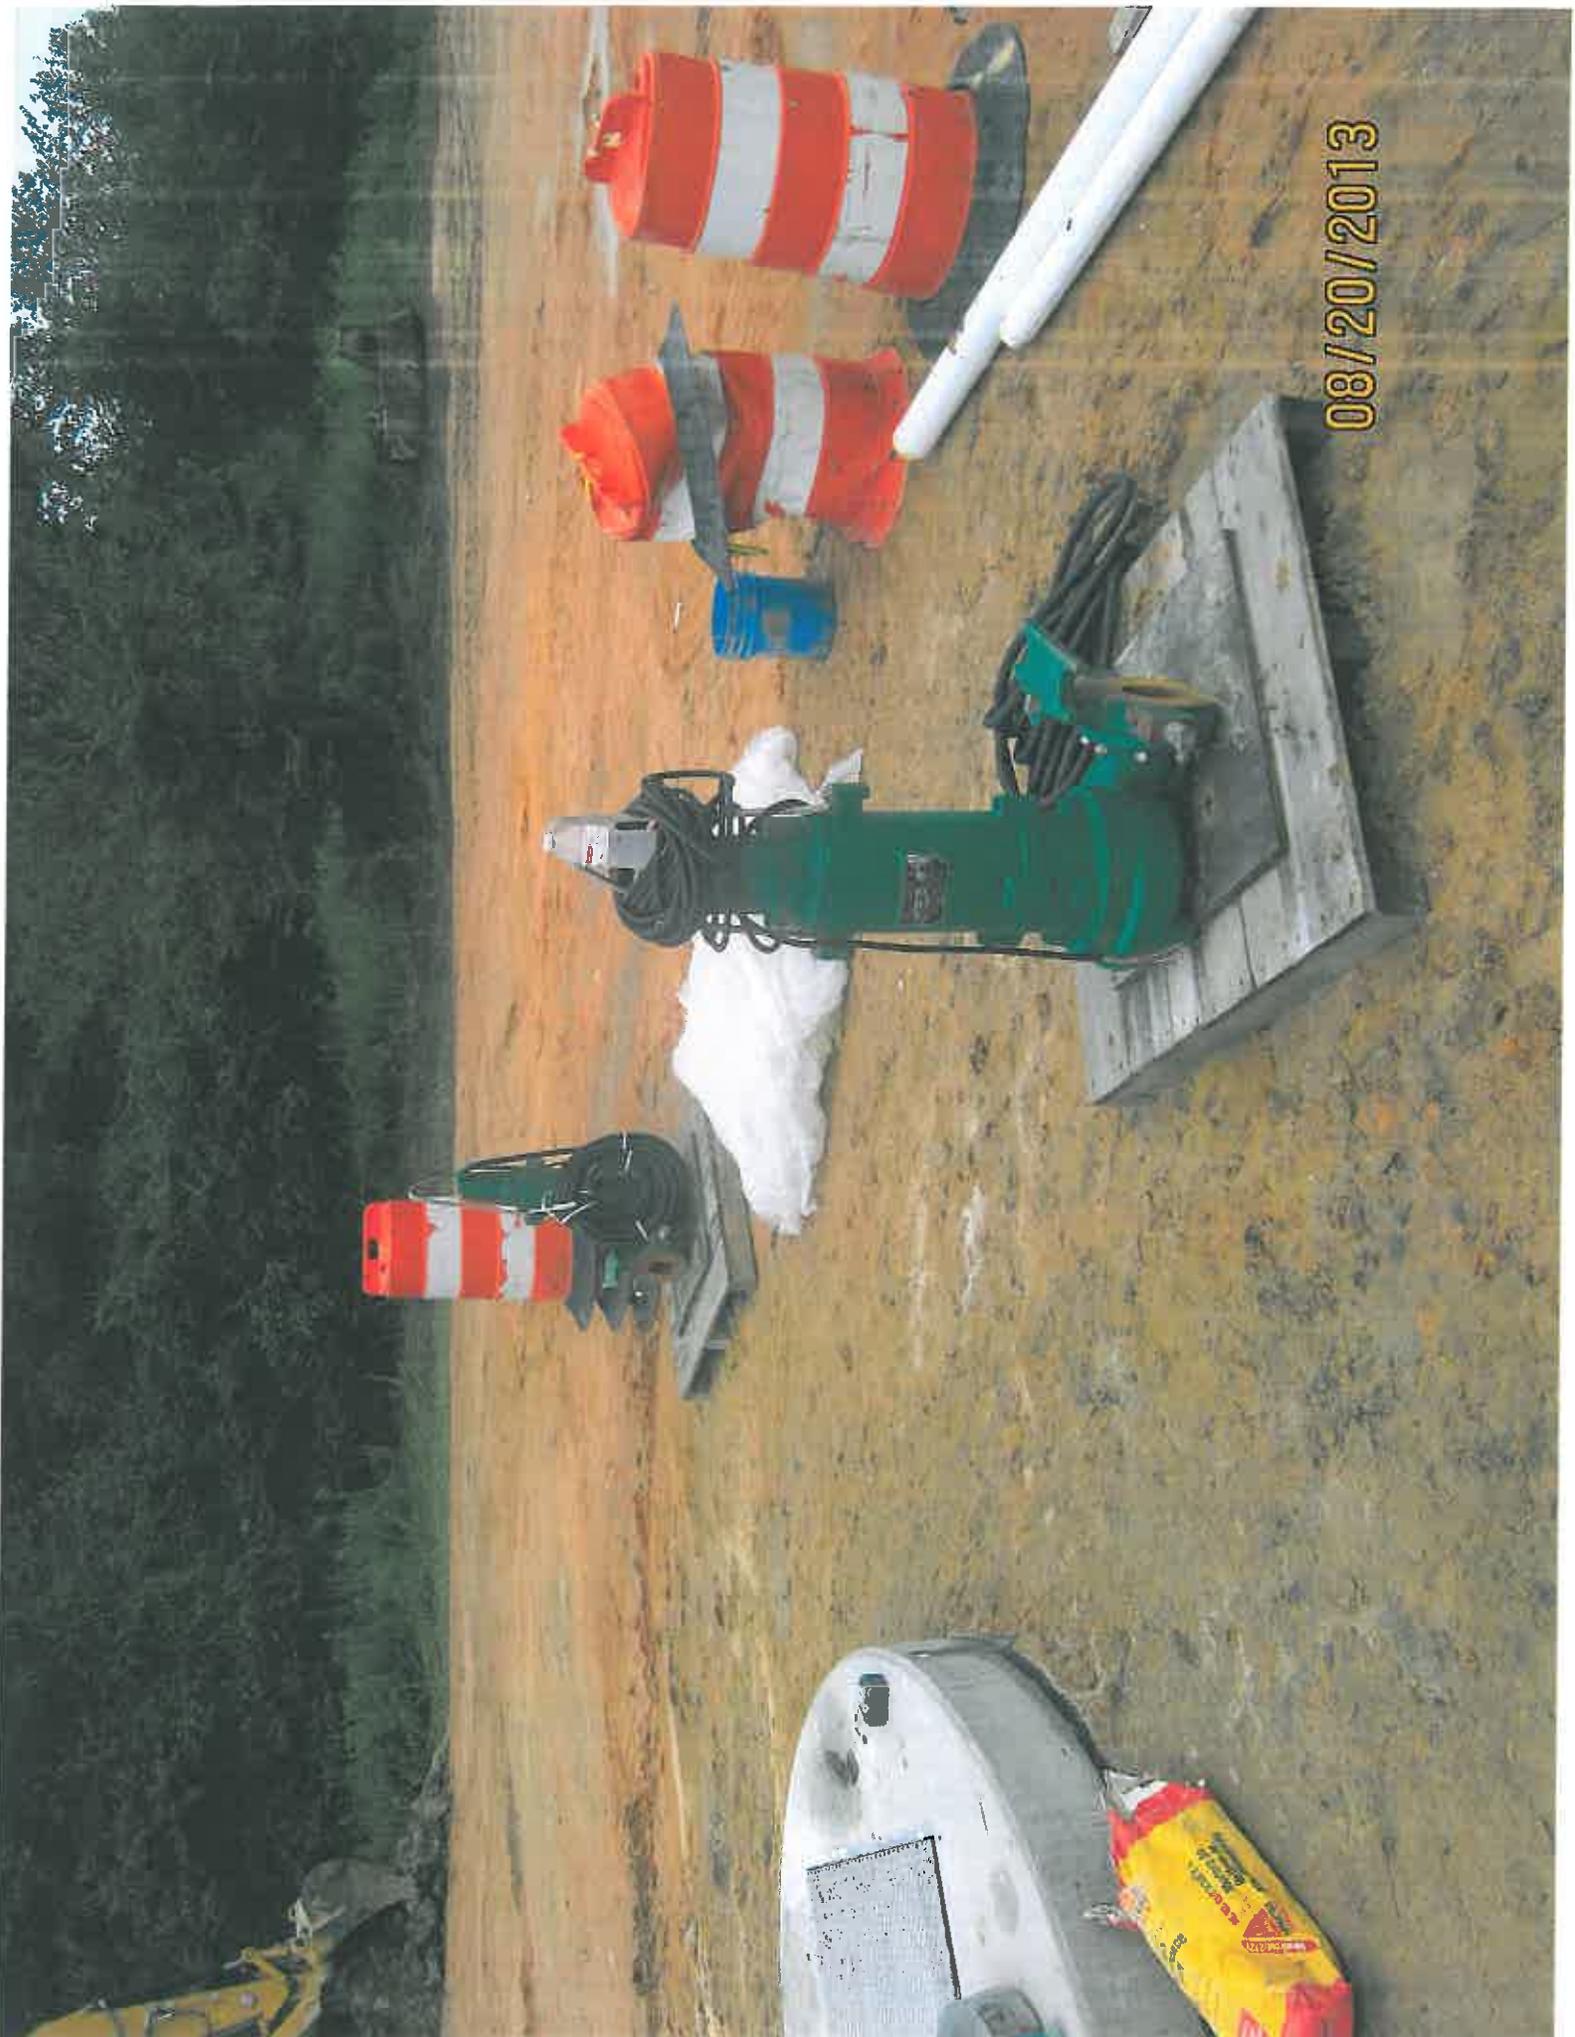
Arrived on site at approx. 9AM to witness the pressure testing of the force main currently underway. Contractor had started the test at 8:45 and pressurized the force main to 200psi. Checked back at 10:45 and the psi had not dropped below 200 psi. Temple crew was also working on miscellaneous item on the wetwell.

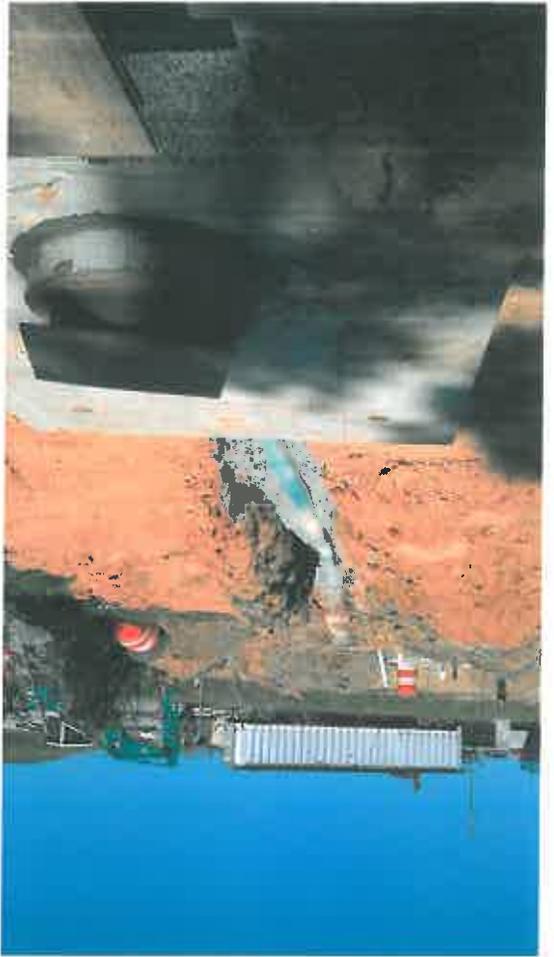
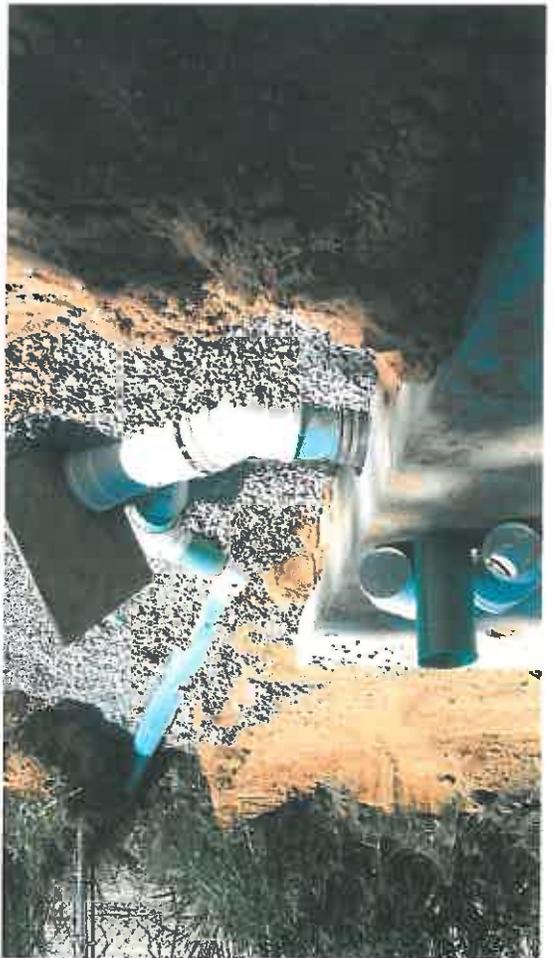
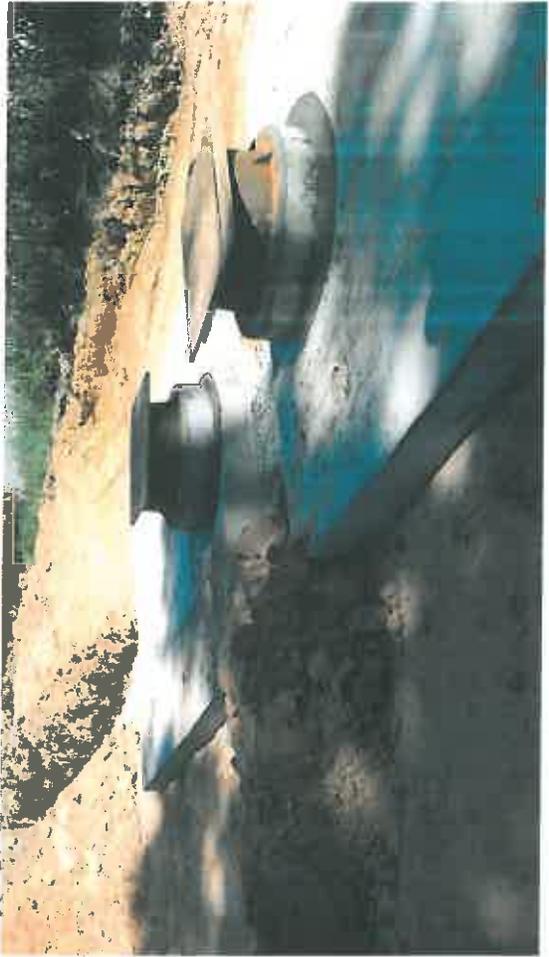
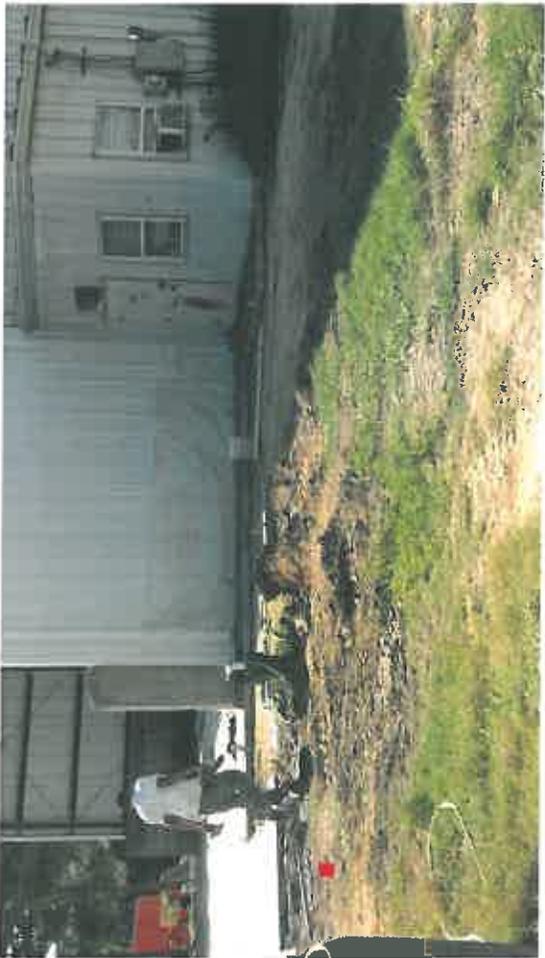
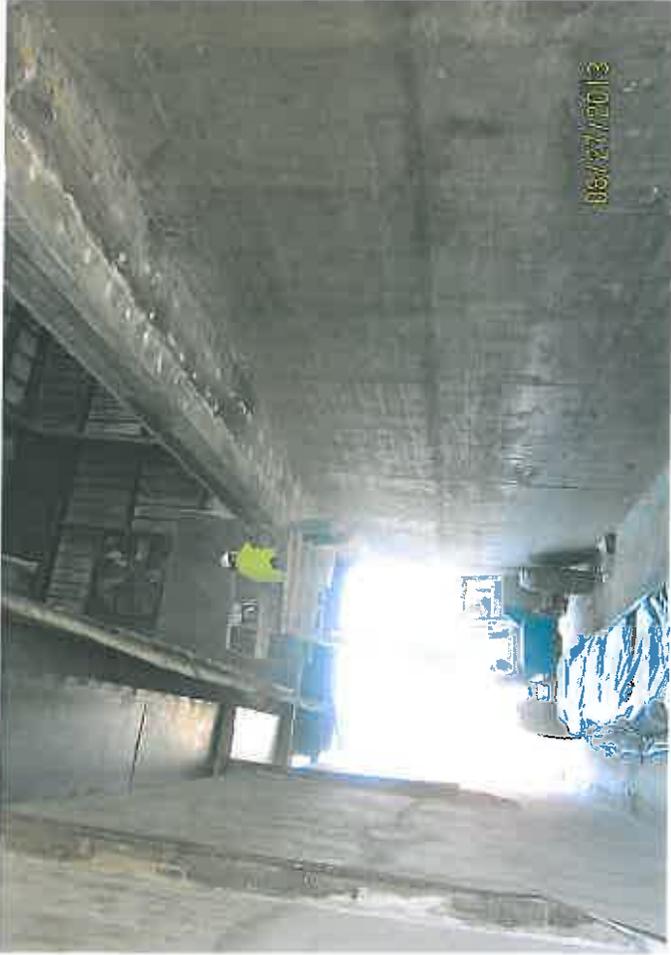
Arrived onsite at 7:30 am. Met with Ralph Barile. We discussed the progress made on last Thursday and Friday.  
Ralph indicated they kept the concrete poured last Friday wet with soaker hoses and covered in plastic to try and  
minimize the occurrence of shrinkage cracks with the portland only mix. Tanks have been set with the tank tie-in  
to the manhole left to complete. The sidewalk to the attendants room is to be poured today.

Both our firm and the Owner has reviewed the proposal to use the Dural 50 LM to seal the shrinkage cracks on outer apron at the Transfer Station. It is our opinion that the cracks occurred due to improper care immediately after the pour occurred.

We approve the use of the Dural 50 LM as a remedial effort in lieu of remove and replacement under the following conditions:

1. Manufacturer's recommended installation methods are to be followed
2. Sand is incorporated in the final surface for additional slip resistance
3. A 2-year bonded warranty is offered on the installation and product (both the Dural and the concrete) to allow for the product to get thru at least two winter (freeze/thaw) cycles
4. ECS will need to be onsite to observe the placement

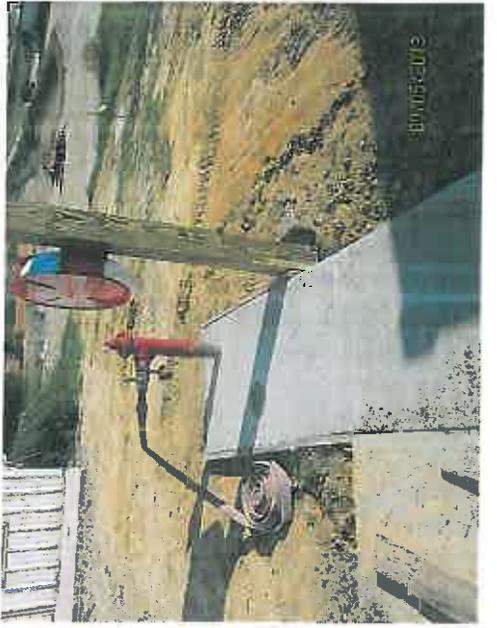
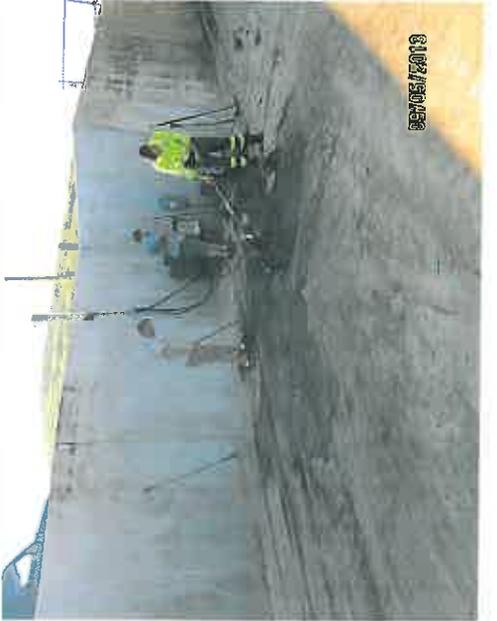
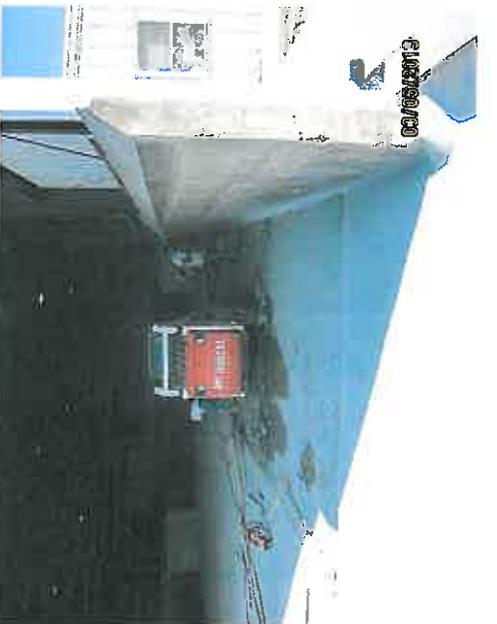
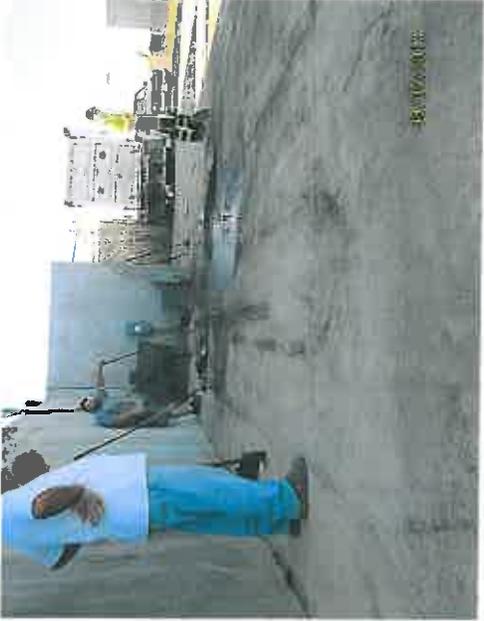
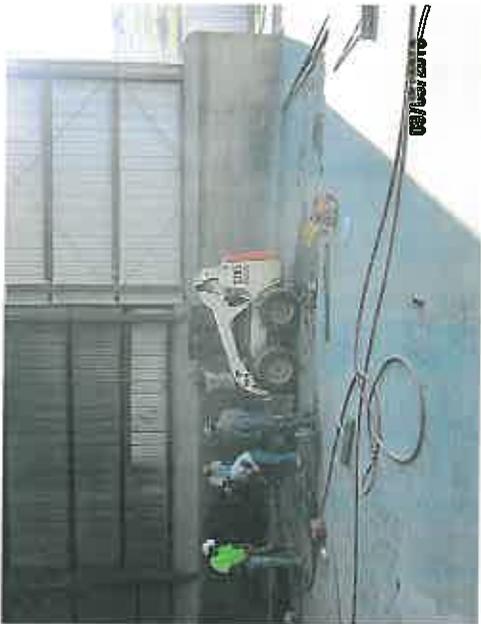
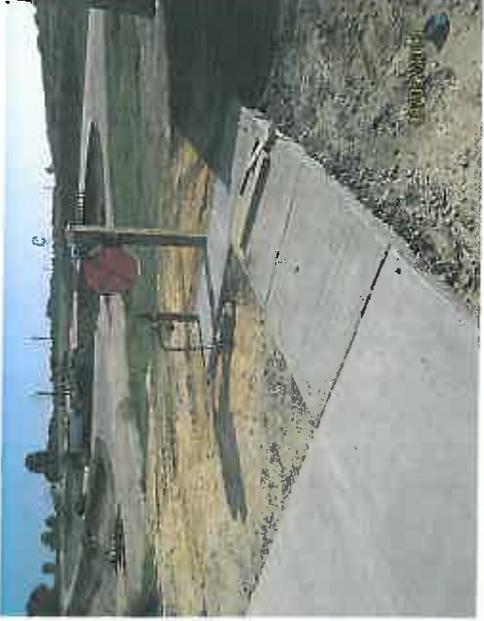
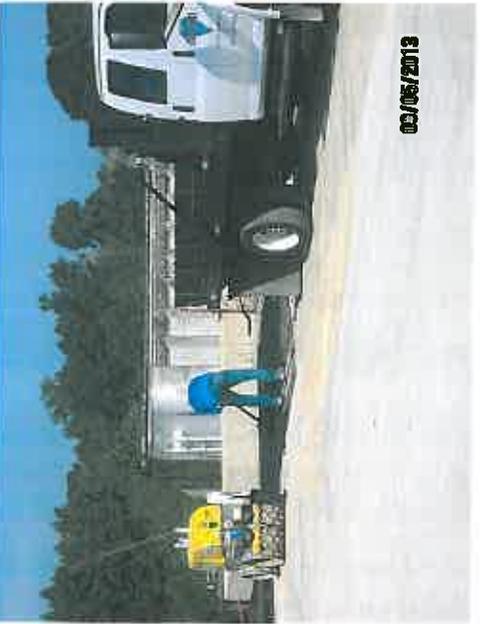
Arrived on-site in afternoon to check on progress at the site. WECC continued with general site cleanup and seedind and mulching. Met with Tyrus Clayton and Scott Eldridge and discussed flow pattern at Transfer Station. Water from the yard hydrant was sprayed onto the tipping floor and water was observed exiting the tipping floor onto the approach apron SE corner. It was discussed that two of the saw cut squares would need to be removed and replaced to remedy the situation. It was also noted that water overtopped the berm on the apron in a few spots.

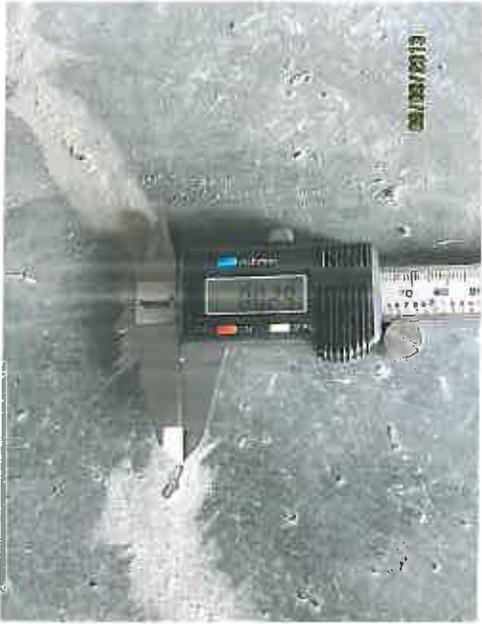
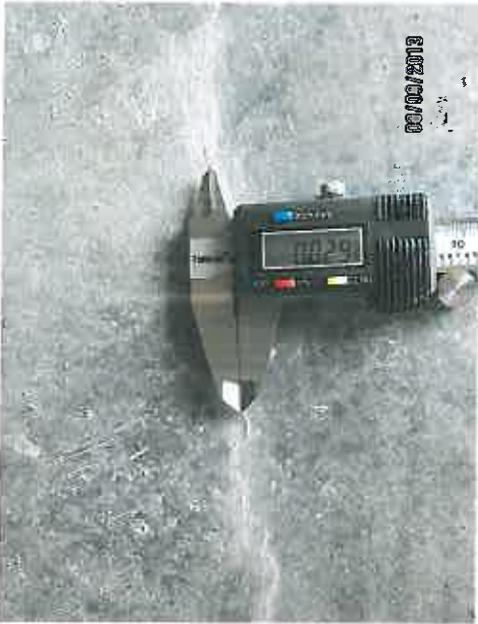
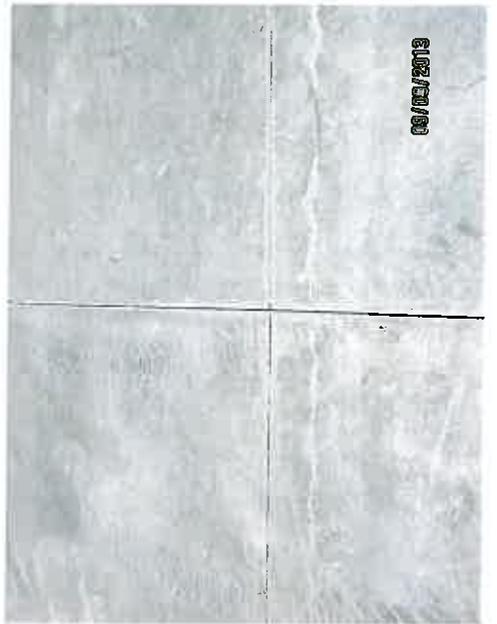
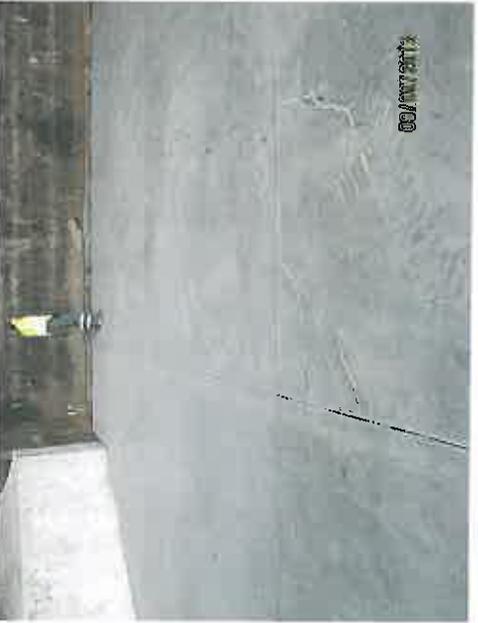
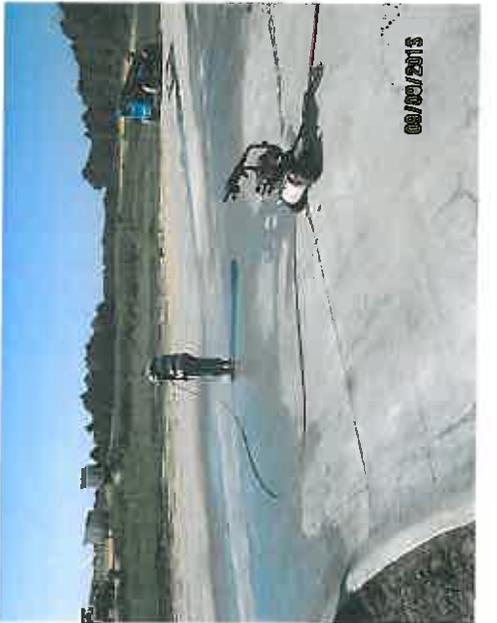
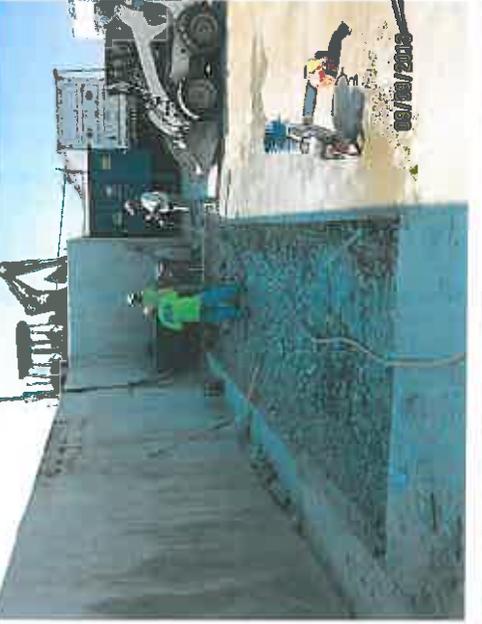
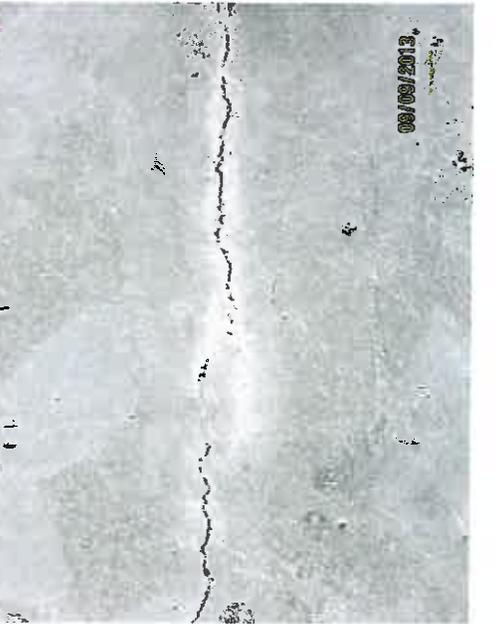
I took pictures of the cracks in the Eucotop and sketched their locations for email to Euclid rep.

I returned in the late afternoon and witnessed the installation of the Dural 50 sealer. ECS rep, Mr. Randy Smith and Ralph Barile were onsite as well. As the material was being applied (squeegeed) I began to notice that there would not be enough material to do all of the apron. I asked Ralph about it and he stated that they had not planned on covering the upper section (last row of sawcut squares leading into transfer station) as he said it did not contain cracks. I began looking at the squares and they did indeed have several hairline cracks visible. Having not enough material, the subcontractor was only able to fill the cracks as I pointed out and did not provide full coverage of all the squares or outer curbing.

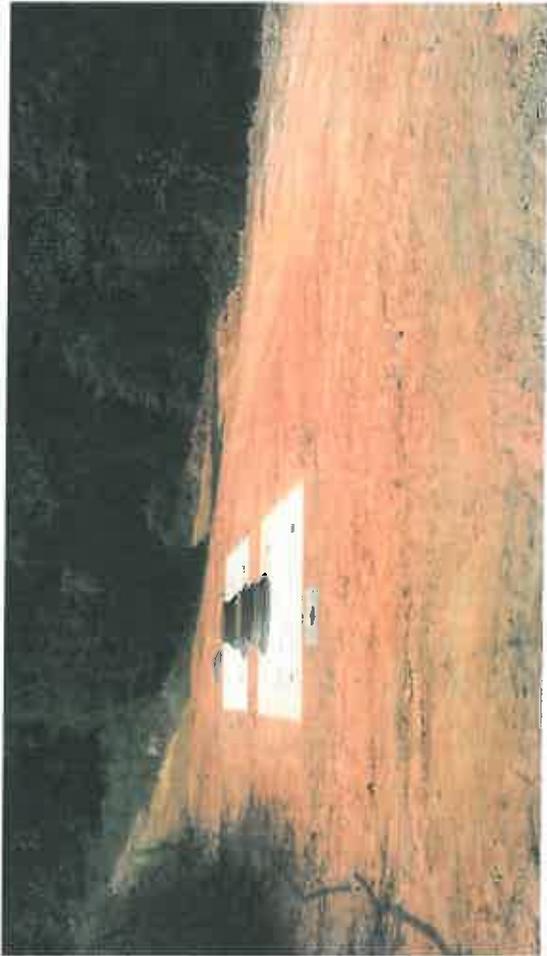
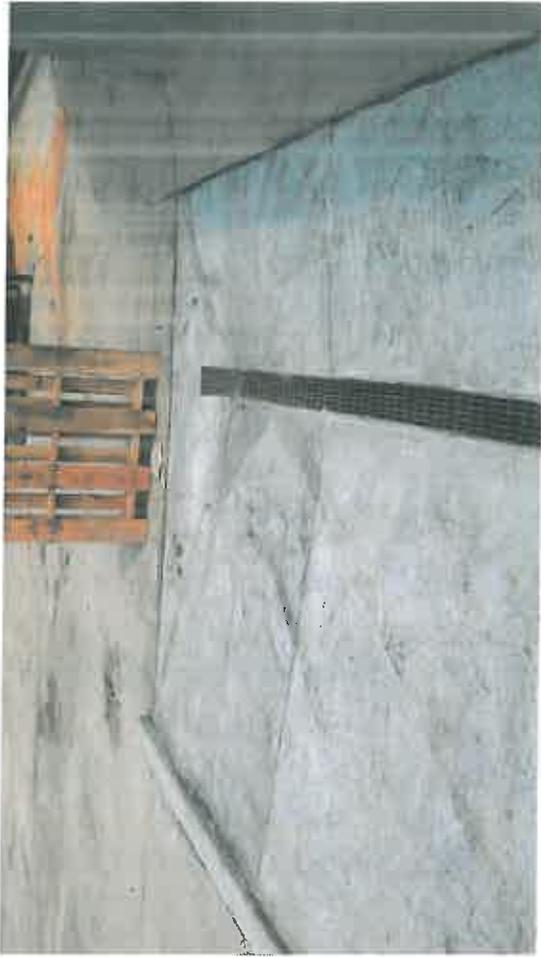
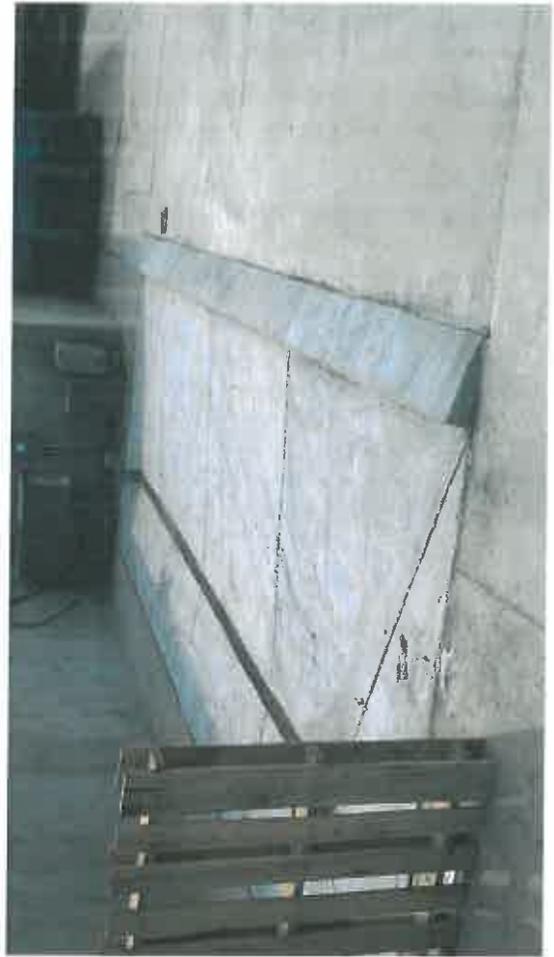
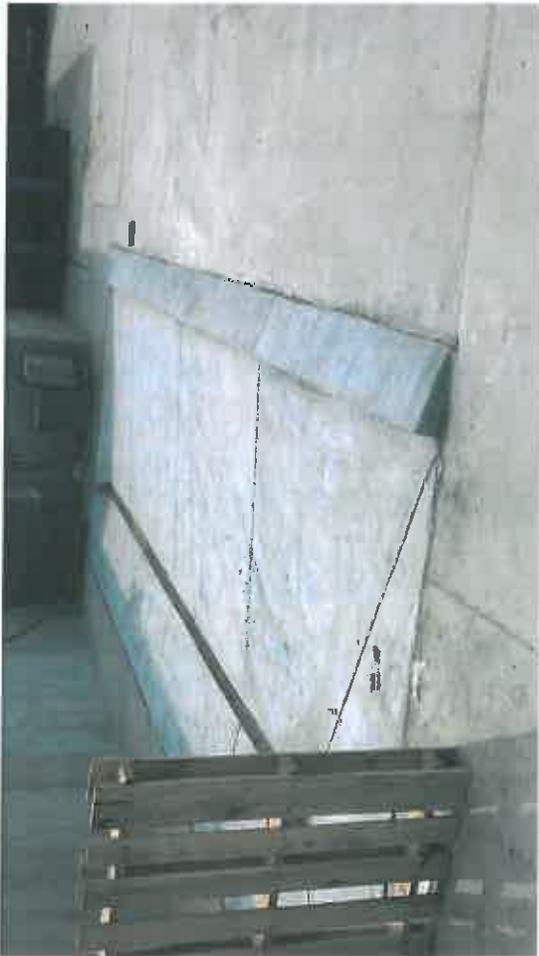
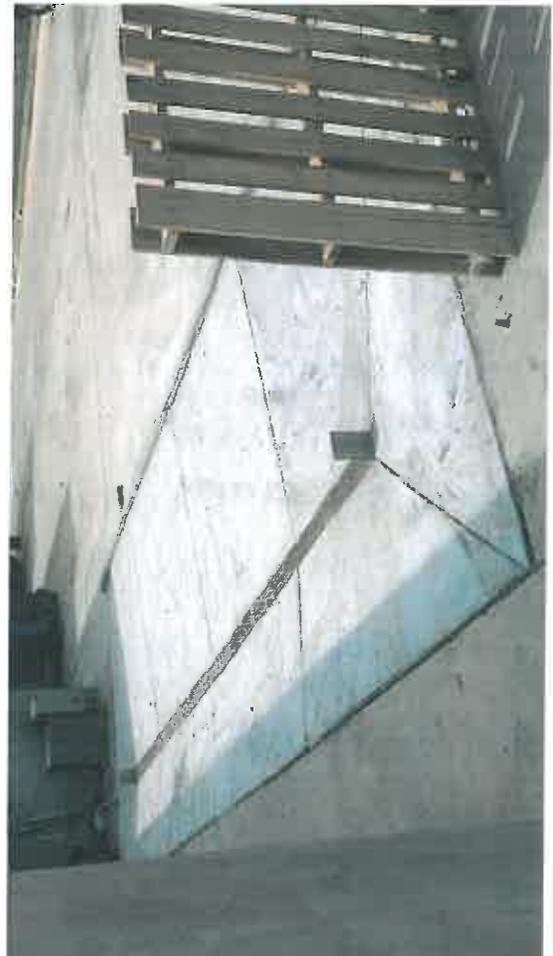
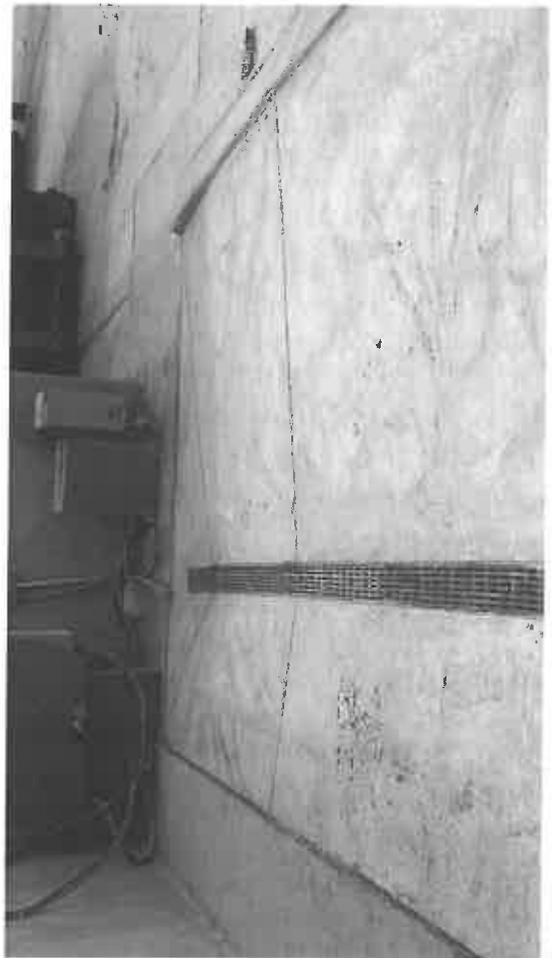
Arrived onsite at approx 9:00 am. Dave Popa was already present and inspecting the cracks in the Eucotop. Ralph Barille and Scott Eldridge arrived shortly thereafter. Mr. Popa indicated the saw cut joints were necessary and would not impact the performance of the EucoTop. We discussed the cracks that have appeared in the floor. Mr. Popa observed that all the cracks were centrally located with the exception of one linear crack that mirrored a saw cut joint. Mr. Popa stated he did not know why the cracks only appeared in the location. We observed a oily residue along each crack. Mr. Popa could not identify the substance. We discussed the need to seal the entire EucoTop with Dural 50 LM or another type of sealant. Mr. Popa indicated he saw no need to coat the entire EucoTop floor. Mr. Popa also indicated in order to be sure of the cause of the cracking, cores would have to be taken and tested and may take up to 6 weeks to get results. Mr. Popa stated he would email out a letter based on his findings and opinions tomorrow.

After Mr. Popa's departure, we observed and discussed the Dural 50 LM application that was completed earlier. Several cracks have not received sealant along the curbing and in the section underneath the building. The overall appearance of the sealant application appears to be uneven and not uniform. There are gaps in the coverage. Mr. Eldridge asked that we re-visit the need to coat the entire section not completed. I indicated I would revisit this with ECS.

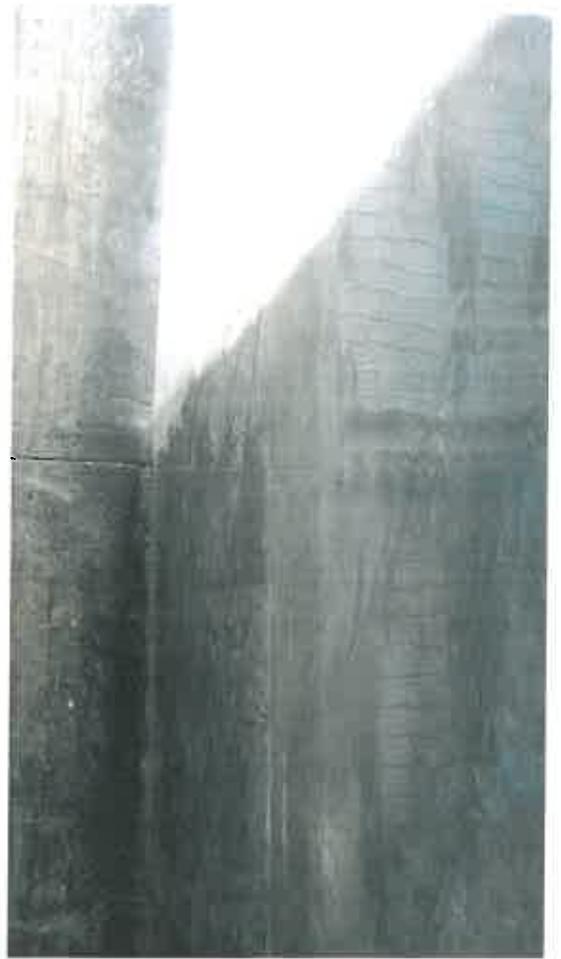
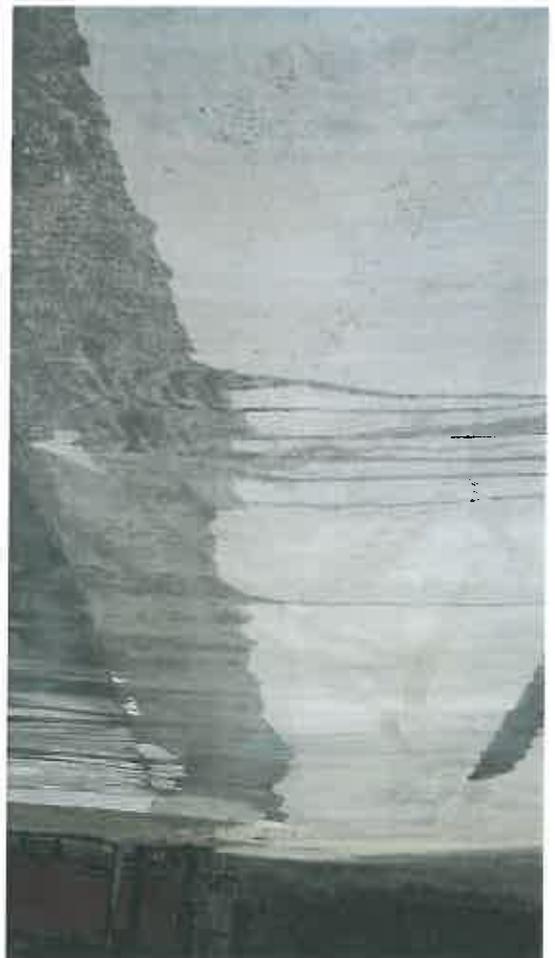
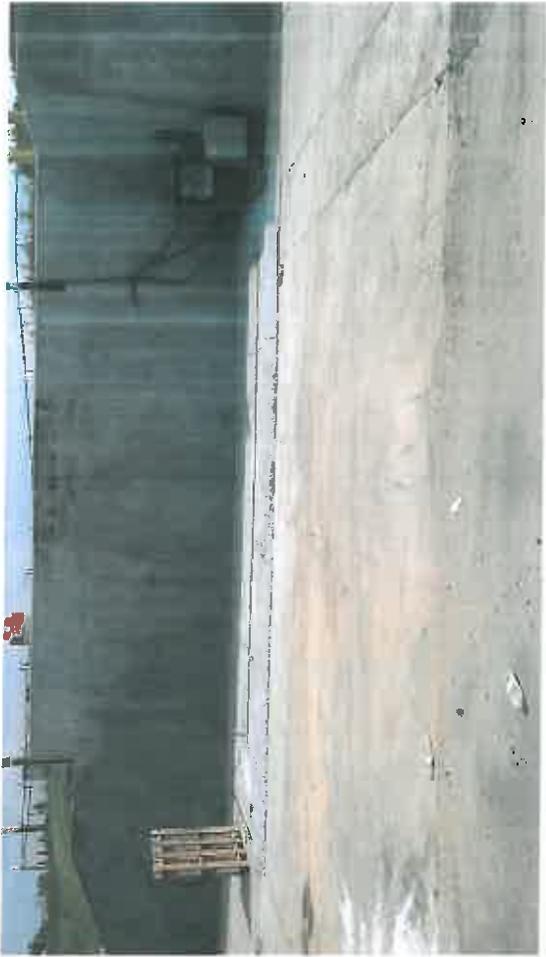
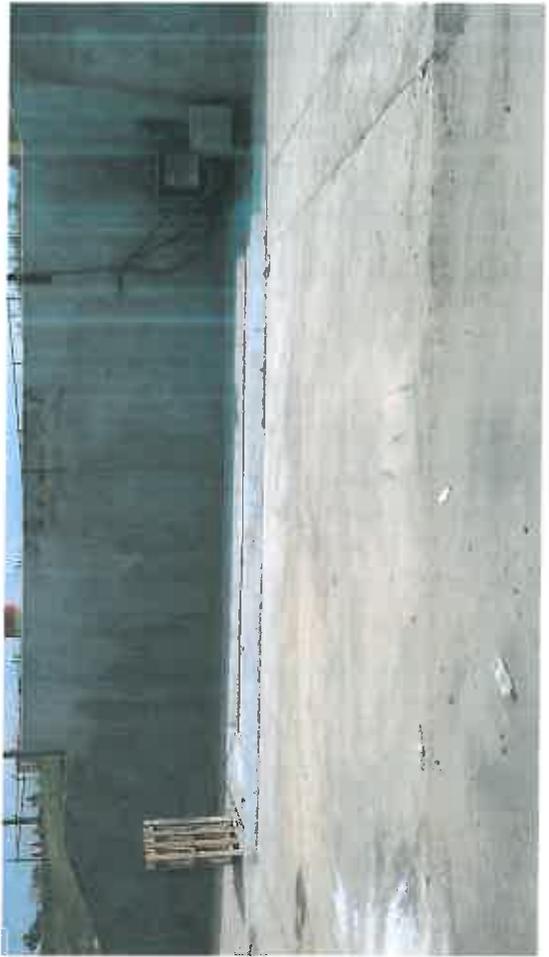
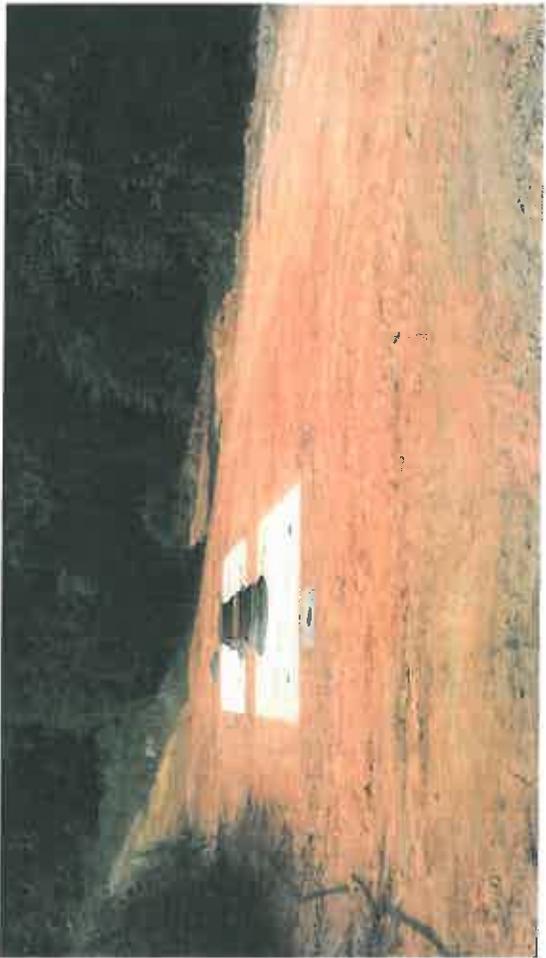
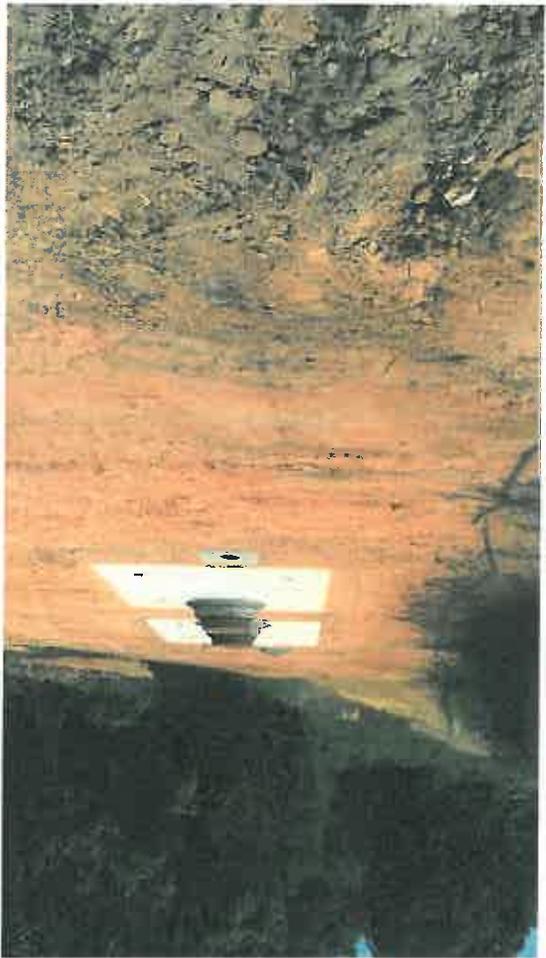
Arrived onsite at approx 9:00 am. Dave Popa was already present and inspecting the cracks in the Eucotop. Ralph Barille and Scott Eldridge arrived shortly thereafter. Mr. Popa indicated the saw cut joints were necessary and would not impact the performance of the Eucotop. We discussed the cracks that have appeared in the floor. Mr. Popa observed that all the cracks were centrally located with the exception of one linear crack that mirrored a saw cut joint. Mr. Popa stated he did not know why the cracks only appeared in the location. We observed an oily residue along each crack. Mr. Popa could not identify the substance. We discussed the need to seal the entire Eucotop with Dural 50 LM or another type of sealant. Mr. Popa indicated he saw no need to coat the entire Eucotop floor. Mr. Popa also indicated in order to be sure of the cause of the cracking, cores would have to be taken and tested and may take up to 6 weeks to get results. Mr. Popa stated he would email out a letter based on his findings and opinions tomorrow.

After Mr. Popa's departure, we observed and discussed the Dural 50 LM application that was completed earlier. Several cracks have not received sealant along the curbing and in the section underneath the building. The overall appearance of the sealant application appears to be uneven and not uniform. There are gaps in the coverage. Mr. Eldridge asked that we re-visit the need to coat the entire section not completed. I indicated I would revisit this with ECS.
