# SITE VISIT REPORT

**Project:** Dunn Erwin Landfill CAP Projects

| <b>Job No.:</b> 3002B | <b>Date:</b> August 20, 2013 |

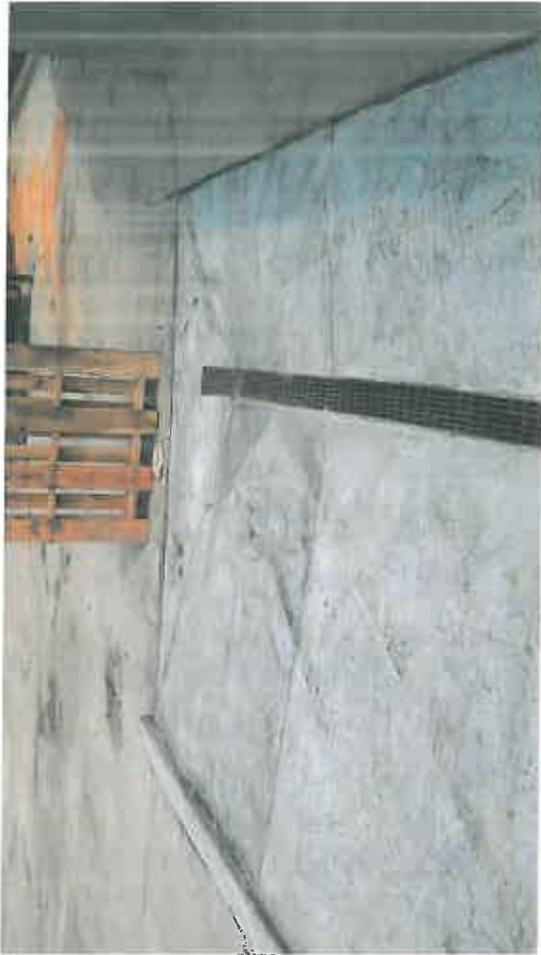
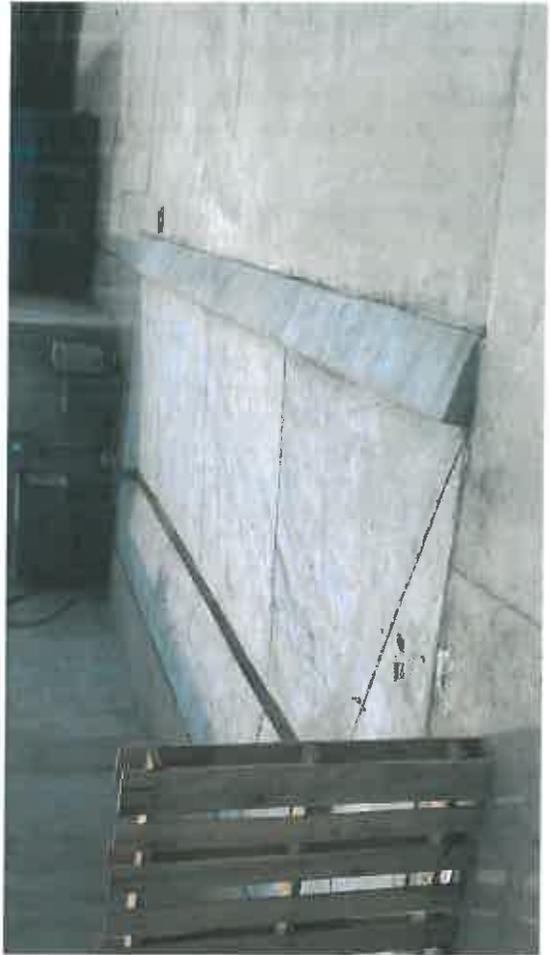
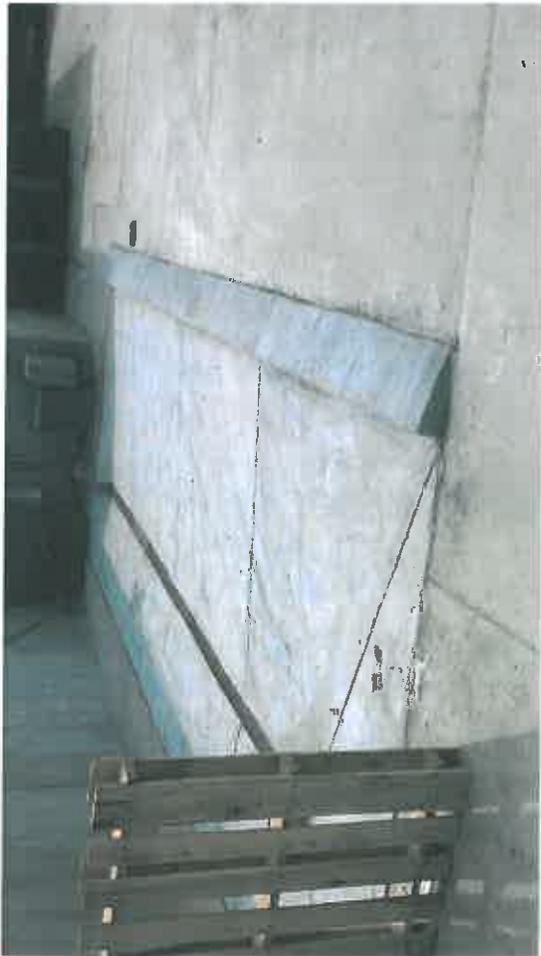
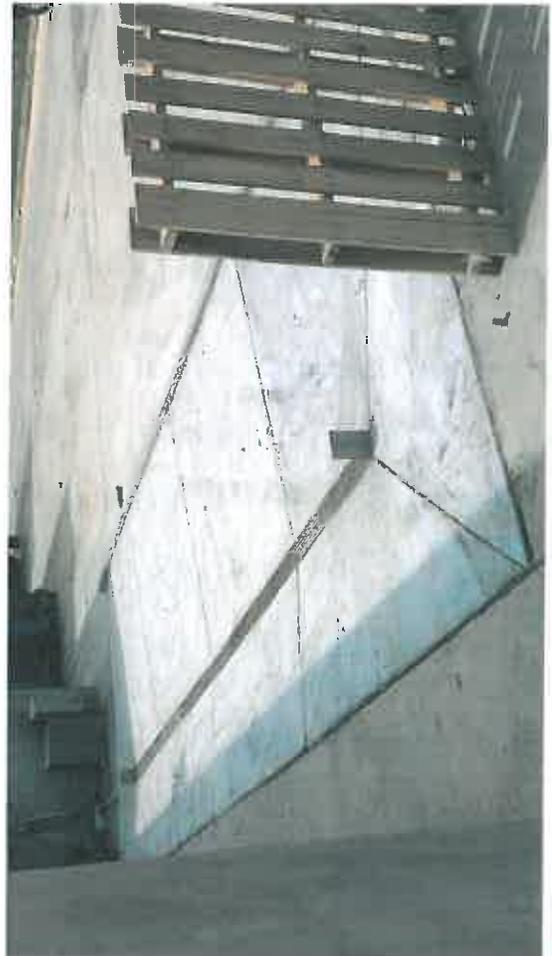
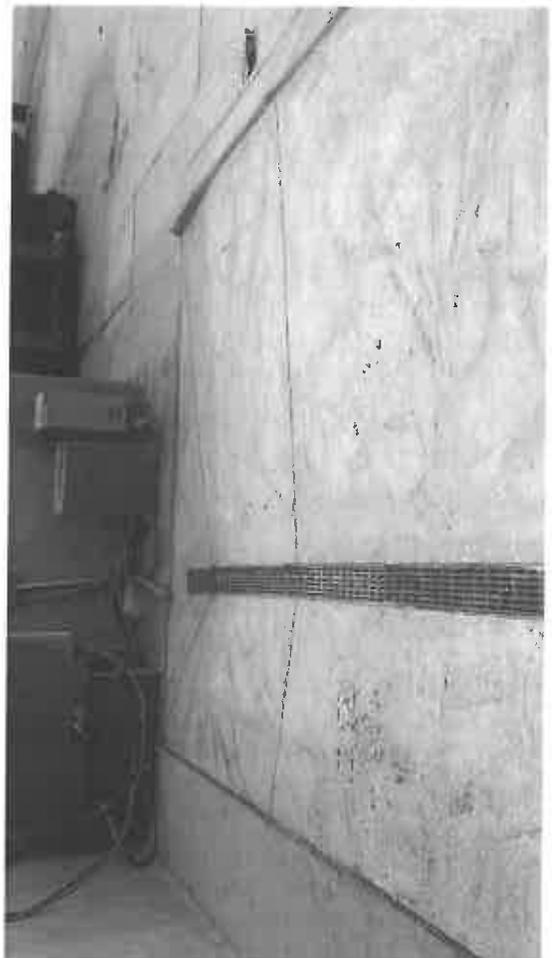
Arrived onsite at approx 9:00 am. Dave Popa was already present and inspecting the cracks in the Eucotop. Ralph Barille and Scott Eldridge arrived shortly thereafter. Mr. Popa indicated the saw cut joints were necessary and would not impact the performance of the EucoTop. We discussed the cracks that have appeared in the floor. Mr. Popa observed that all the cracks were centrally located with the exception of one linear crack that mirrored a saw cut joint. Mr. Popa stated he did not know why the cracks only appeared in the location. We observed a oily residue along each crack. Mr. Popa could not identify the substance. We discussed the need to seal the entire EucoTop with Dural 50 LM or another type of sealant. Mr. Popa indicated he saw no need to coat the entire EucoTop floor. Mr. Popa also indicated in order to be sure of the cause of the cracking, cores would have to be taken and tested and may take up to 6 weeks to get results. Mr. Popa stated he would email out a letter based on his findings and opinions tomorrow.

After Mr. Popa's departure, we observed and discussed the Dural 50 LM application that was completed earlier. Several cracks have not received sealant along the curbing and in the section underneath the building. The overall appearance of the sealant application appears to be uneven and not uniform. There are gaps in the coverage. Mr. Eldridge asked that we re-visit the need to coat the entire section not completed. I indicated I would revisit this with ECS.

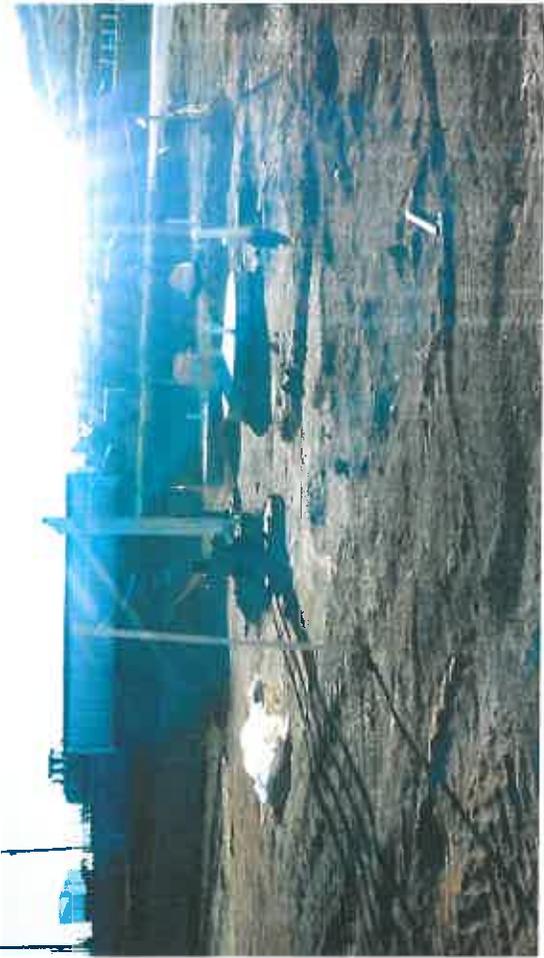
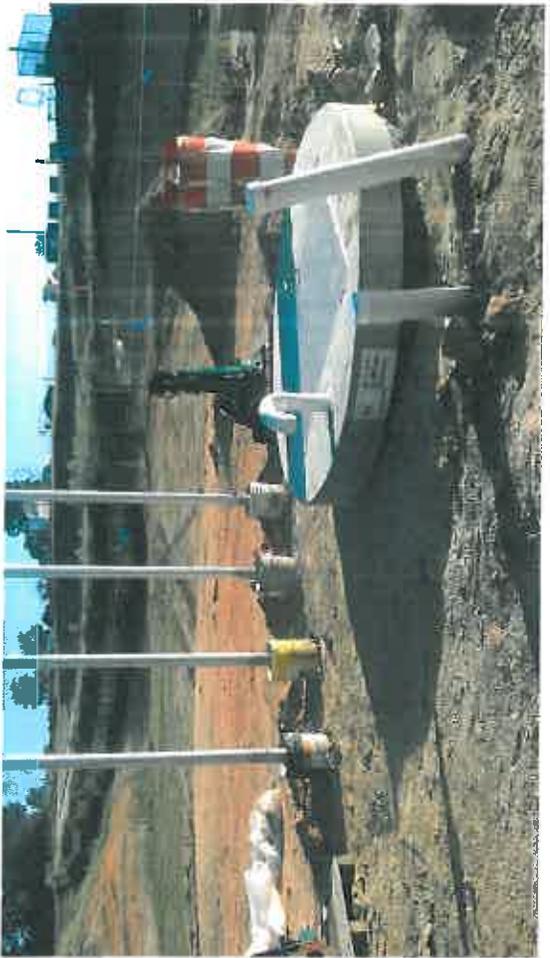
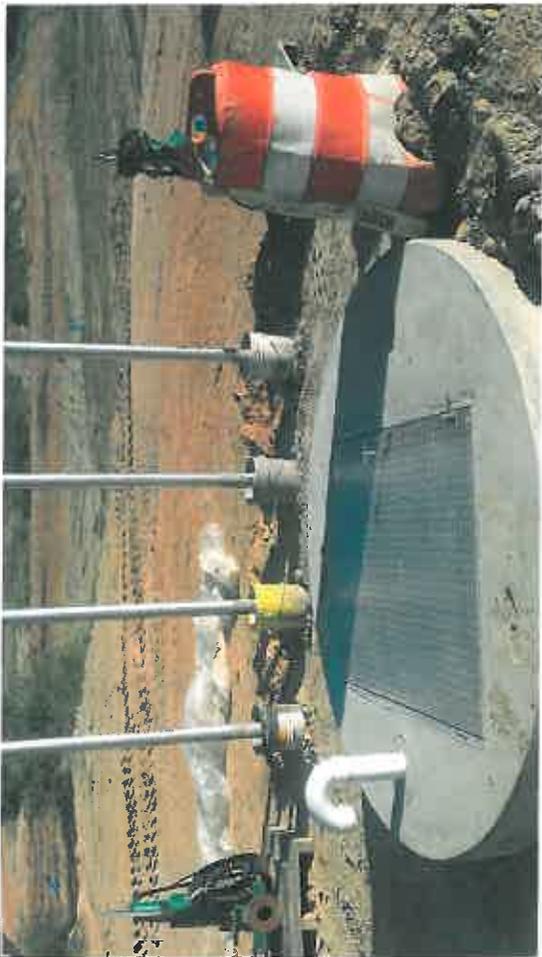
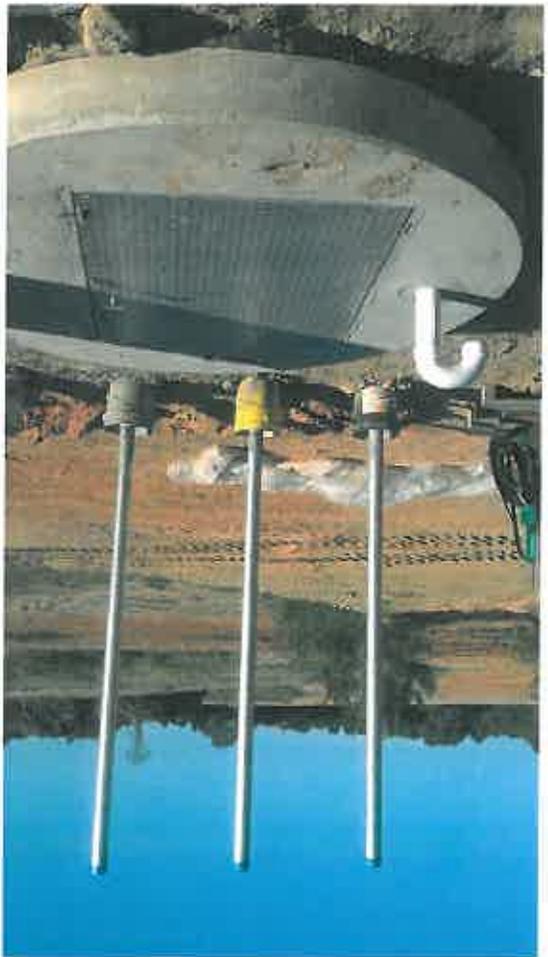
Met with Ralph Barile. Ralph indicated the punch list items would be completed today with the exception of the delivery of the remaining bin blocks, transfer station diversion berm, and painting the metal on the shingles wall. Ralph inquired if a final decision had been made on the final crack issue. I indicated to him it was still under review.

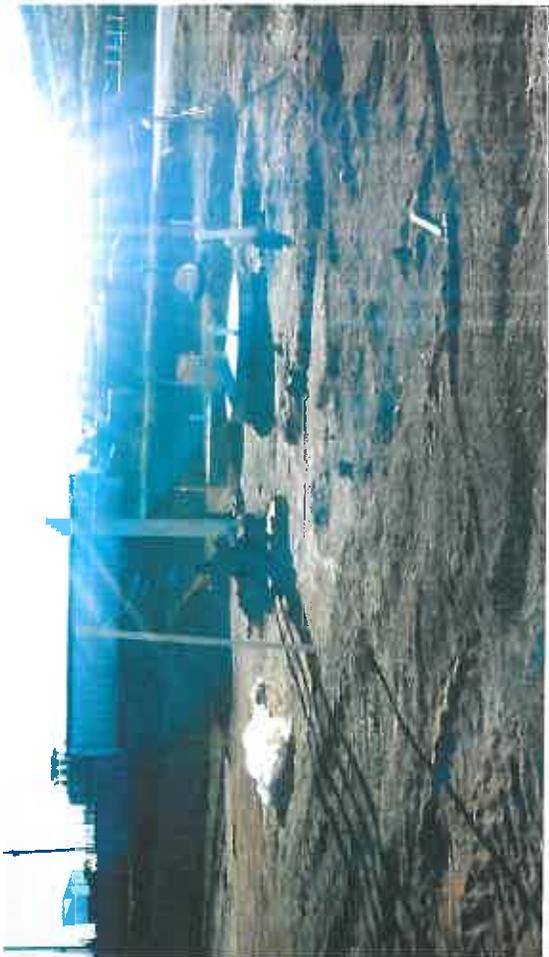
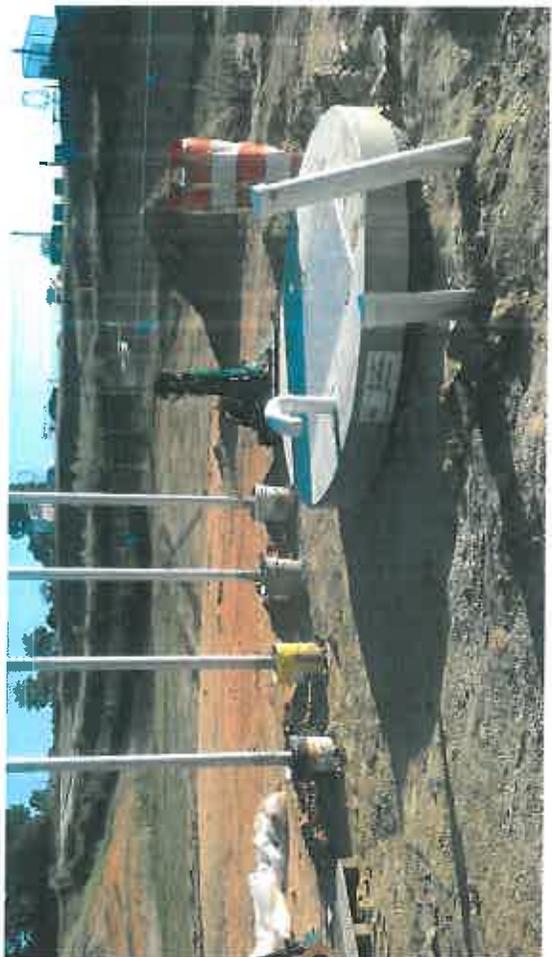
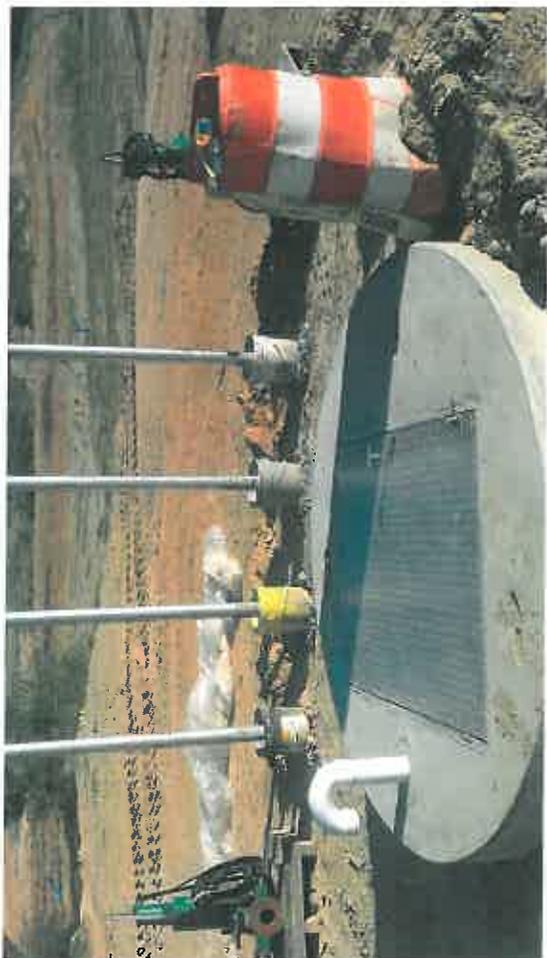
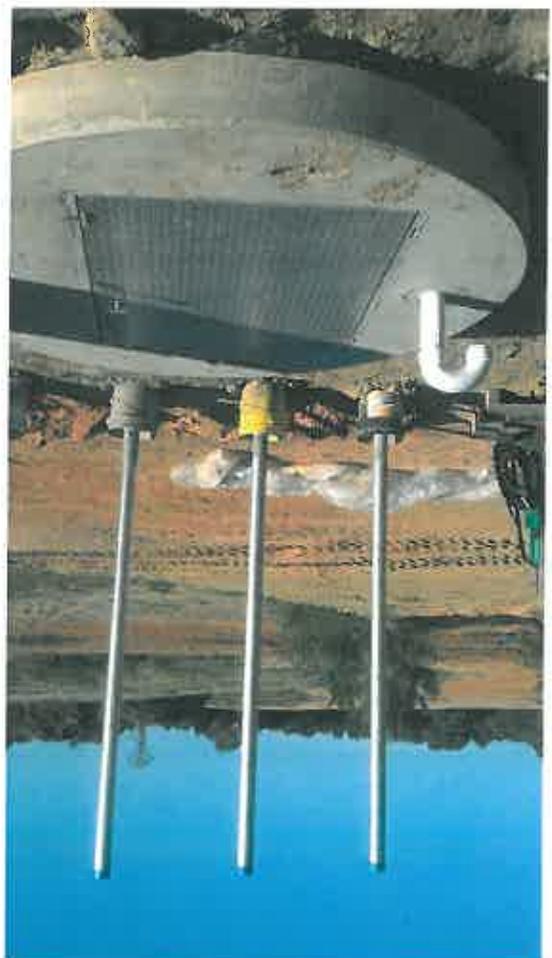
Met with Ralph Barile. Ralph indicated the punch list items would be completed today with the exception of the delivery of the remaining bin blocks, transfer station diversion berm, and painting the metal on the shingles wall. Ralph inquired if a final decision had been made on the final crack issue. I indicated to him it was still under review.
