Site Assessment Report

*File Name: Piedmont Triad Airport Authority-Gulf *Date 11-12-90

*Company/Property Owner: Piedmont Triad Airport Authority

*Address/Location: 421 / Regional Rd.

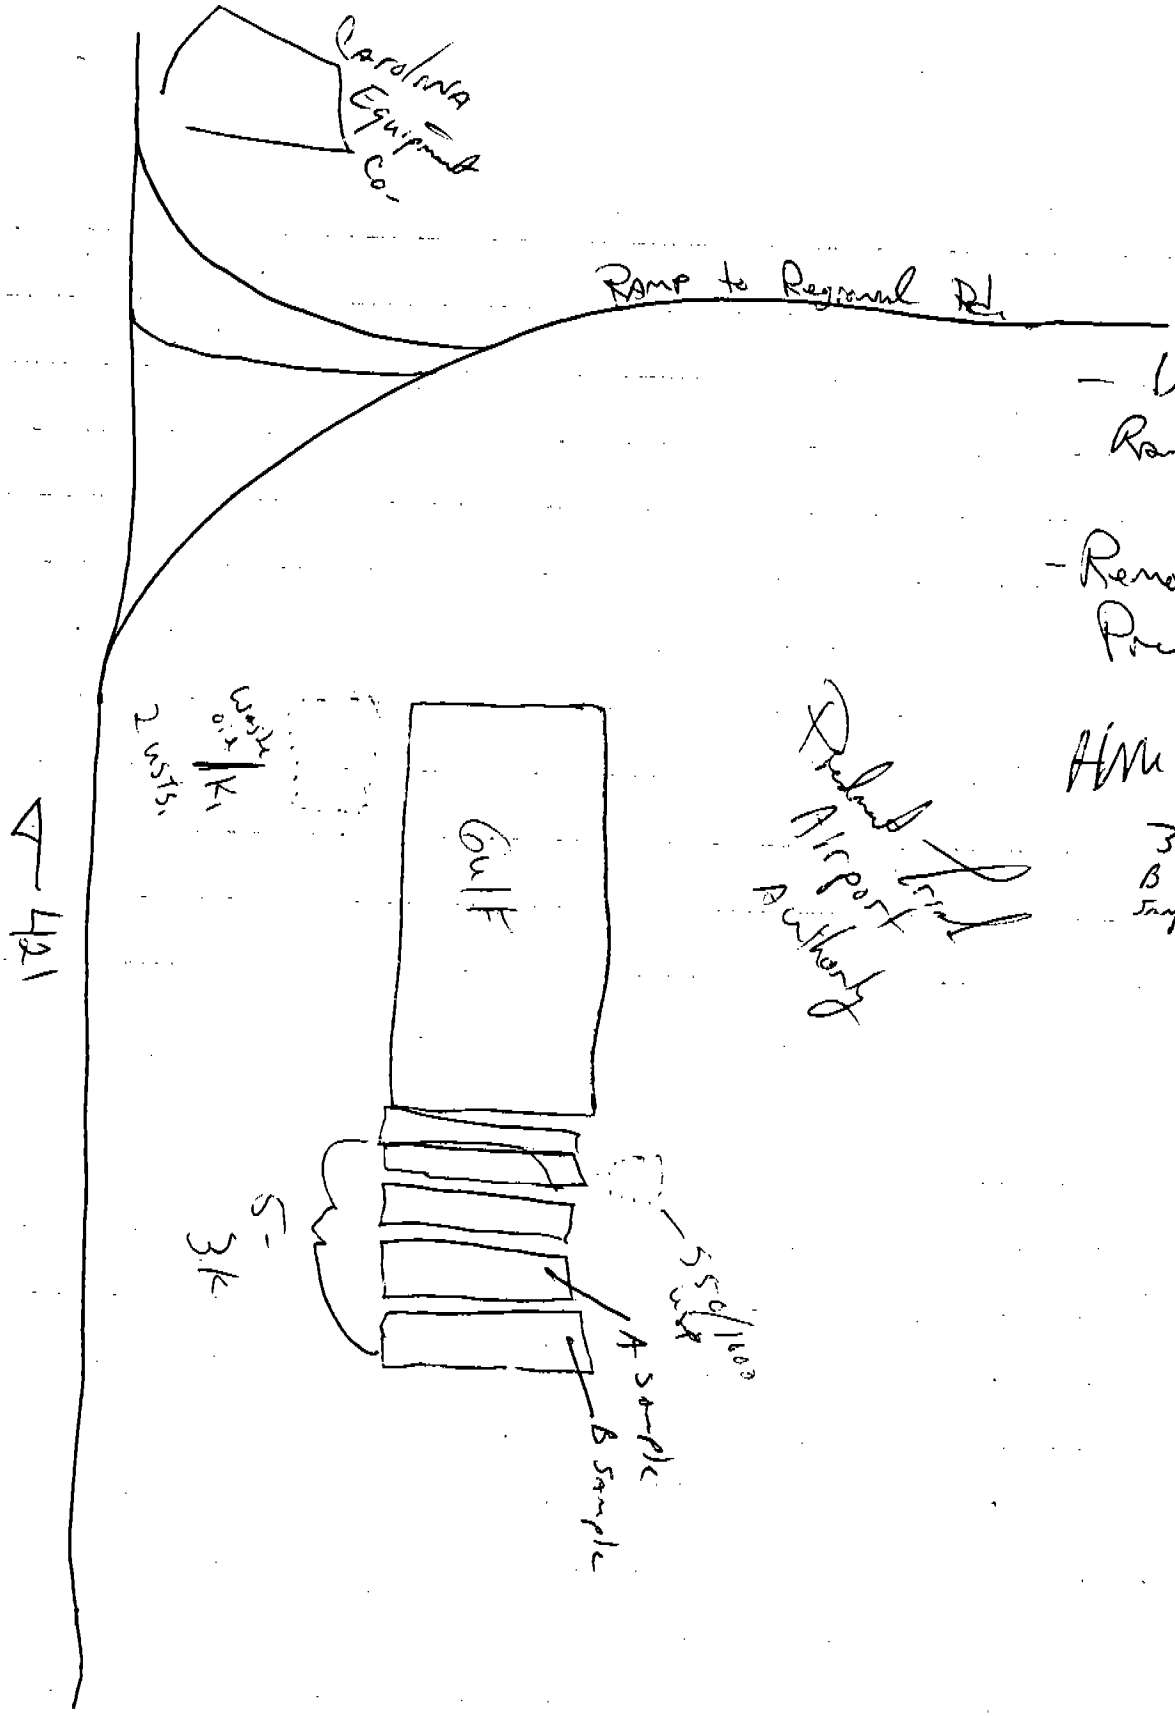
11-12-90

- US 421 at Ramp to Regional Rd.

- Removal by Piedmont Env.

HNU Readings Ranged
3 — 35
B Sample (A Sample
