Soil Management Plan
3rd & Poplar Project Brownfields Site
NC Brownfields Program
Project No. 18017-14-060

W. 3rd Street and S. Poplar Street
Charlotte, North Carolina

H&H Job No. GSL-001
December 30, 2014

**Soil Management Plan
3rd & Poplar Project Brownfields Site
W. 3rd Street and S. Poplar Street
Charlotte, North Carolina
NC Brownfields Program
Project No. 18017-14-060
H&H Job No. GSL-001**

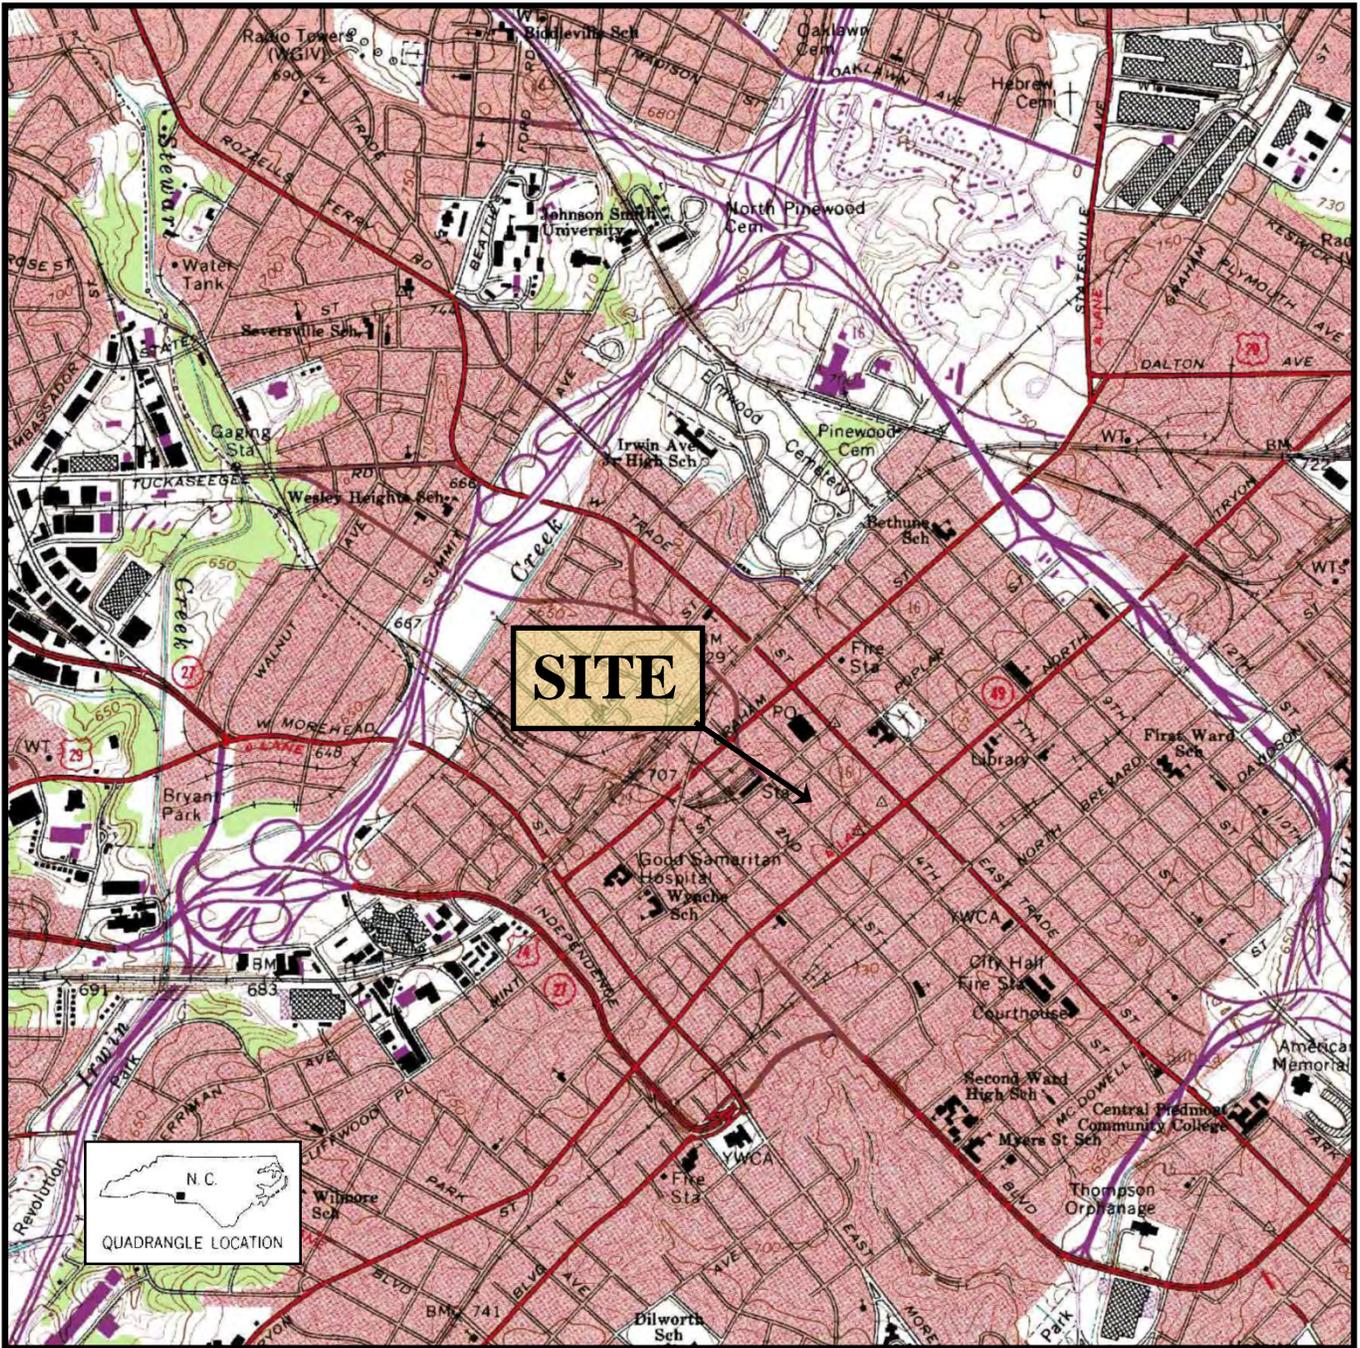
2923 S. Tryon Street, Suite 100 Charlotte, NC 28203 704.586.0007(p) 704.586.0373(f)	
DATE:	3-5-14	REVISION NO:	0
JOB NO:	GSL-001	FIGURE:	1

U.S.G.S. QUADRANGLE MAP
 CHARLOTTE EAST, NC 1991

QUADRANGLE
 7.5 MINUTE SERIES (TOPOGRAPHIC)

Figure 1 Site Location Map

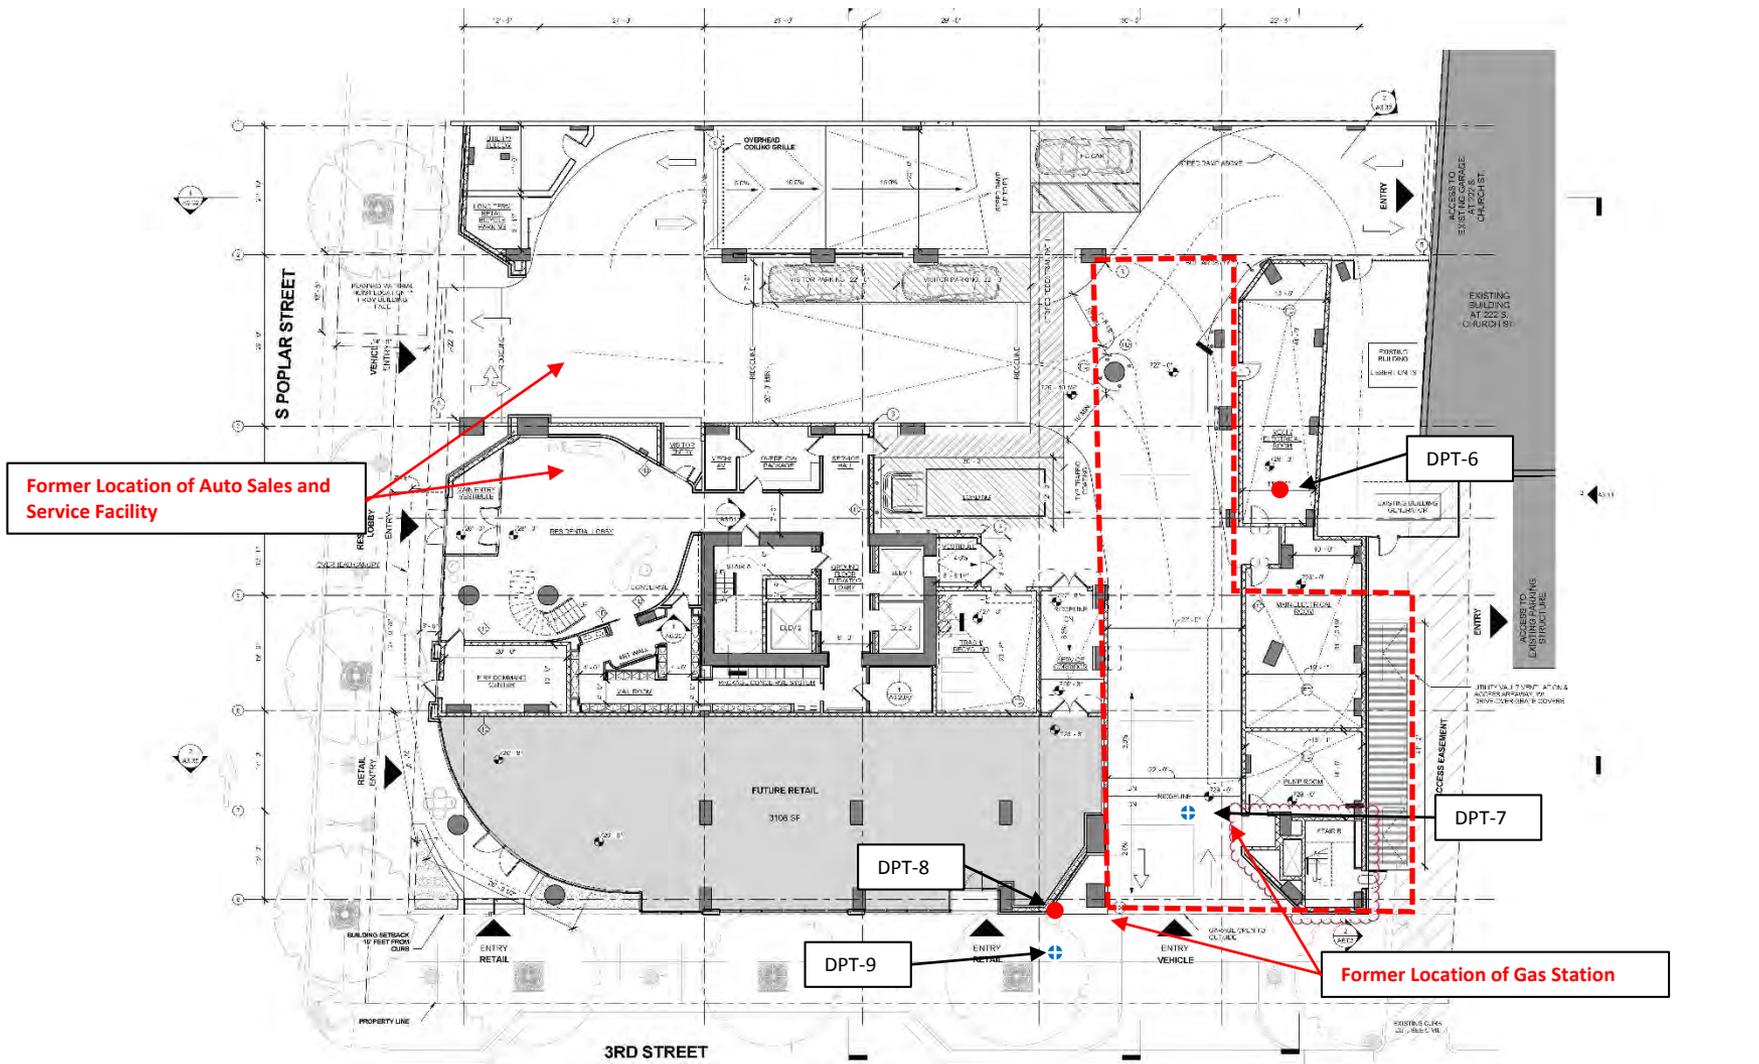
Former Location of Auto Sales and Service Facility

Former Location of Gas Station

Figure 2 Site Map

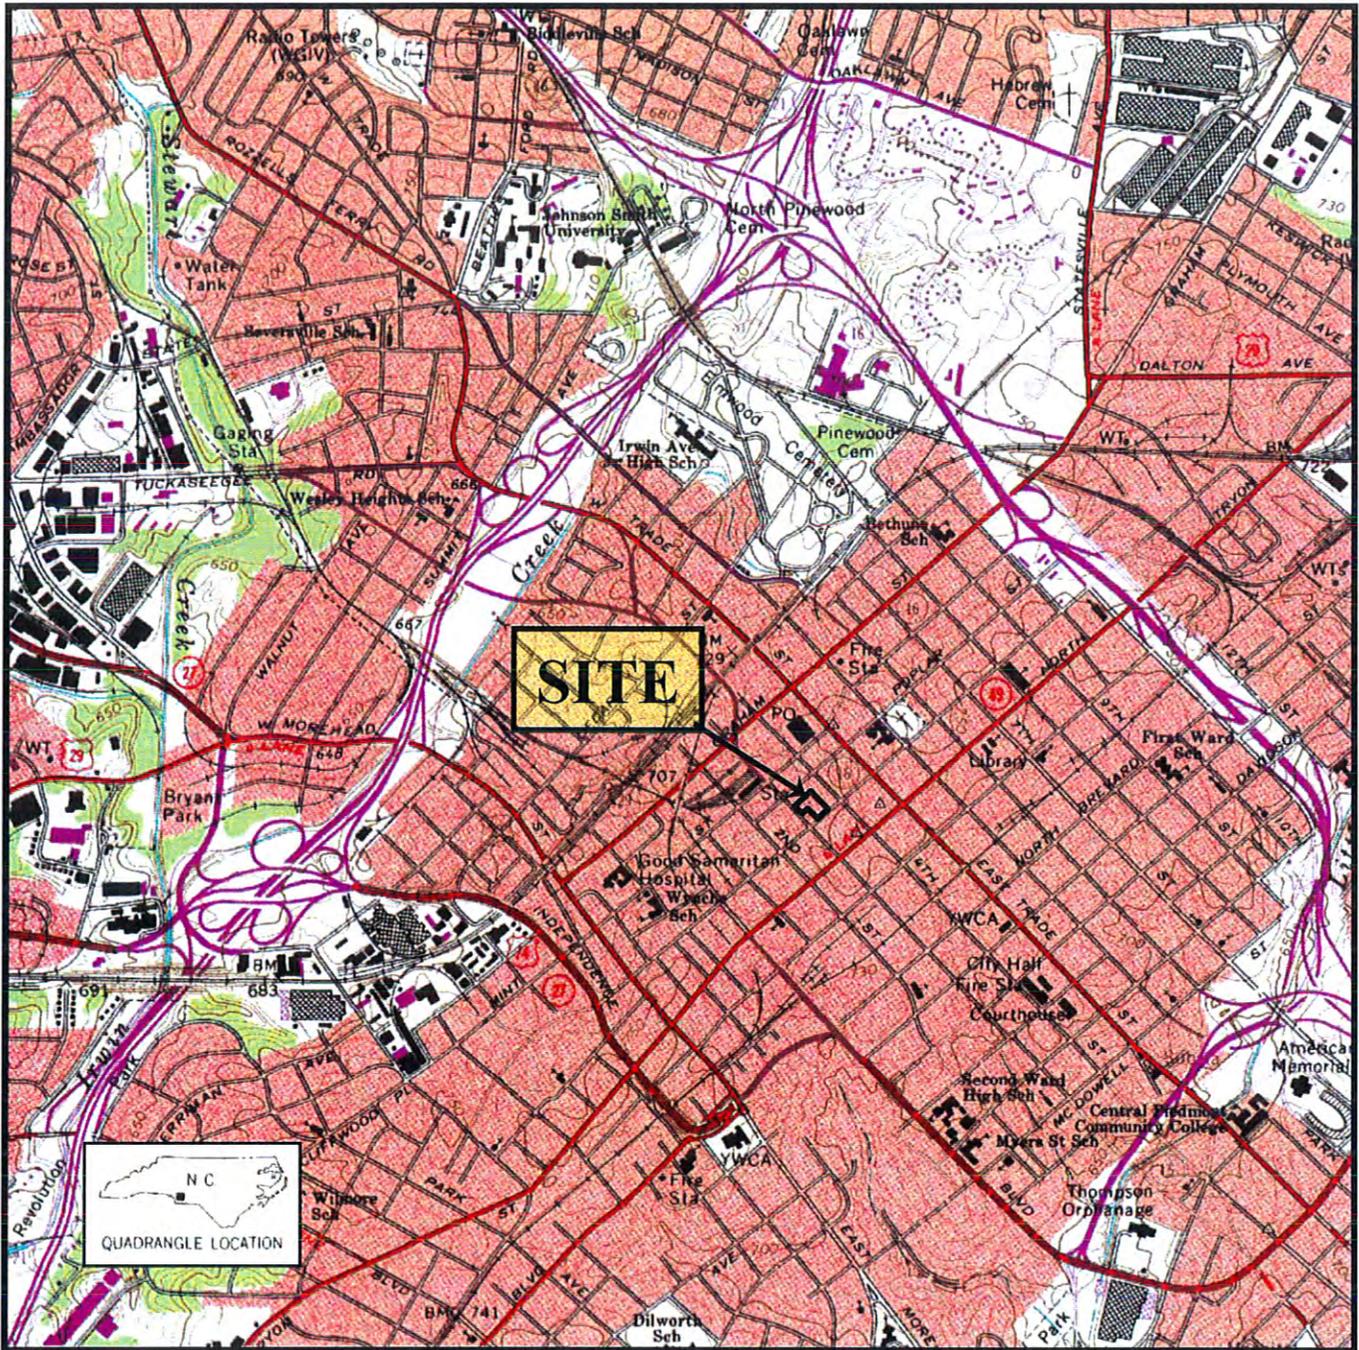
2923 South Tryon Street-Suite 100 Charlotte, North Carolina 28203 A PROFESSIONAL CORPORATION 704-586-0007 (p) 704-586-0373 (f)		
DATE:	11-11-10	REVISION NO: 0
JOB NO:	RED-001	FIGURE: 1

U.S.G.S. QUADRANGLE MAP
 CHARLOTTE EAST, NC 1991

QUADRANGLE
 7.5 MINUTE SERIES (TOPOGRAPHIC)

At your request, Hart & Hickman (H&H) has conducted a Phase II Environmental Site Assessment (ESA) at a commercial office building site located at 222 S. Church Street in Charlotte, North Carolina. The subject site consists of an approximate 0.9-acre land parcel improved with an approximate 109,125-square ft office building and an adjacent parking deck. A site location map is presented as Figure 1, and a site plan is presented as Figure 2.

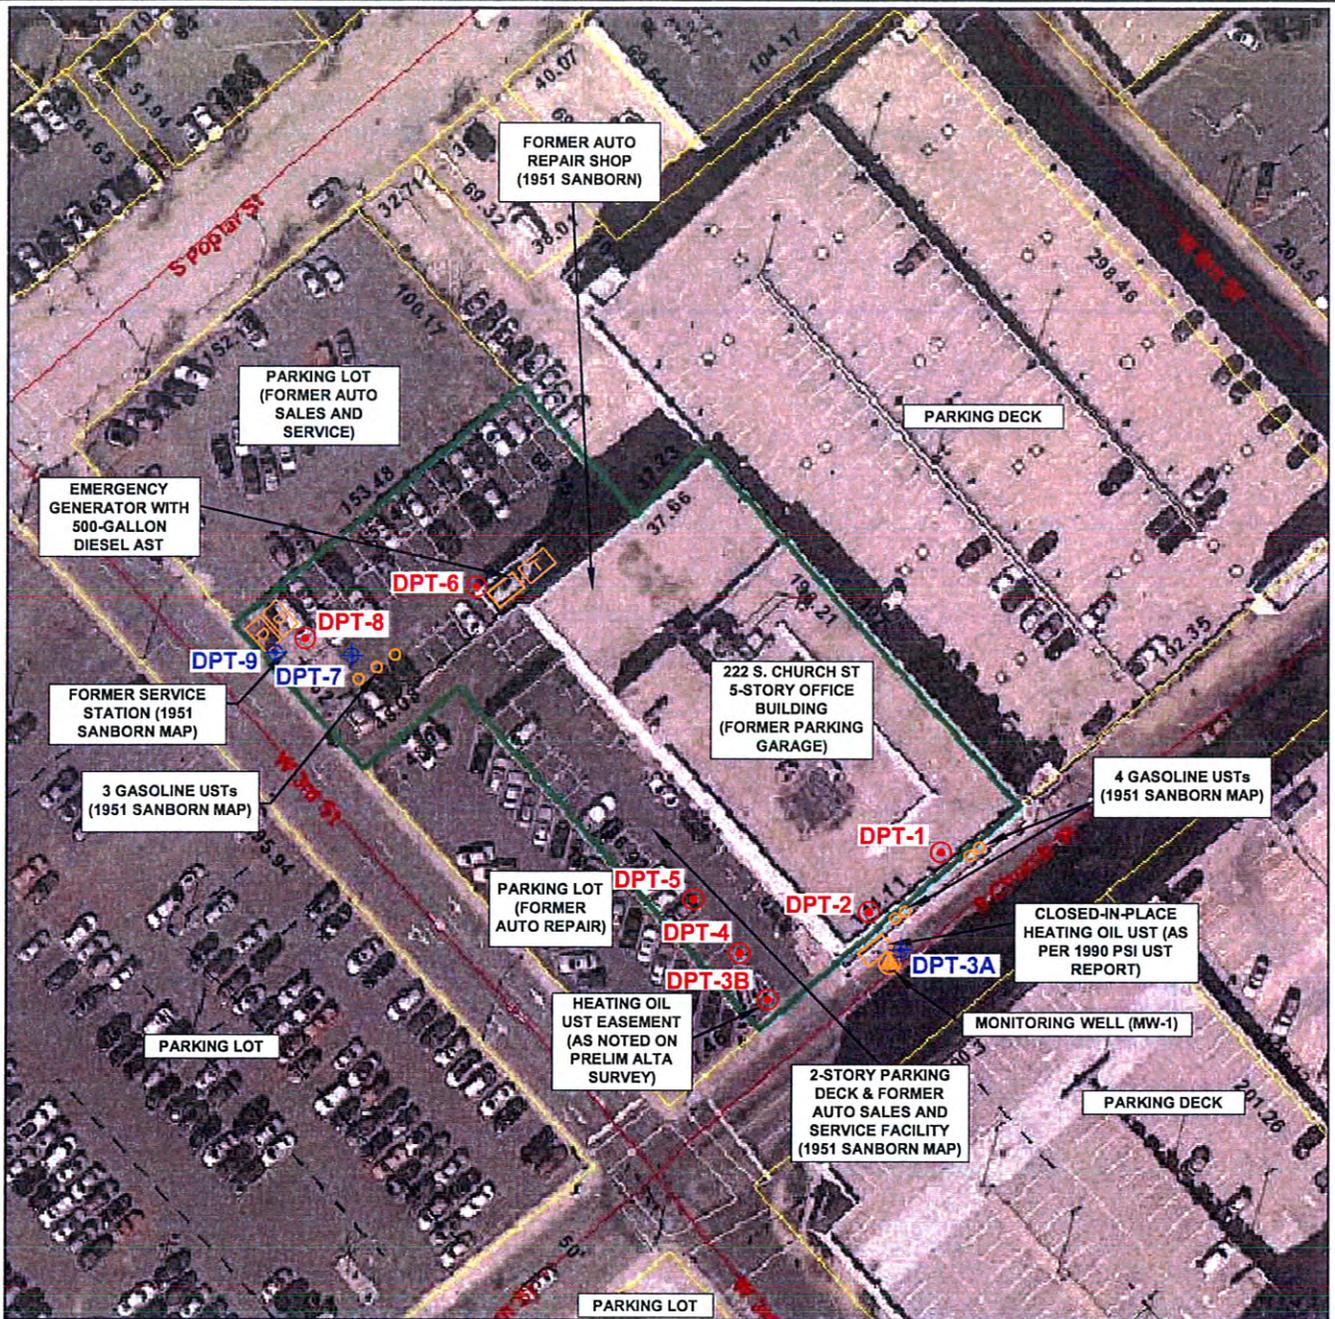
TITLE	
SITE PLAN AND SAMPLE LOCATION MAP	
PROJECT	
222 S. CHURCH STREET CHARLOTTE, NORTH CAROLINA	
2923 South Tryon Street-Suite 100 Charlotte, North Carolina 28203 704-586-0007(p) 704-586-0373(f) License # C-1269	
DATE: 11-9-10	REVISION NO. 0
JOB NO: RED-001	FIGURE: 2

- T PAD-MOUNTED TRANSFORMER
- D DUMPSTER
- EXISTING MONITORING WELL
- ⊕ SOIL BORING/ TEMPORARY MONITORING WELL LOCATION
- ⊙ SOIL BORING LOCATION

Prior to ground water sampling activities, H&H obtained a Subsurface Investigation Permit (SIP) from the Groundwater and Wastewater Services Section of the Mecklenburg County Land Use and Environmental Services Agency (LUESA). Phase II ESA sampling locations are shown on Figure 2.

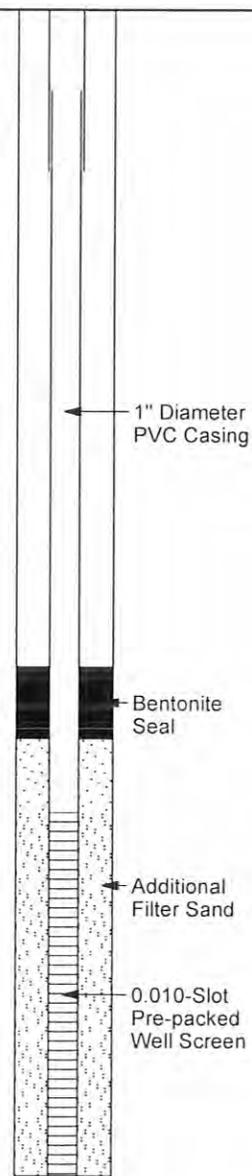
BORING NUMBER DPT-3B

BORING STARTED: 11/2/10
 BORING COMPLETED: 11/2/10
 TOTAL DEPTH: 32
 SURFACE ELEV:
 DEPTH TO WATER:

Remarks:
 Soil samples collected from 2-4 ft, 9-11 ft, and 18-20 ft

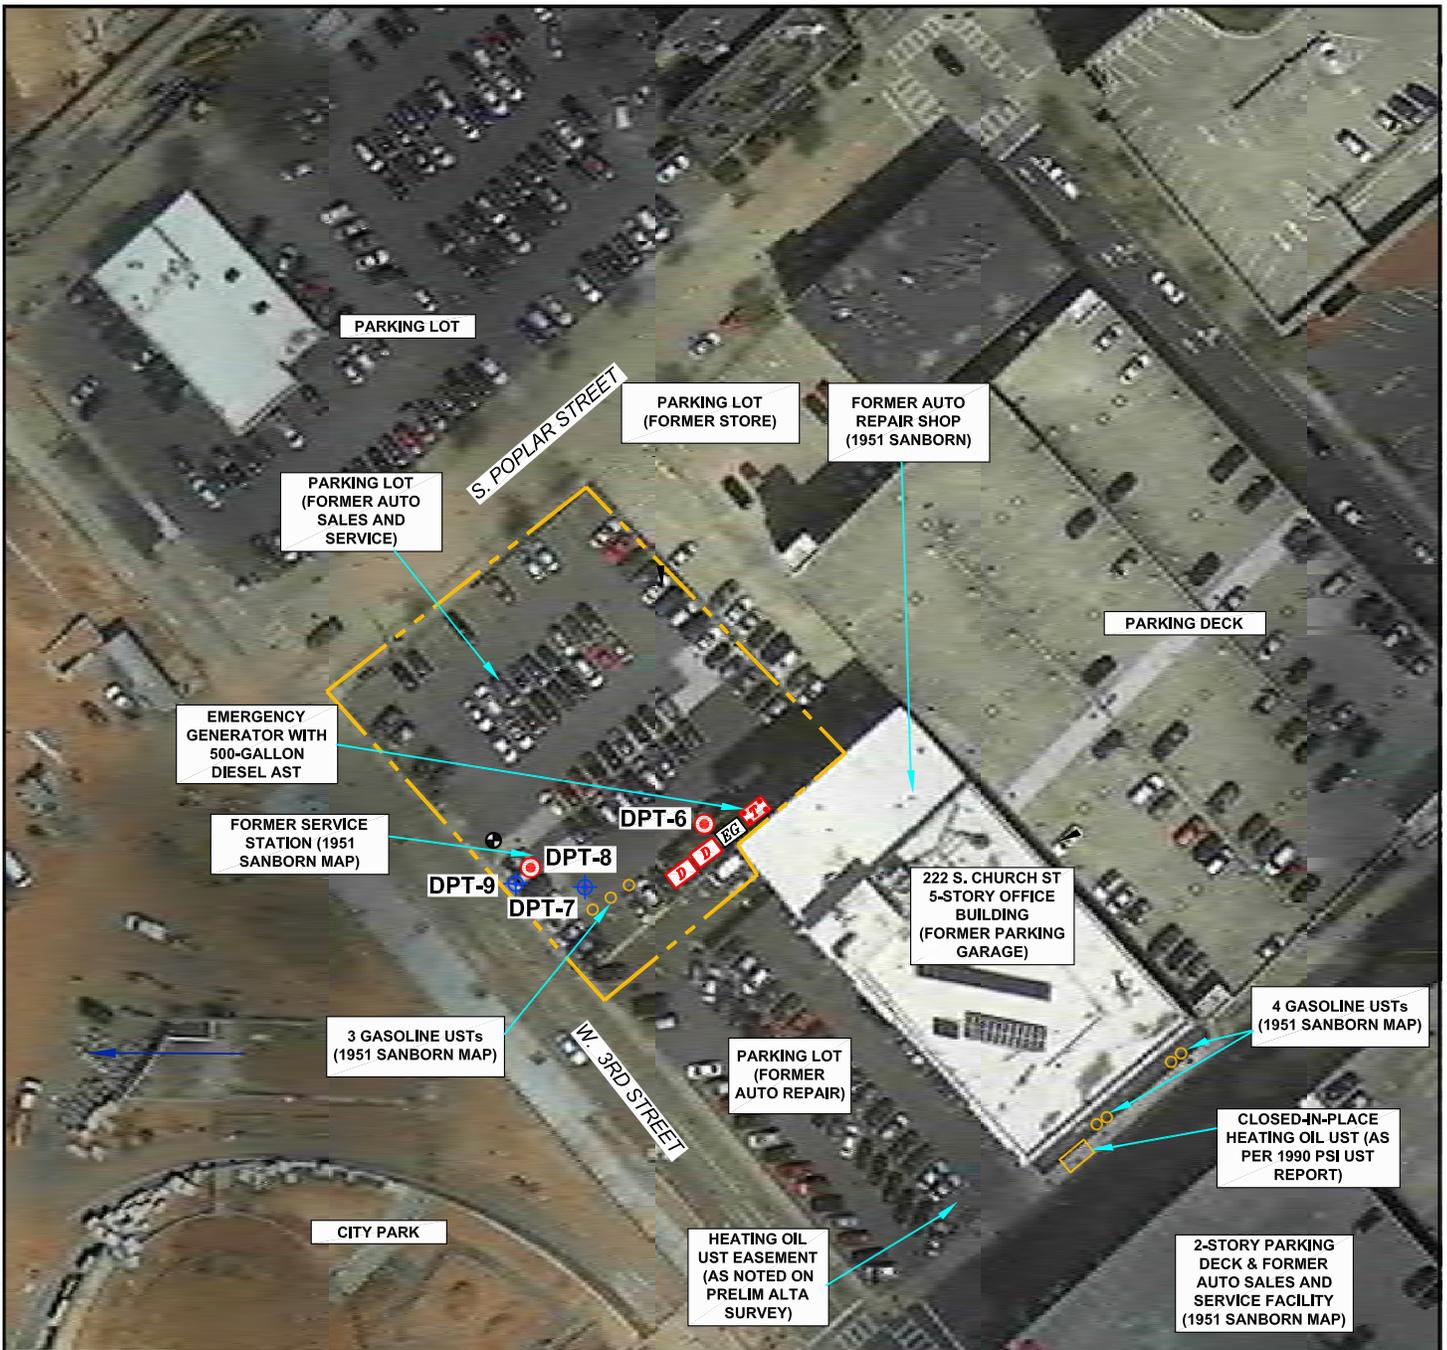
TITLE SITE MAP	
PROJECT PARKING LOTS 1 & 2 W. 3RD STREET AND S. POPLAR STREET CHARLOTTE, NORTH CAROLINA	
2923 South Tryon Street-Suite 100 Charlotte, North Carolina 28203 704-586-0007(p) 704-586-0373(f) License # C-1269 / #C-245 Geology	
DATE: 03-14-14	REVISION NO. 0
JOB NO. GPL-001	FIGURE NO. 2

- SITE PROPERTY BOUNDARY
- PAD-MOUNTED TRANSFORMER
- DUMPSTERS
- EMERGENCY GENERATOR
- EXISTING MONITORING WELL
- SOIL BORING/TEMPORARY MONITORING WELL LOCATION
- SOIL BORING LOCATION
- GROUNDWATER FLOW DIRECTION

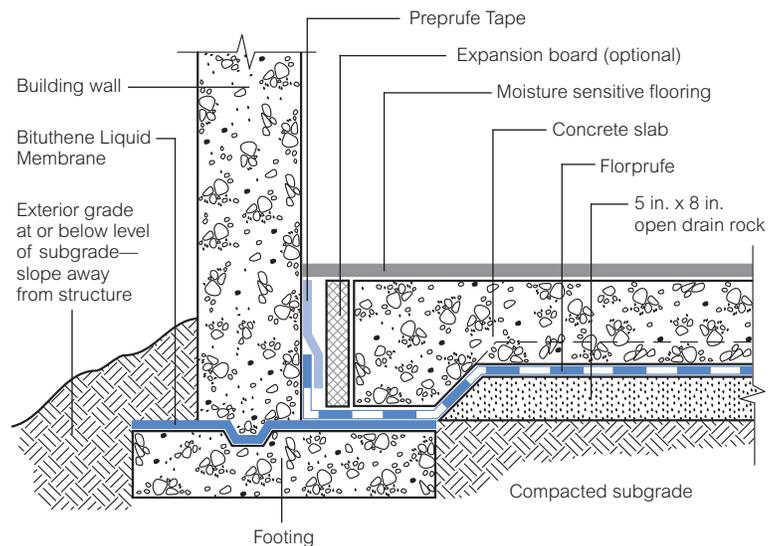
Typical Assembly

Florprufe 120 can be applied at temperatures of 25°F (-4°C) or above. Membrane installation is unaffected by wet weather. Installation and detailing of Florprufe 120 are generally in accordance with ASTM E1643-98.

Drawings are for illustration purposes only. Please refer to www.graceconstruction.com for specific application details.

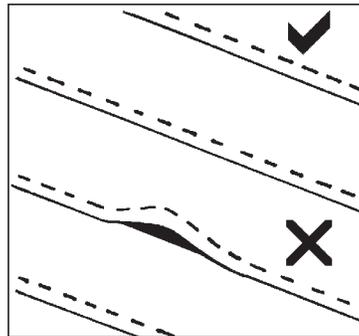
Figure 1

To prevent the membrane from moving and gaps opening, the laps should be fastened together at 39 in. (1.0 m) maximum centers. Fix through the center of the lap area using 0.5 in. (12 mm) long washer-head, self-tapping, galvanized screws (or similar) and allowing the head of the screw to bed into the adhesive compound to self-seal. It is not necessary to fix the membrane to the substrate, only to itself. Ensure the membrane lays flat and no openings occur. (See Figure 1.) Additional fastening may be required at corners, details, etc. Continuity is achieved once the slab is poured and the bond to concrete develops.

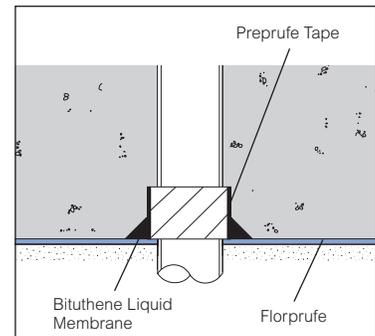
Mix and apply Bituthene Liquid Membrane detailing compound to seal around penetrations such as drainage pipes, etc. (See Figure 2 and refer to the Bituthene Liquid Membrane data sheet, BIT-230.)
