Phase I Environmental Site Assessment

Gateway Center Land - Sycamore
Charlotte, North Carolina 28202
Mail Code: NCW-289

April 29, 2011

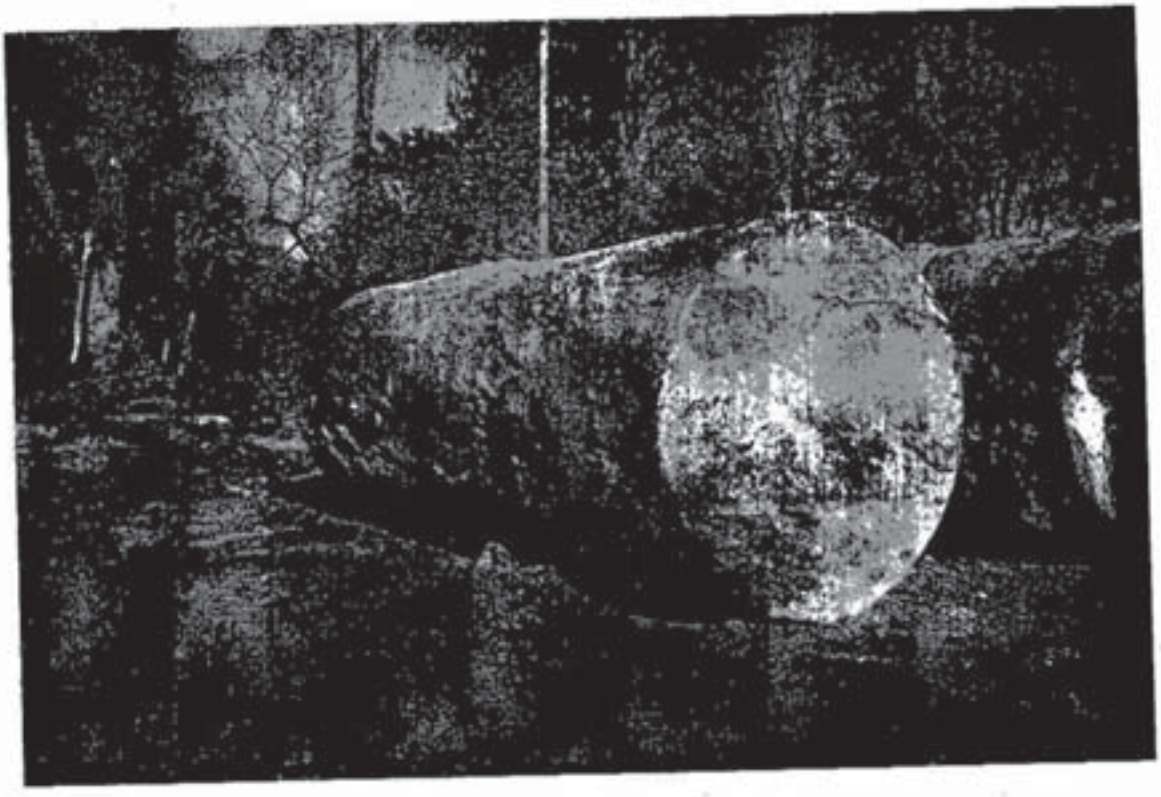
Photograph 4: View of Tank No. 3.
