Site Name (Subject):	STALLINGS SALVAGE
Site ID (Document ID):	NCSFN0406894
Document Name (DocType):	Correspondence (C)
Report Segment:	
Description:	General Corresponsdence, 1999 - 2006
Date of Document:	11/14/2006
Date Received:	
Box: *Enter SF and # with no spaces*	SF10,624
Access Level:	PUBLIC
Division:	WASTE MANAGEMENT
Section:	SUPERFUND
Program (Document Group):	SERB (SERB)
Document Category:	FACILITY

STALLINGS SALVAGE

Subject: Abbreviated Preliminary Assessment
Stallings Salvage Site
Monroe, Union County, North Carolina
US EPA ID: NCSFN 0406 894

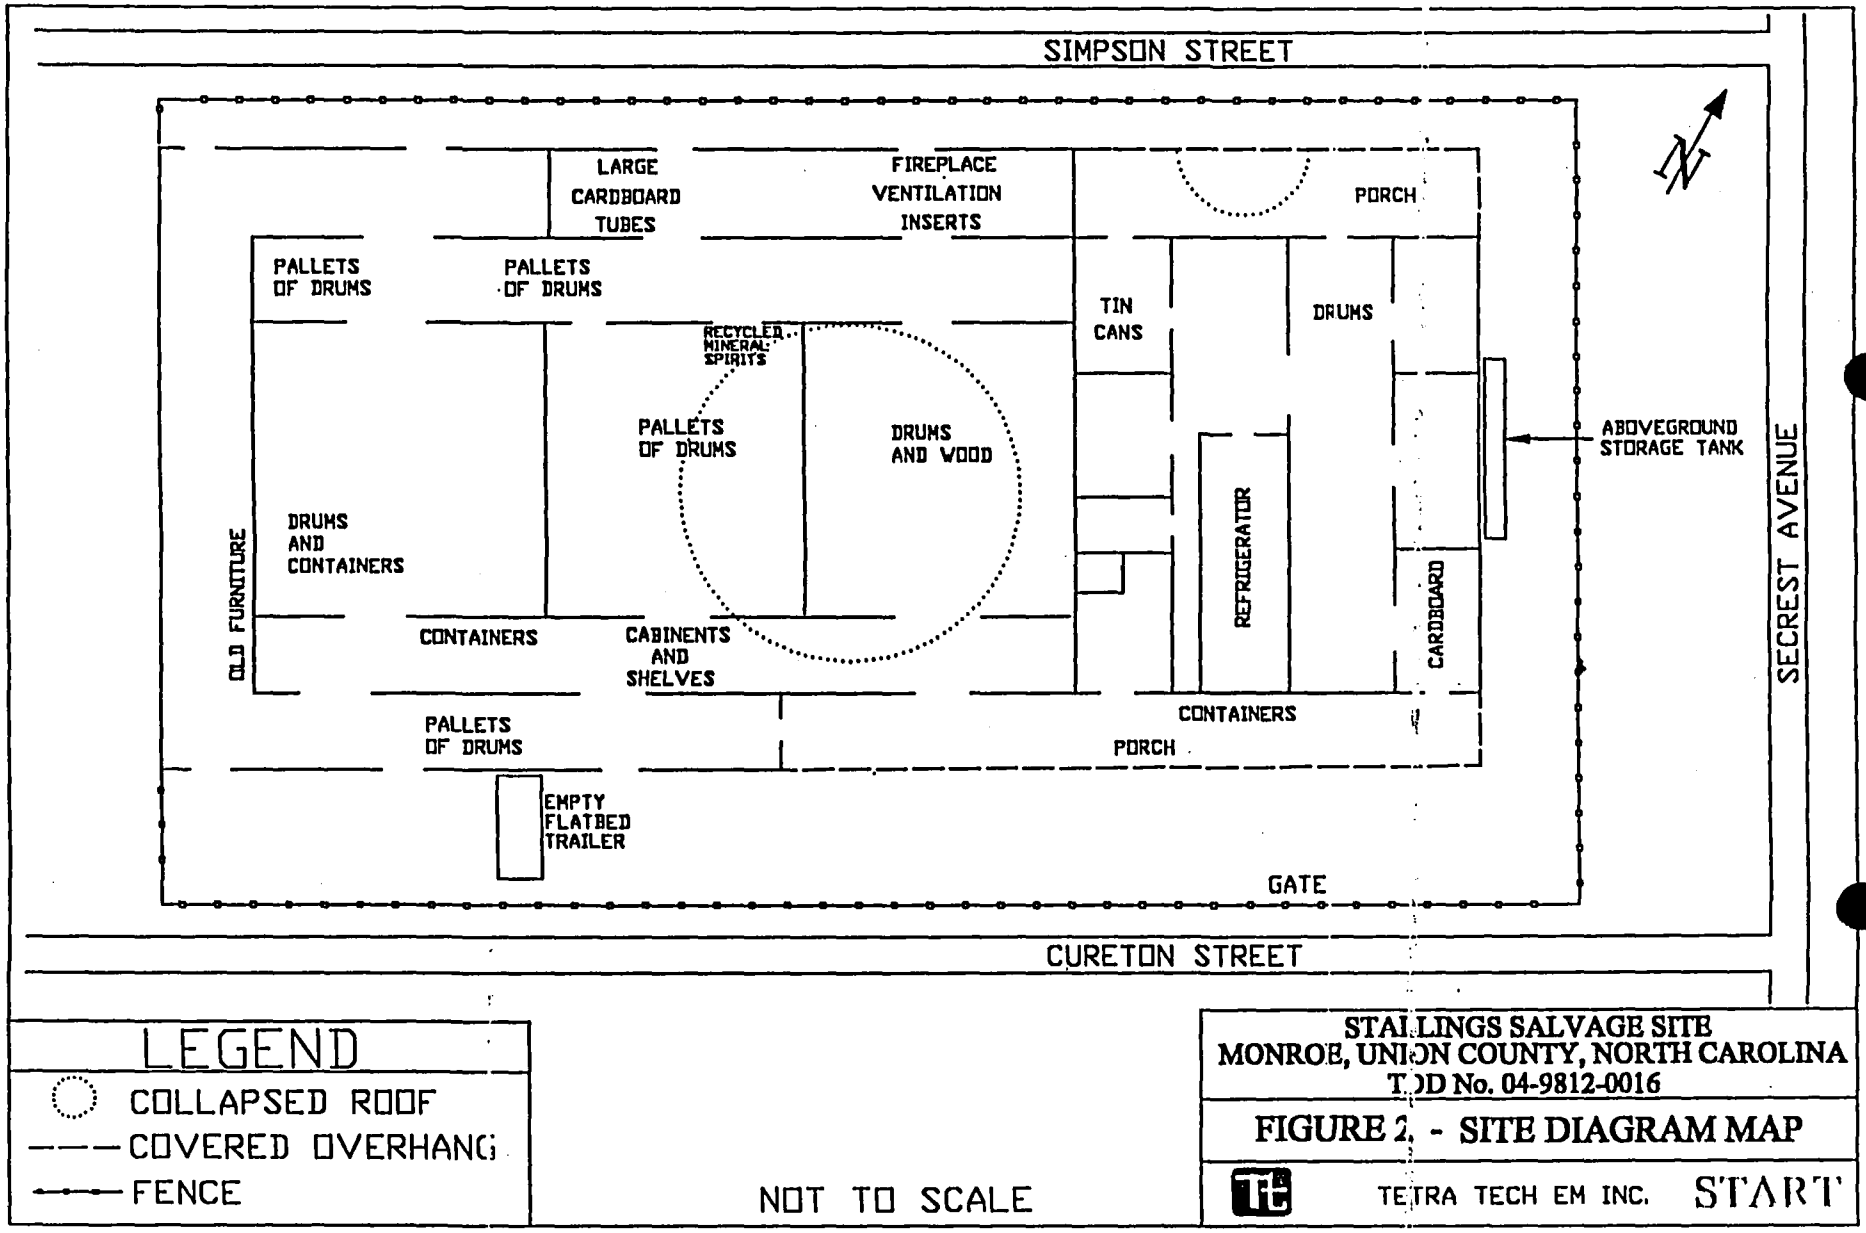
SIMPSON STREET
LARGE CARDBOARD TUBES
FIREPLACE VENTILATION INSERTS
PORCH
PALLETS OF DRUMS
PALLETS OF DRUMS
TIN CANS
DRUMS
RECYCLED MINERAL SPIRITS
PALLETS OF DRUMS
DRUMS AND WOOD
ABOVEGROUND STORAGE TANK
DRUMS AND CONTAINERS
OLD FURNITURE
REFRIGERATOR
CARDBOARD
CONTAINERS
CABINENTS AND SHELVES
CONTAINERS
PALLETS OF DRUMS
PORCH
EMPTY FLATBED TRAILER
GATE
SECREST AVENUE
CURETON STREET
LEGEND
COLLAPSED ROOF
COVERED OVERHANG
FENCE
NOT TO SCALE
STALLINGS SALVAGE SITE
MONROE, UNION COUNTY, NORTH CAROLINA
TOD No. 04-9812-0016
FIGURE 2. - SITE DIAGRAM MAP
TETRA TECH EM INC.
START

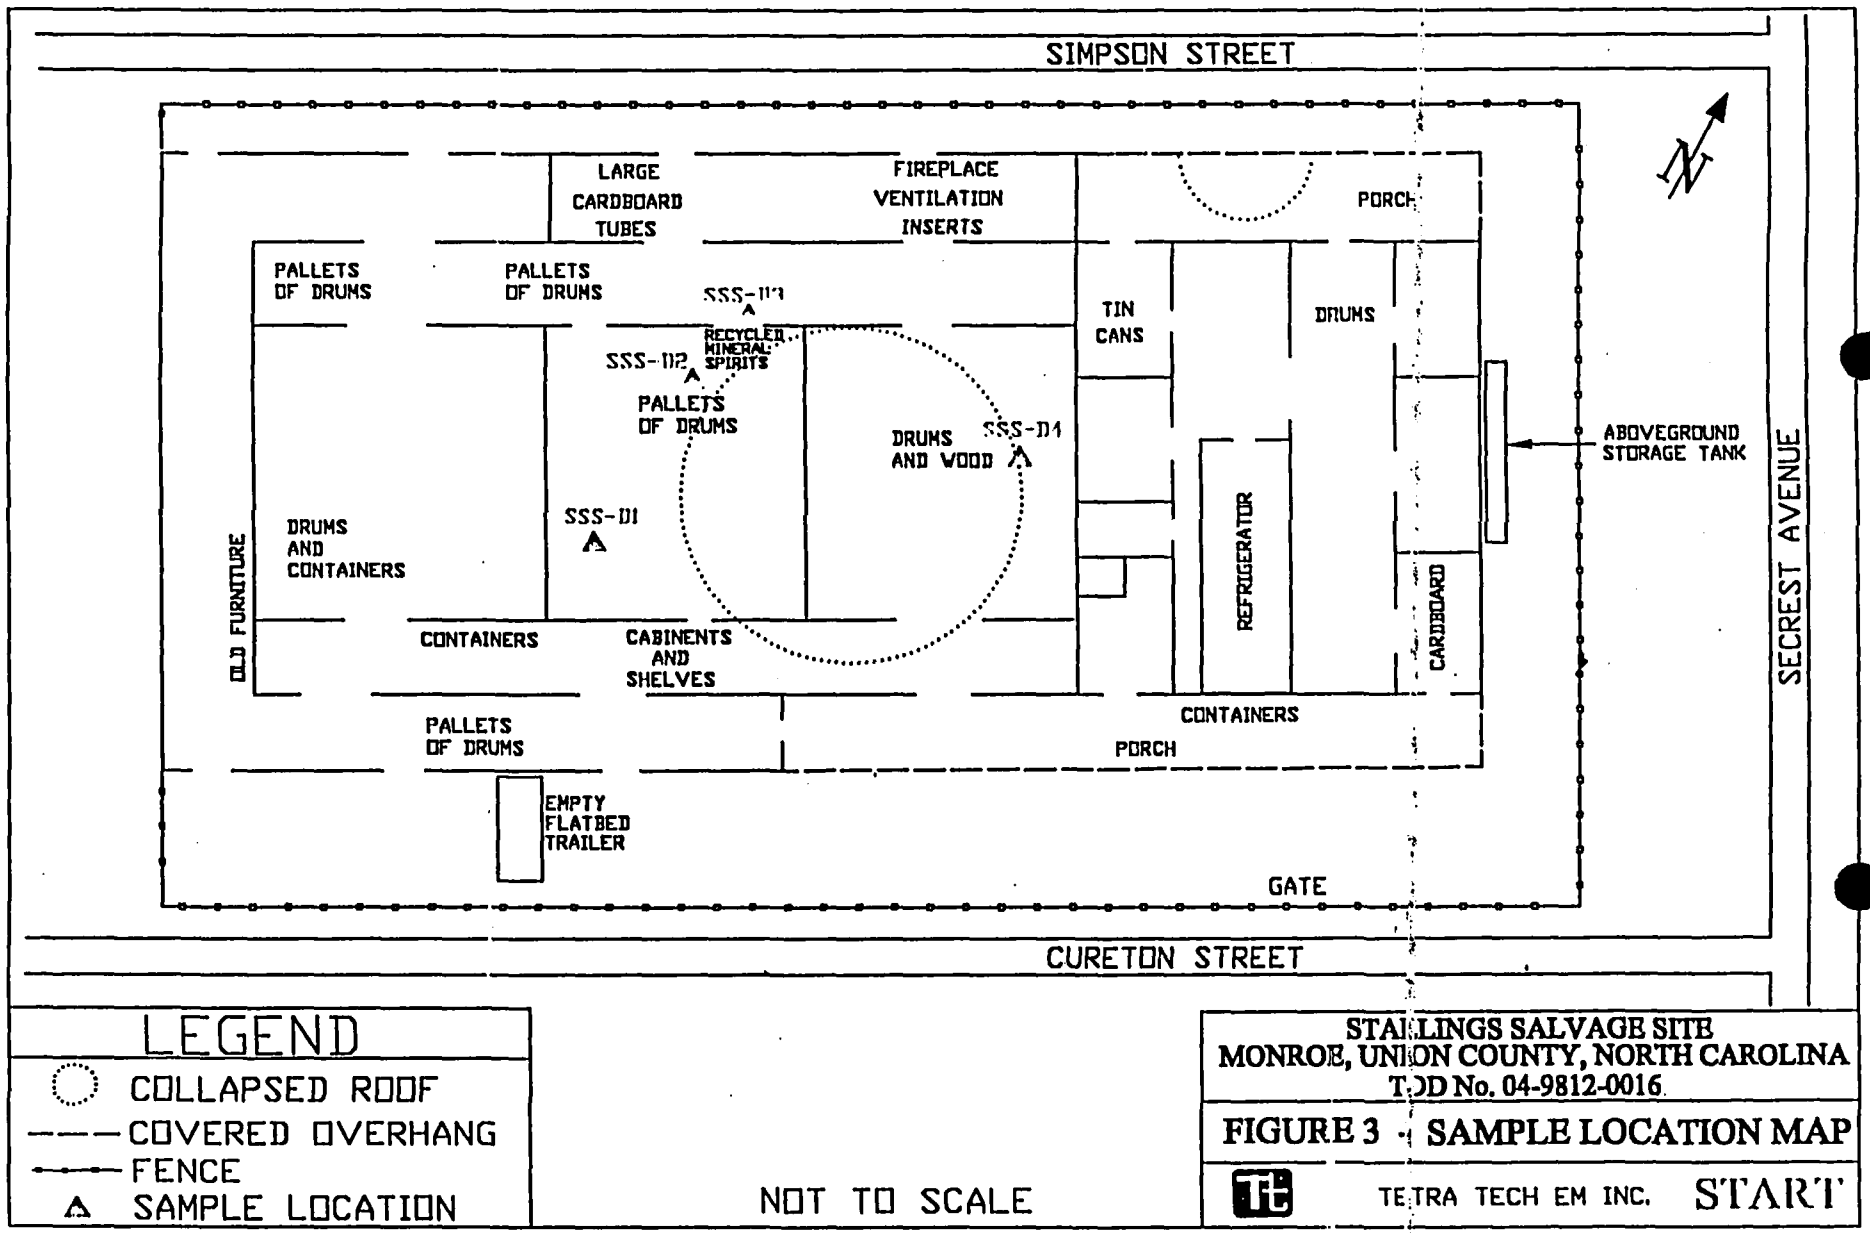
SIMPSON STREET
LARGE CARDBOARD TUBES
FIREPLACE VENTILATION INSERTS
PORCH
PALLETS OF DRUMS
PALLETS OF DRUMS
SSS-D3
RECYCLED MINERAL SPIRITS
SSS-D2
PALLETS OF DRUMS
TIN CANS
DRUMS
DRUMS AND WOOD
SSS-D4
ABOVEGROUND STORAGE TANK
SECREST AVENUE
DRUMS AND CONTAINERS
SSS-D1
OLD FURNITURE
REFRIGERATOR
CARDBOARD
CONTAINERS
CABINENTS AND SHELVES
CONTAINERS
PALLETS OF DRUMS
PORCH
EMPTY FLATBED TRAILER
GATE
CURETON STREET
LEGEND
COLLAPSED ROOF
COVERED OVERHANG
FENCE
SAMPLE LOCATION
NOT TO SCALE
STALLINGS SALVAGE SITE
MONROE, UNION COUNTY, NORTH CAROLINA
TOD No. 04-9812-0016
FIGURE 3 - SAMPLE LOCATION MAP
TETRA TECH EM INC.
START
