SOLID WASTE ENGINEERING AND MANAGEMENT

APPENDIX A
FRACTURE TRACE ANALYSIS

WILKES COUNTY LANDFILL
FRACTURE TRACE ANALYSIS
WESTINGHOUSE PROJECT NO. 4112-90-121

WILKES COUNTY LANDFILL
FRACTURE TRACE ANALYSIS
4112-90-121

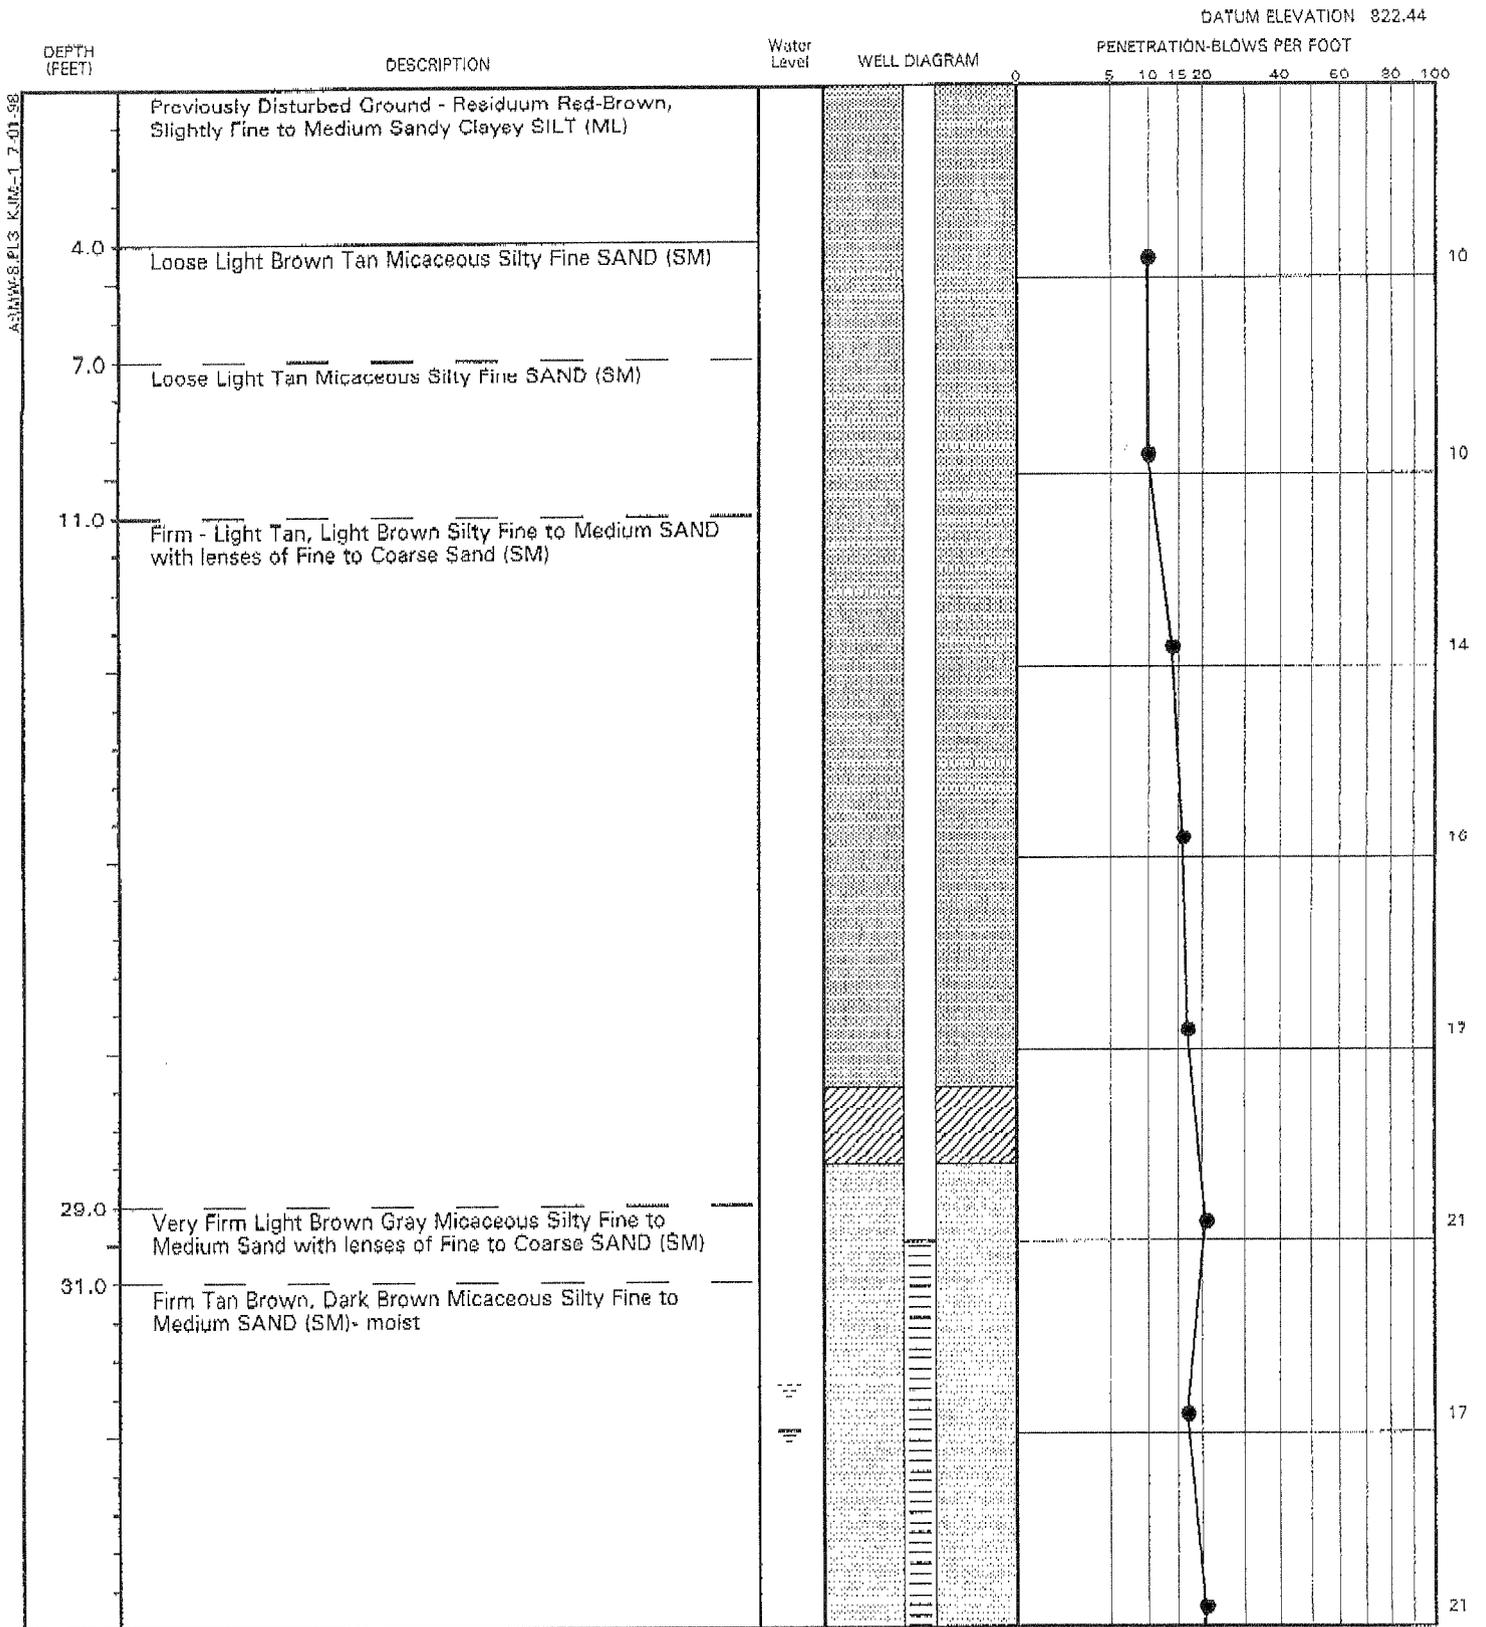
BORING LOG

DRILLED BY LAW
 LOGGED BY RT
 CHECKED BY KJM

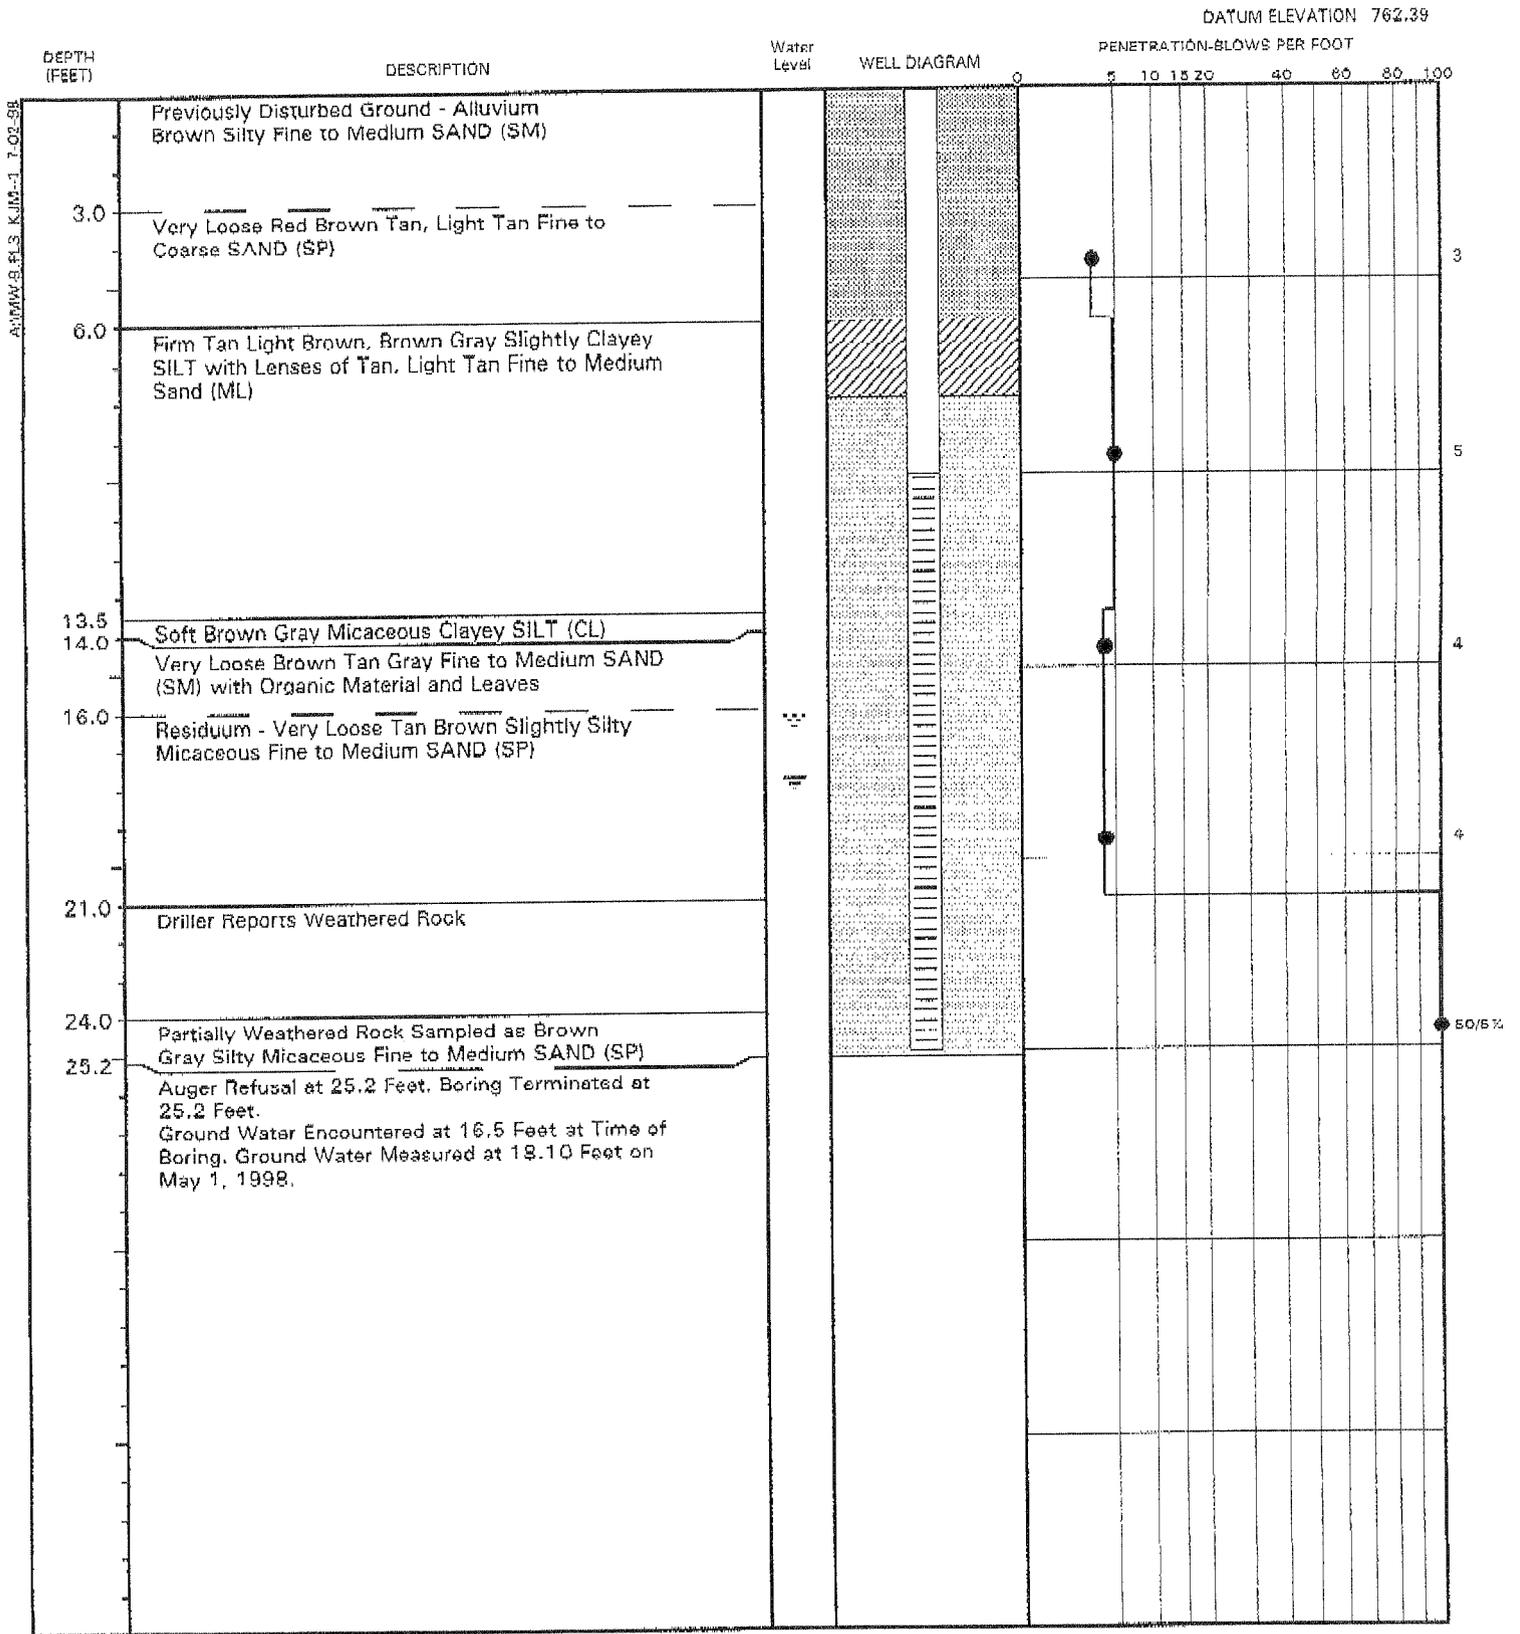
BORING LOG

Drilled with 8-inch Hollow-Stem Augers. Set 2-inch Schedule 40 PVC with 15 Feet of 0.010-inch Slotted Screen to 25.0 Feet. Sand to 8.0 Feet, Bentonite Seal to 6.0 Feet, Grout to Ground Surface. Set Lockable Steel Cover.

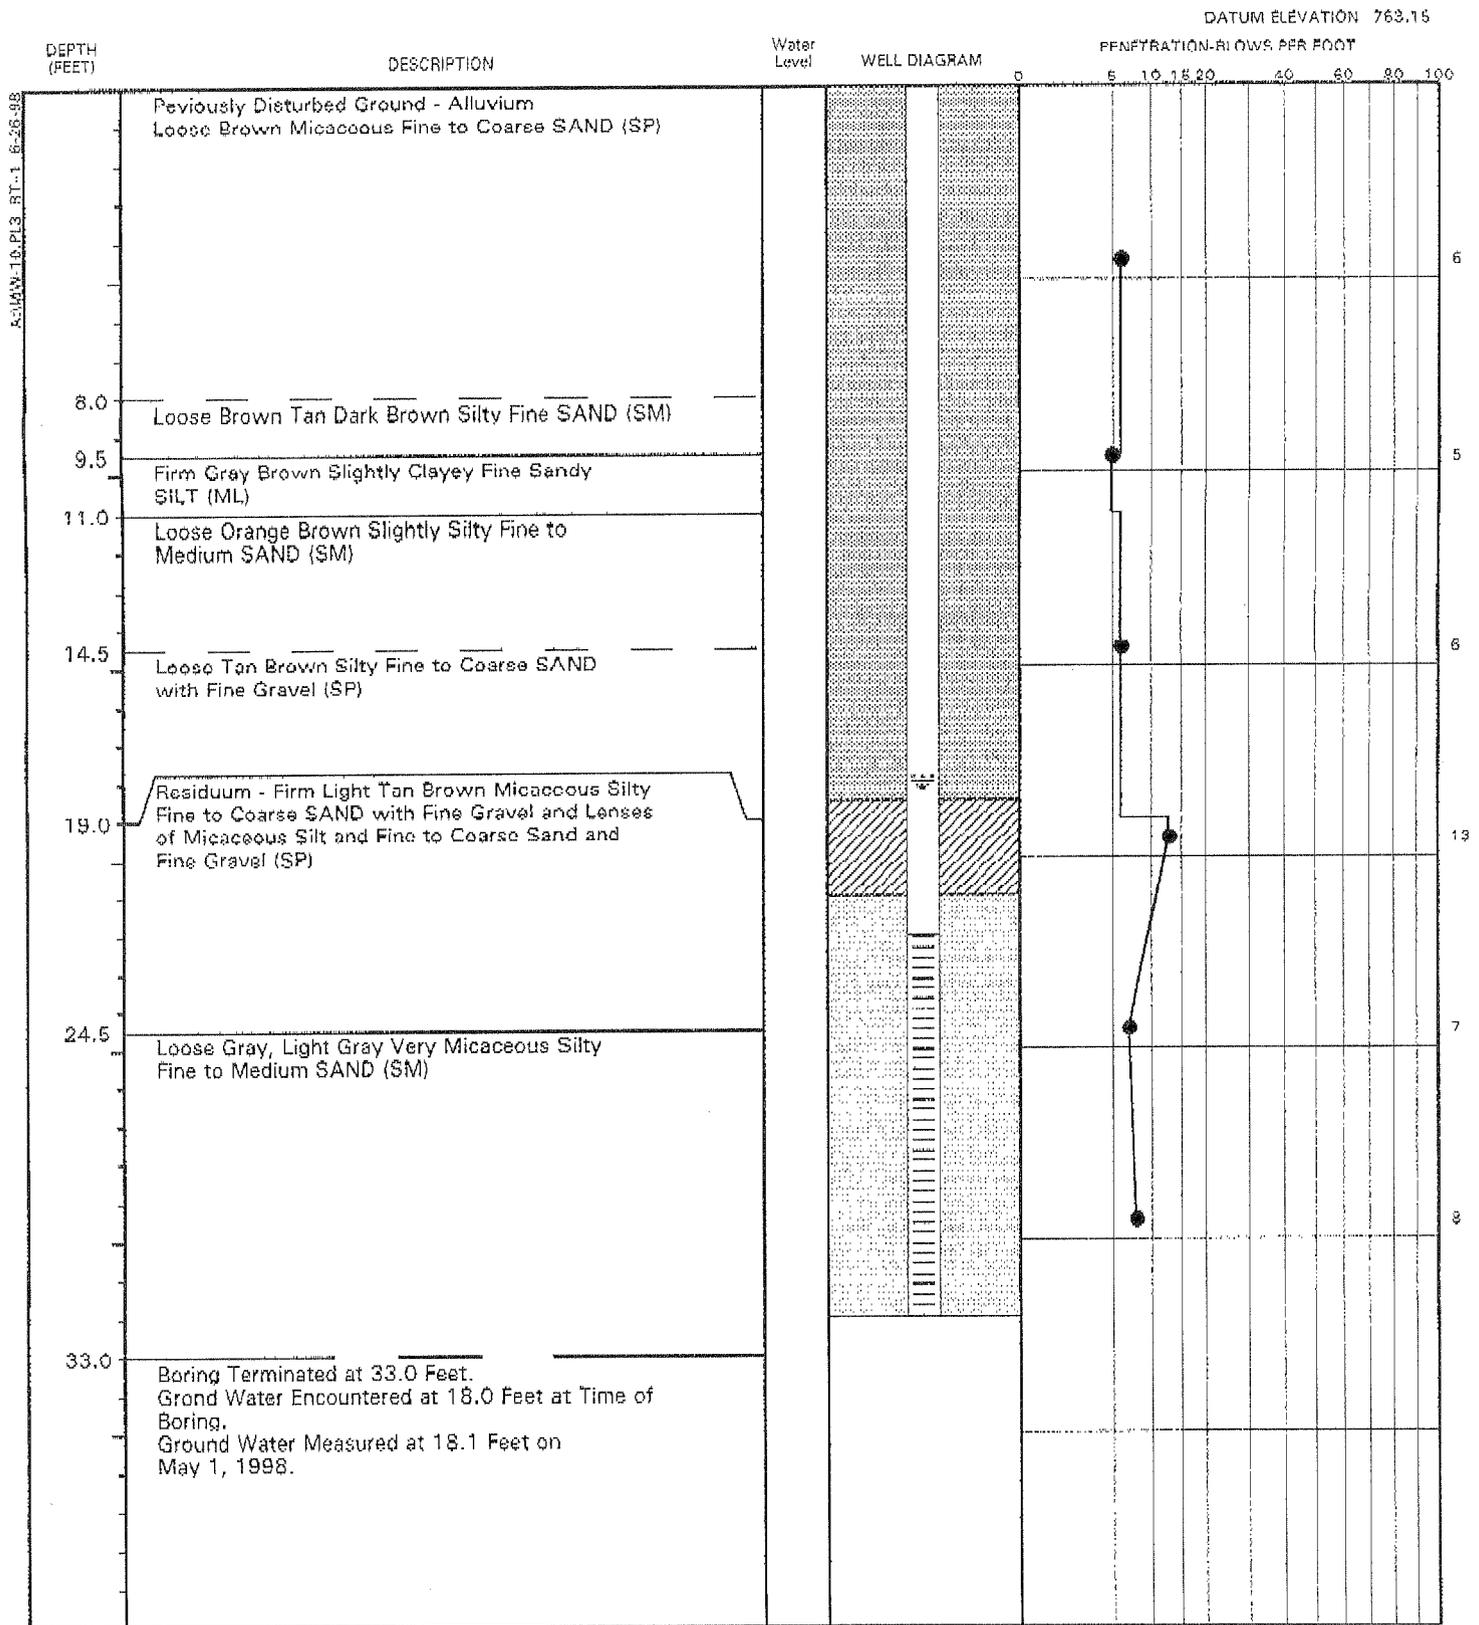
BORING LOG

Drilled with 8 inch Hollow Stem Augers. Set 2-inch Schedule 40 PVC with 10 Feet of 0.010-inch Slotted Screen to 32.0 Feet. Sand to 21.0 Feet, Bentonite Seal to 18.5 Feet, Grout to Ground Surface. Set Lockable Steel Cover.

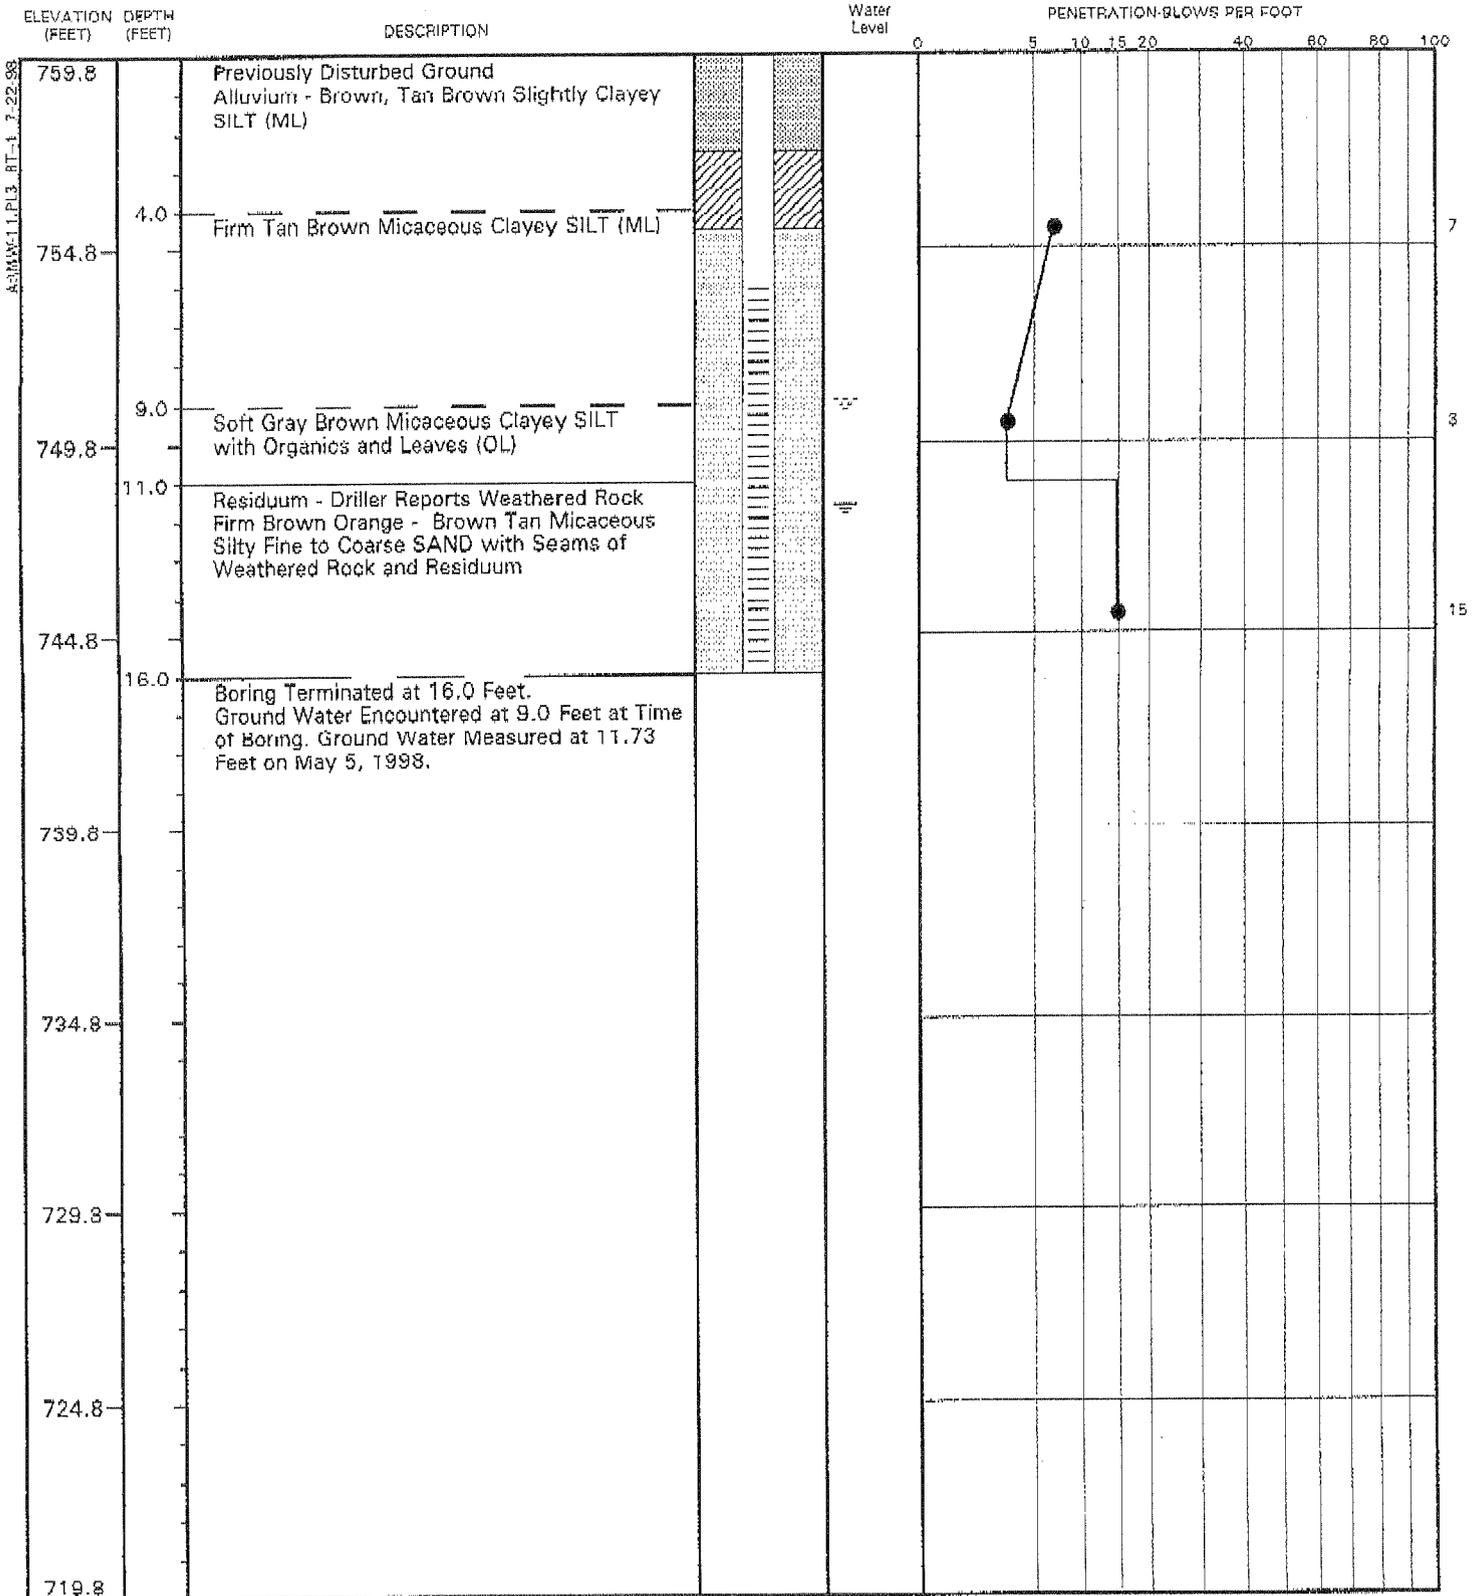
TEST BORING RECORD

DATUM ELEVATION: 759.77

Drilled with 8-inch Hollow-Stem Augers. Set 2-inch Schedule 40 PVC with 10 Feet of 0.070-inch Slotted Screen to 16.0 Feet. Sand to 4.5 Feet, Bentonite Seal to 2.5 Feet, Grout to Ground Surface. Set Lockable Steel Cover.

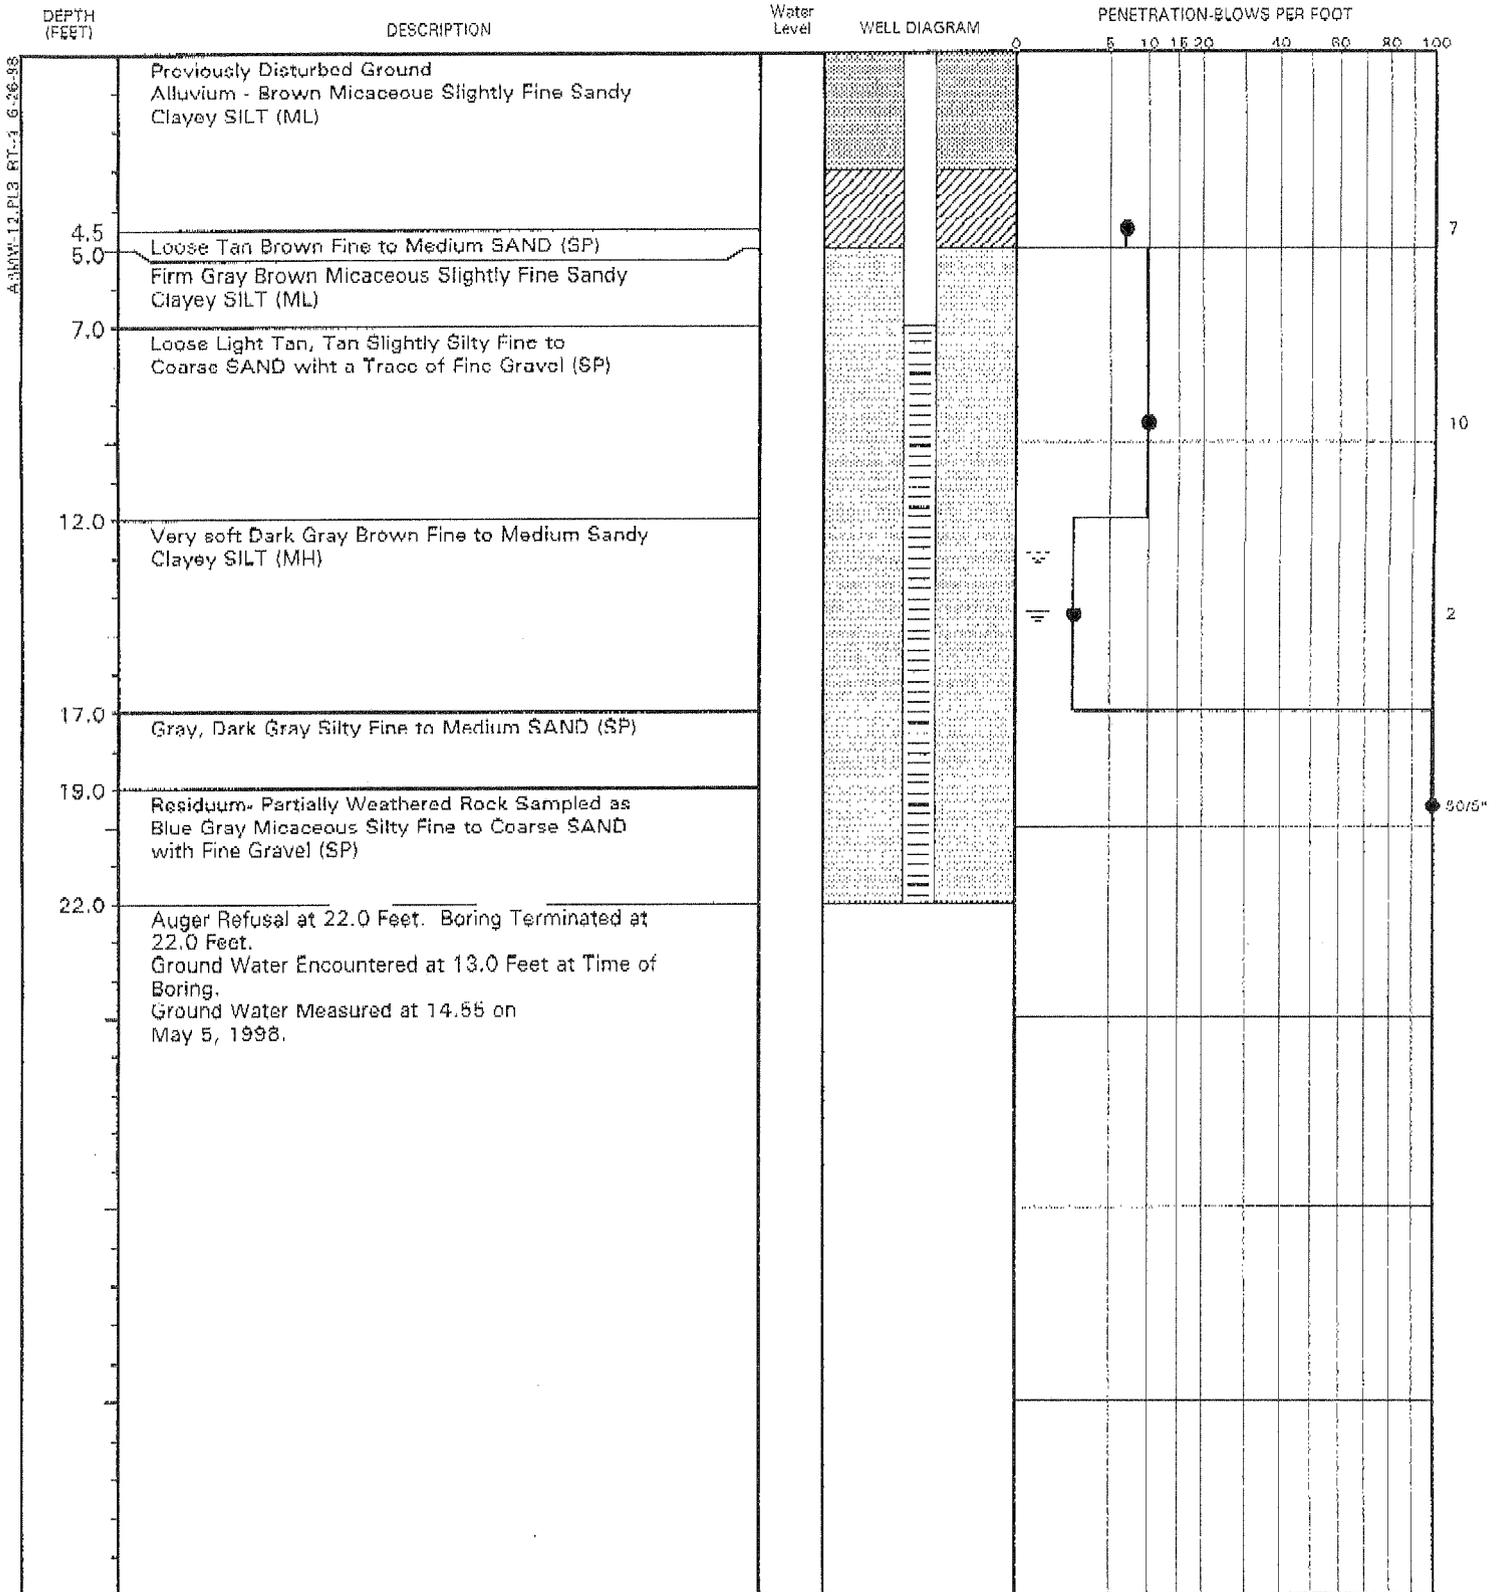
BORING LOG

DATUM ELEVATION 759.84

Drilled with 8-inch Hollow-Stem Augers. Set 2-Inch Schedule 40 PVC to 22.0 Feet with 15 Feet of 0.010-inch Slotted Screen. Sand to 5.0 Feet, Bentonite Seal to 3.0 Feet, Grout to Ground Surface. Set Lockable Steel Cover.
