**FACILITY COMPLIANCE AUDIT REPORT**  
**Division of Waste Management**  
**Solid Waste Section**

**UNIT TYPE: Structural Fill/CCB**

Structural Fill	<b>X</b>		Active		Certified Closure	<b>Y</b>						<b>COUNTY: IREDELL</b> <b>PERMIT NO.: CCB0040</b> <b>FILE TYPE: COMPLIANCE</b>
Permitted Site Y/N	<b>N</b>		Inactive	<b>X</b>								
Notified Site Y/N	<b>Y</b>		Recorded Y/N	<b>Y</b>

Lake Norman Airport – Lot #3  
 #123/#125 Yeager Road, Mooresville, NC

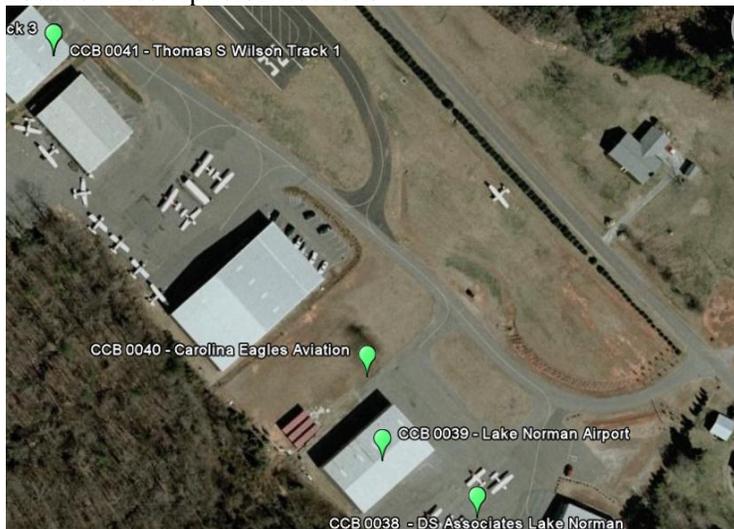
Google Earth 12/17/09

1. Historical Information
  - a. Estimated Fill Volume = 10,000 cubic yards fly ash
  - b. Proposed End Use: airport expansion
  - c. Facility Information:
2. Location Description/Directions

3. Current Use: Site is stabilized with concrete and a hangar for planes.
4. Waste Limit Siting Requirements:
