Site Name (Subject):	TOM SADLER ROAD WELLS
Site ID (Document ID):	NCD986231967
Document Name (DocType):	Preliminary Assessment/Site Inspection (PA/SI)
Report Segment:	
Description:	Site Inspection
Date of Document:	7/15/1996
Date Received:	
Box: *Enter SF and # with no spaces*	SF10,632
Access Level:	PUBLIC
Division:	WASTE MANAGEMENT
Section:	SUPERFUND
Program (Document Group):	SERB (SERB)
Document Category:	FACILITY

SITE INSPECTION

Tom Sadler Road Wells
NCD 986 231 967
Charlotte, Mecklenburg, North Carolina
Reference No. 06103

July 1996

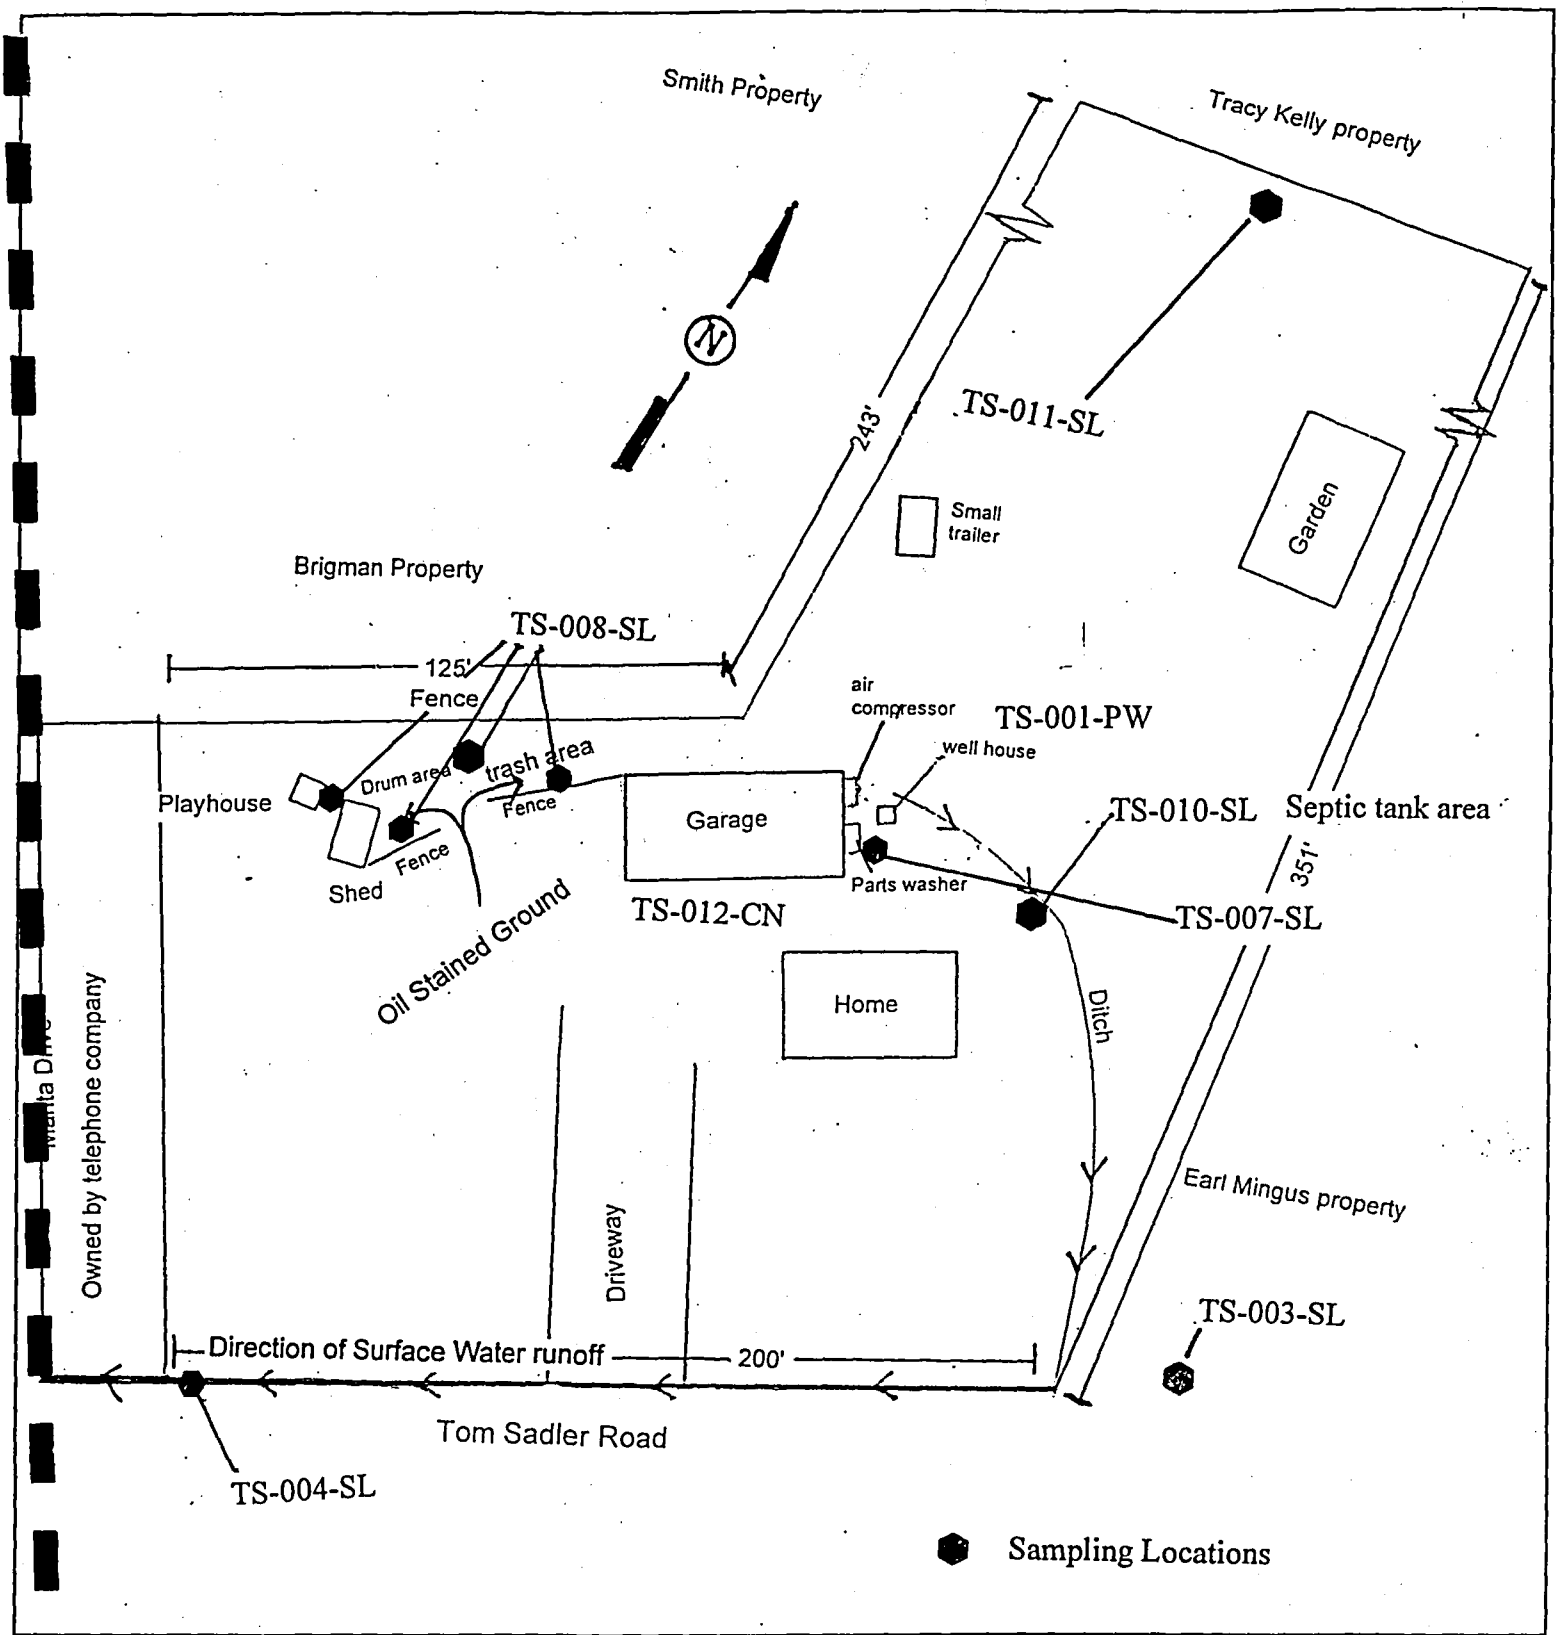
Fig. No: 2	Title: **Site Map and Sampling Locations**		
North Carolina Division of Solid Waste Management	Scale: Not to Scale	Date: February 1996	Drawn By: Stanley
Superfund Section	Site Name: Tom Sadler Road Wells		NCD 986 231 967

There are signs of stressed vegetation in the on site drum storage area The surface area of oil-stained ground in the trash and empty drum storage areas on the Mingus property is about 600 square feet (Ref. 27; Fig. 2).

Soil sampling conducted on the site has shown an area approximately 600 square feet containing lead at 3,100 mg/kg. The NC Superfund Section has requested that the US EPA ERRB evaluate this site for additional removal action. The area of stained soil is accessible and is near a children's playhouse that has been used by Mingus family members. No one is currently using the playhouse. The threat posed by this soil contamination likely affects only the on-site residents and their families.

Based on the lead levels detected in surface soils, the NC Superfund Section has requested that the US EPA ERRB evaluate the site for further removal action. Further evaluation of on-site soils for metals and volatile organic compounds may identify a source of chlorinated solvents which should also be removed. Pending the results of the removal evaluation, the Tom Sadler Road Wells site is recommended for a low priority for further remedial action under CERCLA.

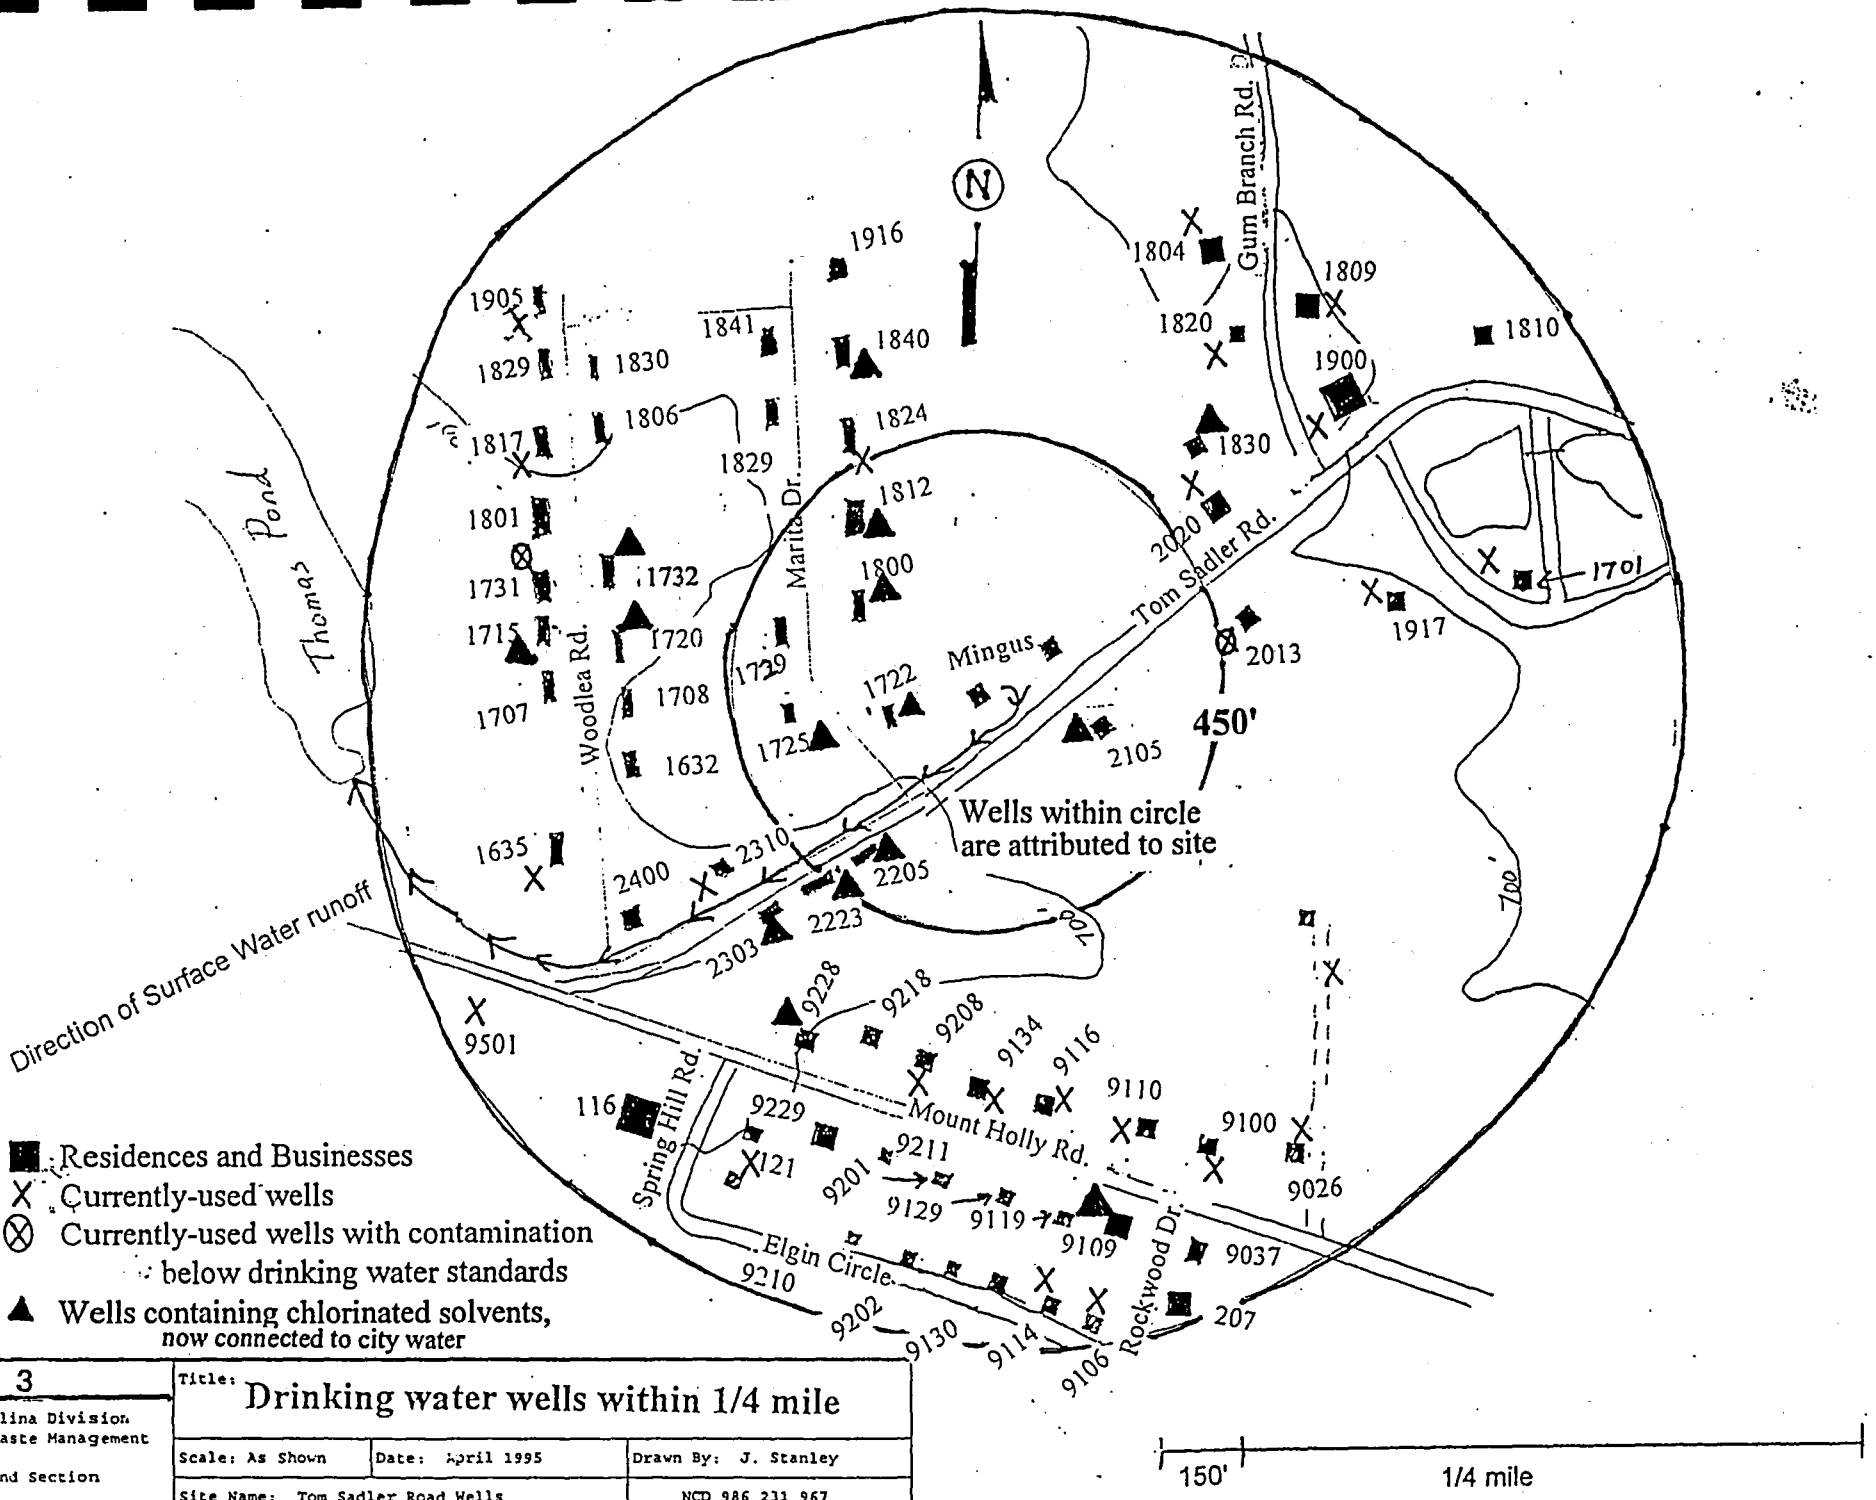
Fig. No: 3	Title: Drinking water wells within 1/4 mile		
North Carolina Division of Solid Waste Management Superfund Section	Scale: As Shown	Date: April 1995	Drawn By: J. Stanley
	Site Name: Tom Sadler Road Wells		NCD 986 231 967

The total number of groundwater users within four miles of the site is 4,464. The closest private drinking water well still in use is located at 1824 Marita Drive, about 450 feet northwest of the site (Ref. 14, Fig. 3). All wells within 450' of the site (seven) were found to be contaminated with chlorinated solvents and have been connected to city water. These wells are identified in Table 3. The well at 2013

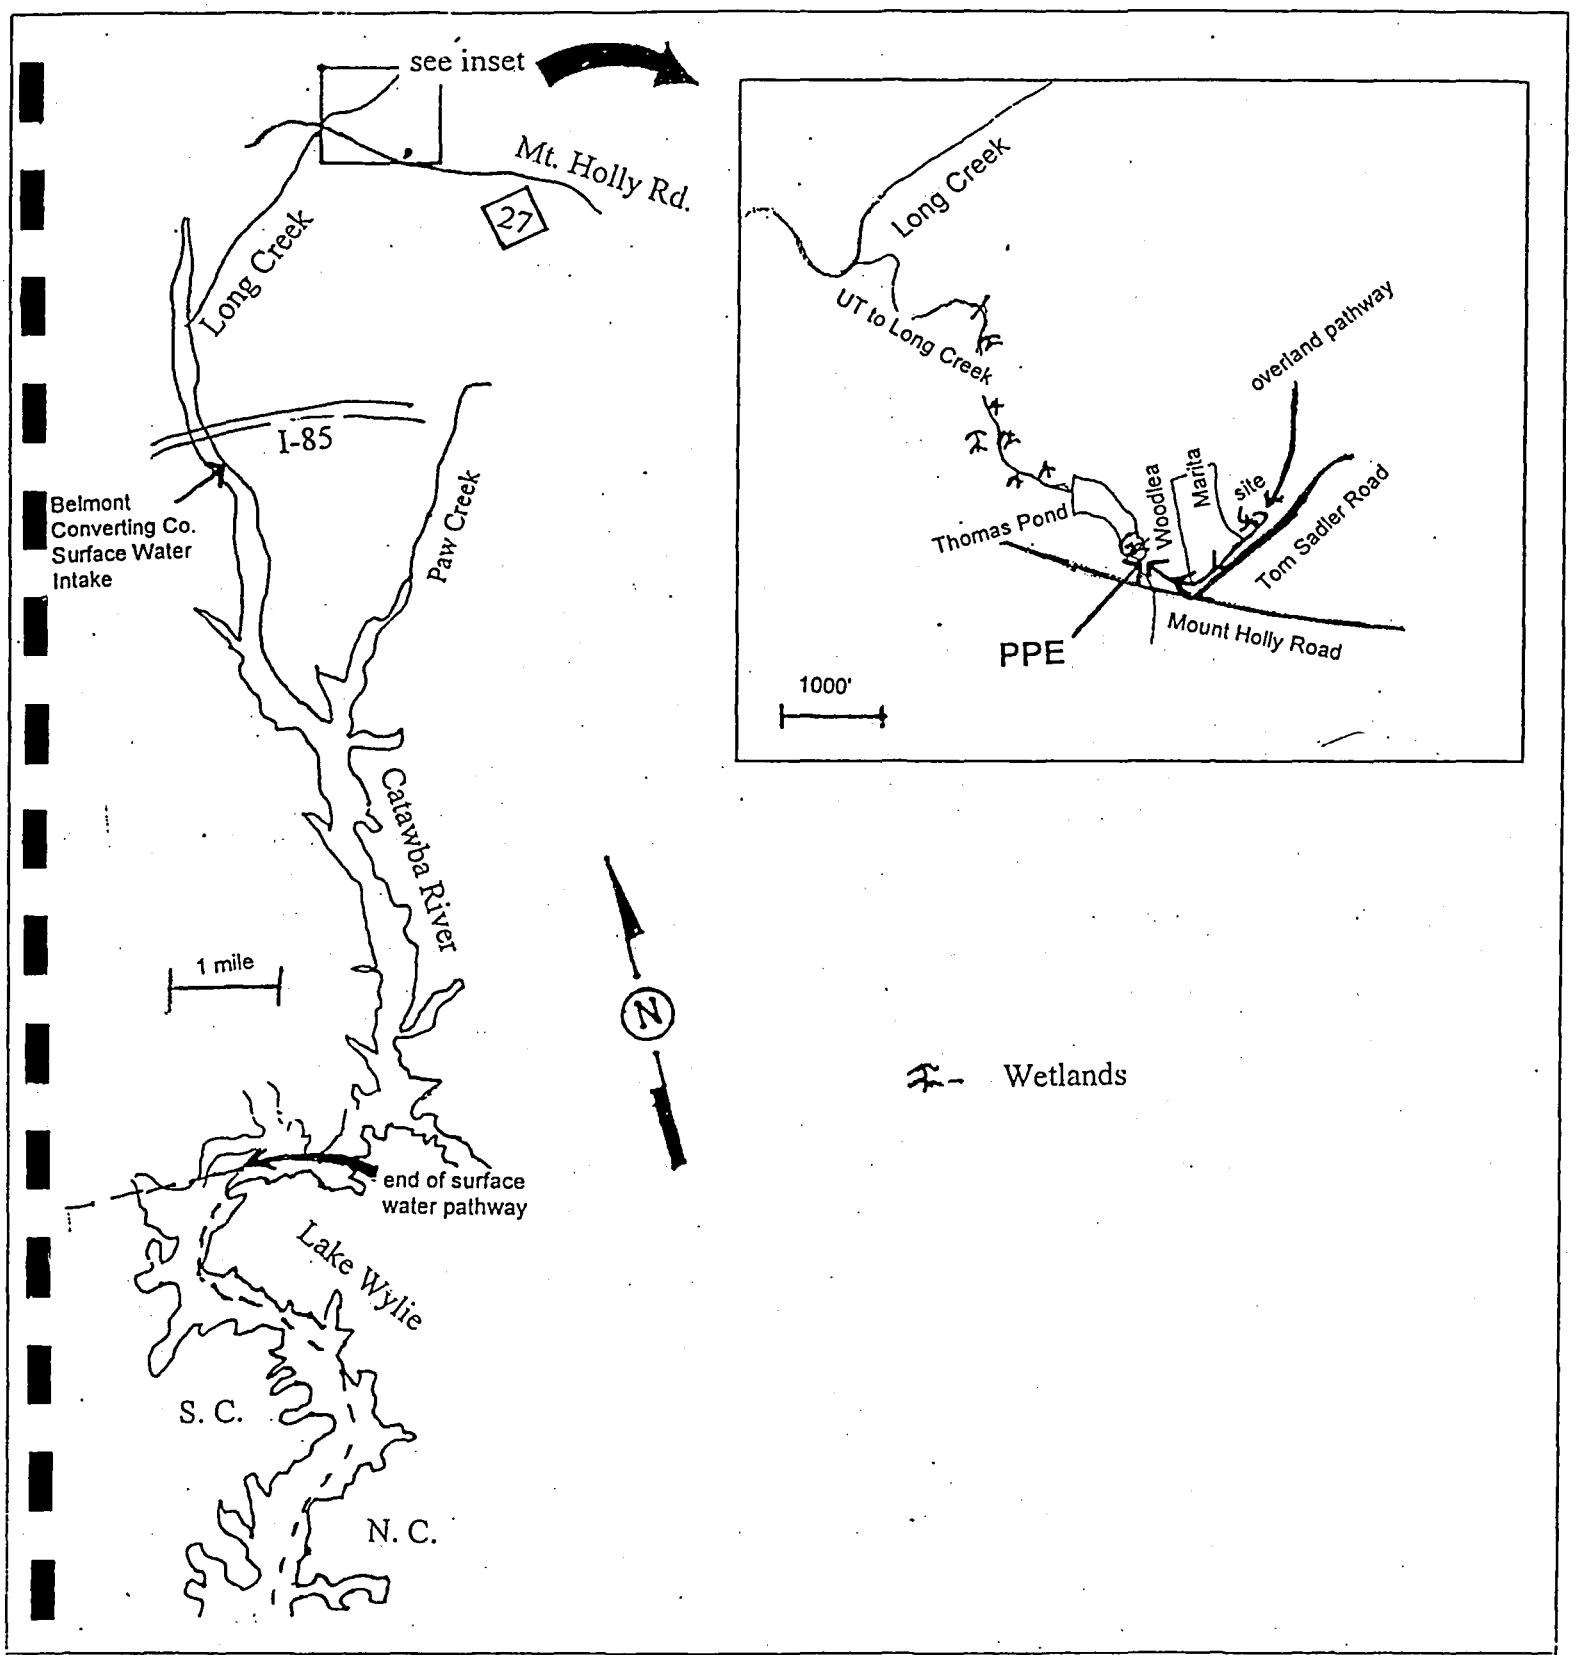
Fig. No: 4	Title: Surface Water Pathway		
North Carolina Division of Solid Waste Management	Scale: As Shown	Date: April 1995	Drawn By: Stanley
Superfund Section	Site Name: Tom Sadler Road Wells		NCD 986 231 967

During the February 13, 1996 SI, surface water and sediment samples were taken in the Thomas Pond headwaters below more than 0.1 mile of wetland frontage. Background surface water and sediment samples were taken on the opposite side of Mount Holly Road in the stream feeding the pond (Figure 5). Table 4 below shows the results of these tests. The level of chromium found in the Thomas Pond sediment is greater than three times background (ND) but similar to that found in the background soil sample (14 mg/kg, TS-011-SL. The methylene chloride reported in the Thomas Pond surface water is a common laboratory contaminant and may not actually be in the sample. A trace of chloroform was reported in the Thomas Pond sediment sample. Neither methylene chloride nor chloroform were detected in the onsite soil or in the Mingus well.

While chromium at 26 mg/kg was reported in the downstream pond sediment, this level is similar to that reported in the background soil. Low levels of two chlorinated hydrocarbons were also reported, but neither of these were found on the site and one is a common laboratory contaminant. Based on these facts, there has been no release of contaminants to the surface water pathway. The Thomas Pond fishery and wetland will be destroyed within 10 years during highway construction.

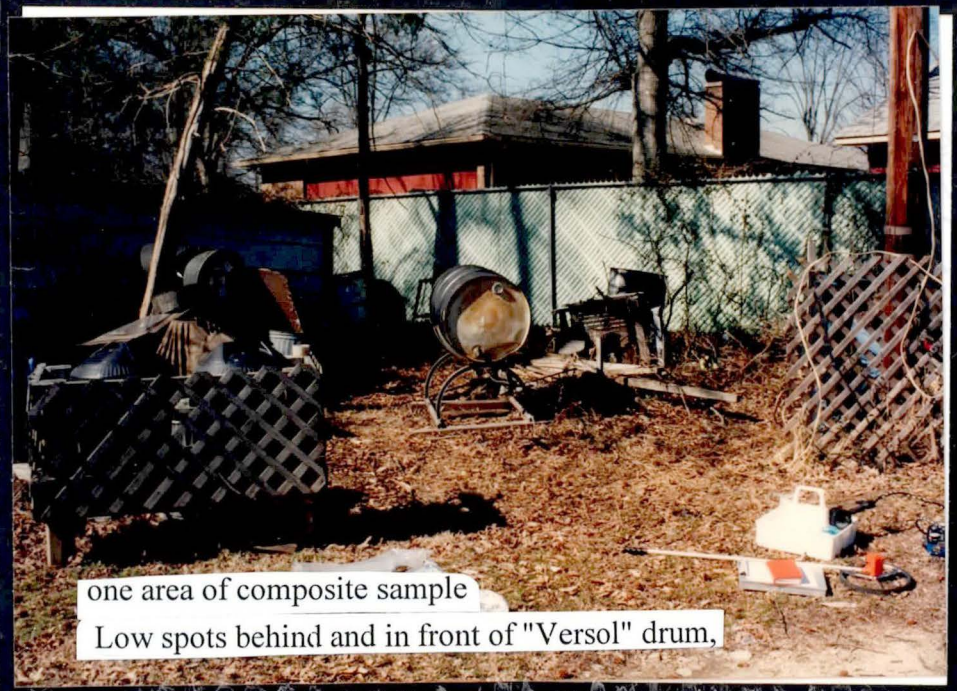
one area of composite sample

Low spots behind and in front of "Versol" drum,

We went to the low area between the parts washer and the well house, on the east side of the garage. We augured to 6" and used the OVA in the hole. There was no reading above background. The sample was taken from 6 - 15". The OVA still showed no reading in the hole. The soil was a sandy clay with no stains below 4". Sample TS-007-SL was taken at 1250. Photograph #6 was taken at this sample point.

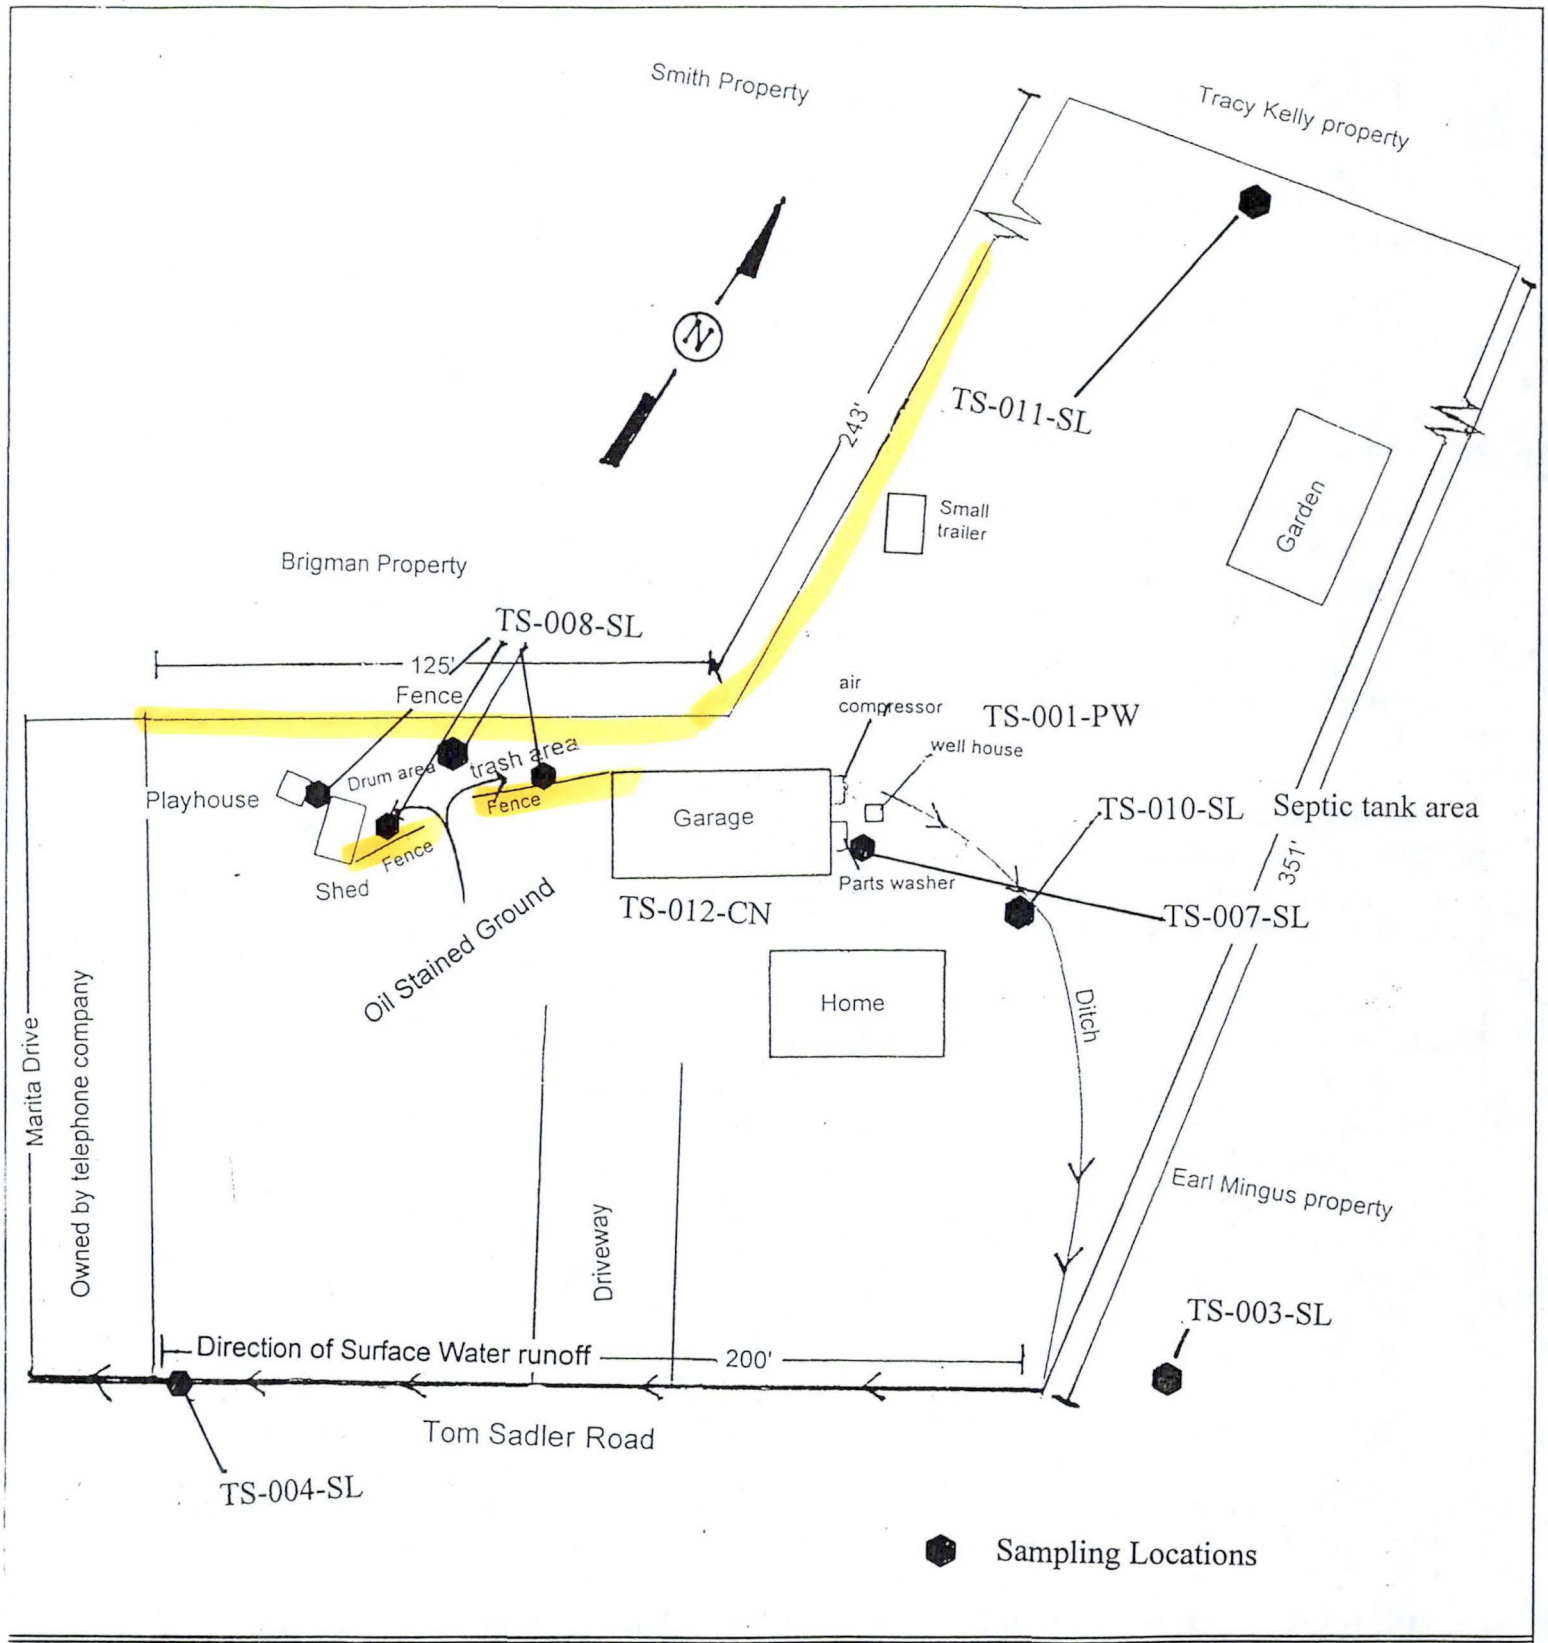
Fig. No: 1	Title: **Site Map and Sampling Locations**		
North Carolina Division of Solid Waste Management	Scale: Not to Scale	Date: February 1996	Drawn By: Stanley
Superfund Section	Site Name: Tom Sadler Road Wells		NCD 986 231 967

TCLP analysis of this contaminated soil sample showed lead at 6.04 mg/L. In addition, lead was detected at 24 and 28 mg/kg in samples TS-007-SL and TS-010-SL, respectively. Chromium, copper and arsenic were also detected in these two soil samples. The old drinking water well (no longer being used for drinking) contained 0.031 mg/L lead. The well is still being used for watering the garden and washing cars. A copy of the analytical results is attached. A map of the sampling locations is also attached. The fence shown in the area of sample location TS-008-SL is a low fence that hides some the stored material. It does not restrict access.

Based on these findings, I am requesting a removal evaluation. I will be notifying Mr. Mingus by telephone and letter of these findings and recommend that he restrict use of this area of this property, particularly by children.
