SEMI-ANNUAL GROUNDWATER MONITORING EVENT

Former Parkway Chevrolet Facility
205 Smoky Park Highway
Asheville, Buncombe County, North Carolina

NC DENR Facility I.D. #0-029190
NC DENR Incident I.D. #18332

Prescott Environmental Job Number 98-007

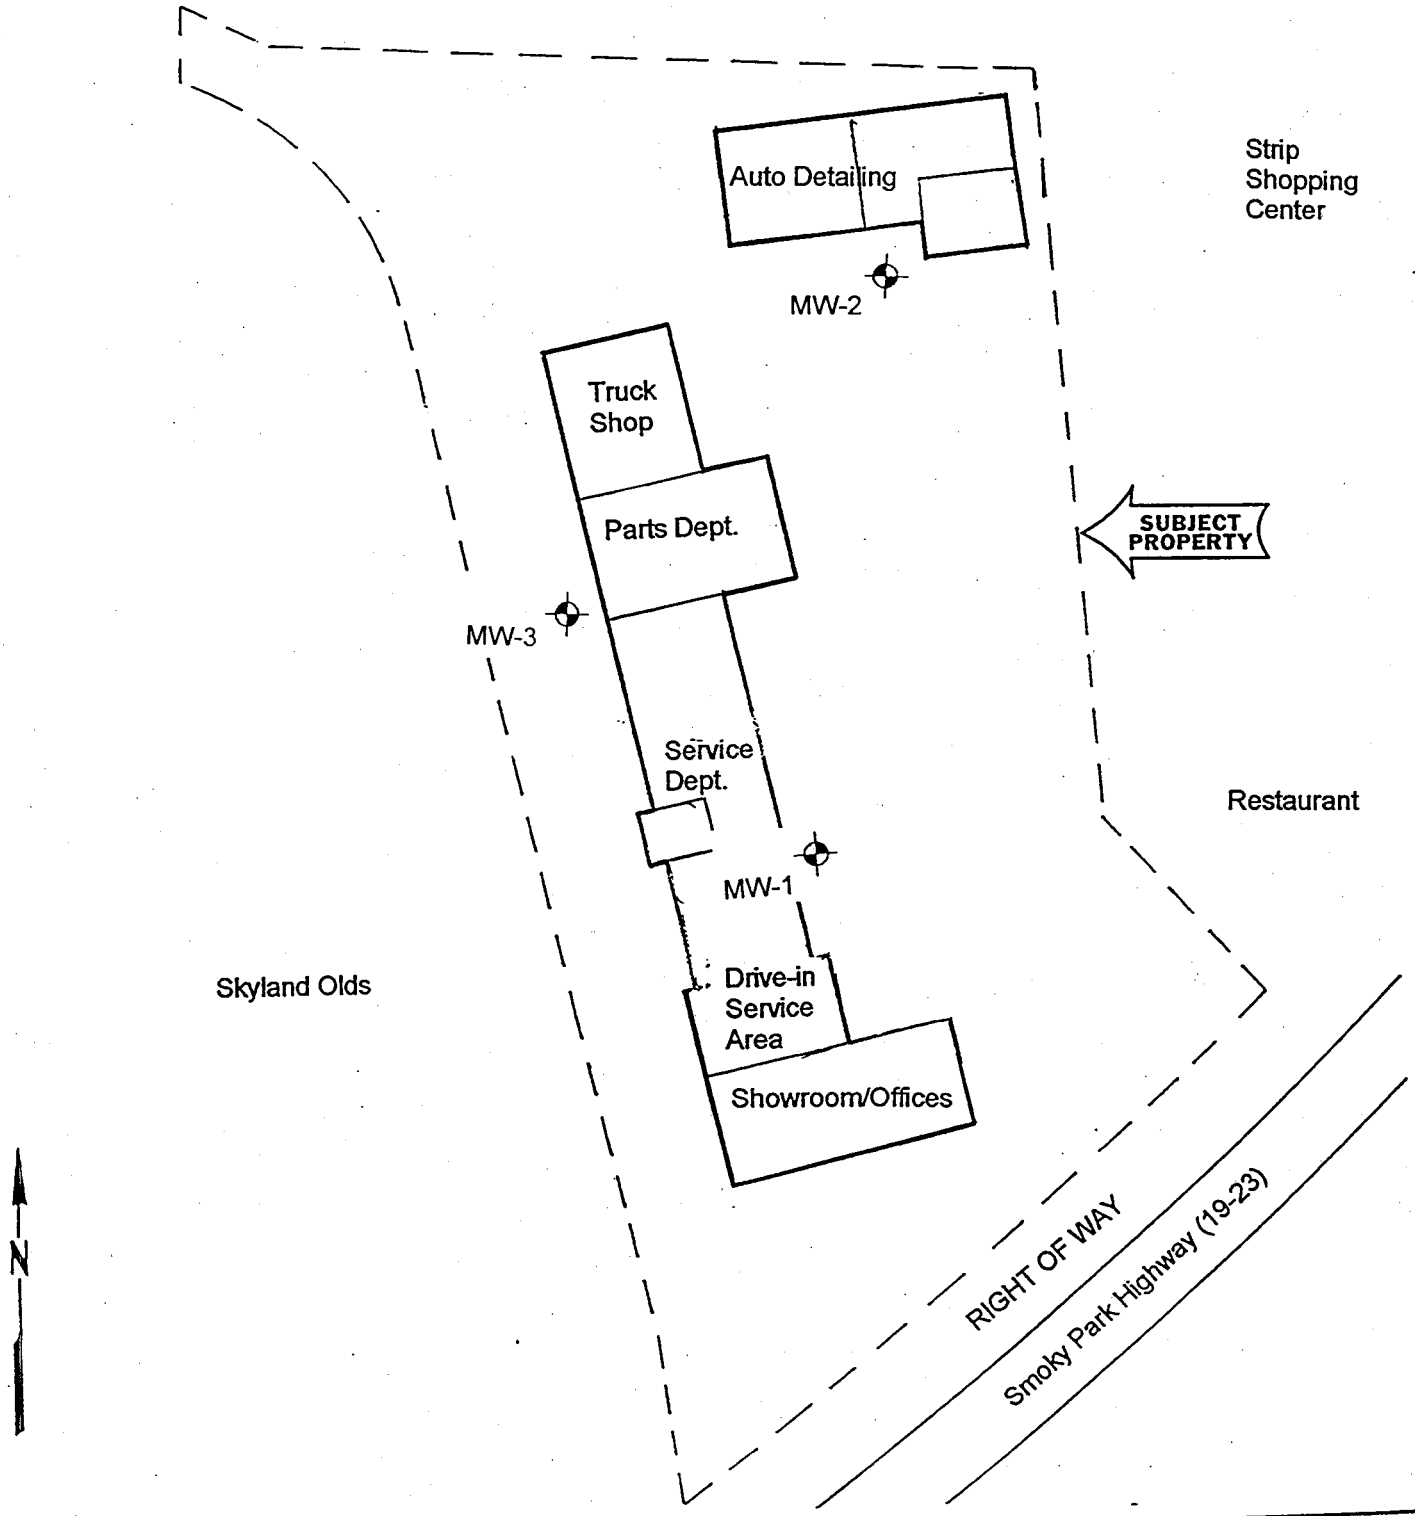
Project: Groundwater Monitoring Event Semi-Annual Groundwater Monitoring	Job No: 98-007		Figure No: 2 Site Base Map/Layout
	Drawn By: CRG		Date: 3/8/98
	Checked By: DPG		Scale: 1" = 128'

Eastern Side of Main Service Area - one shallow well to 30 feet (MW-1);

South Side of Auto Detailing Shop Building - one shallow well to 22 feet (MW-2); and,

West Side of Parts Dept. Building - one shallow well to 25 feet (MW-3).

The groundwater horizontal hydraulic gradient at the Site was determined by surveying the location and elevation of the groundwater monitoring wells to a common benchmark. The survey is accurate to the nearest 0.1 foot horizontally and nearest 0.01 foot vertically. Prescott personnel measured the distance from the static groundwater level to the top of the well casings to an accuracy of 0.01-foot. Using this water level information, Prescott previously compiled a hydraulic gradient map which can be found in a Comprehensive Site Assessment report issued August 5, 1998 (Figure 6). Prescott also calculated the horizontal groundwater gradient across the site to be 0.08 ft/ft. Based on data collected during previous measuring events, it was concluded that the groundwater gradient trends mainly in a southern direction, toward Smoky Park Highway.
