FACILITY COMPLIANCE INSPECTION REPORT

Division of Waste Management Solid Waste Section

Carteret County/CRSWMA Transfer Facility
 800 Hibbs Road
 Newport, NC

1604T-20150311INSP

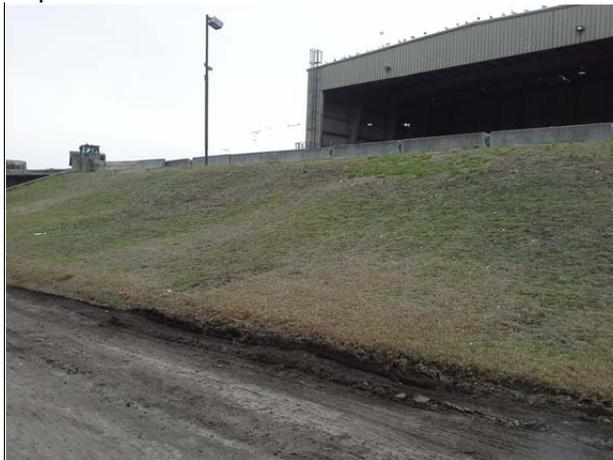
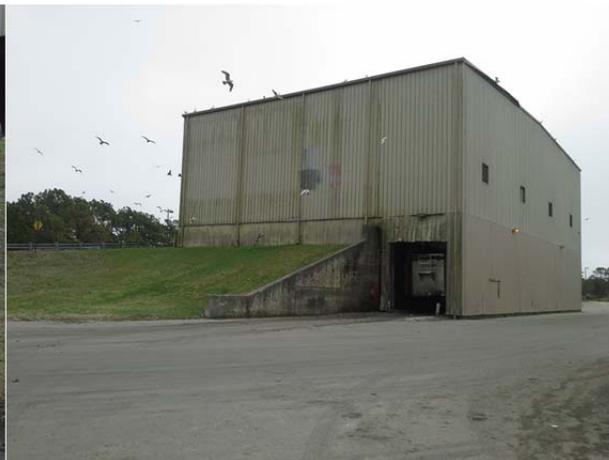
- 6) Proper signage including the Facility permit number, accepted waste types, banned or excluded items, hours of operation, and the emergency contact number is posted at the facility entrance.
- 7) The hours of operation are Monday through Friday 7:30 AM to 4:30 PM and Saturday 7:30 AM to 12:00 PM.
- 8) The Facility is secured by means of a locked gate at the facility entrance.
- 9) The Facility access road is of all-weather construction and is being maintained in overall good condition.
- 10) Access around the Facility is generally stable; no areas of erosion were observed during this Facility Compliance Inspection.

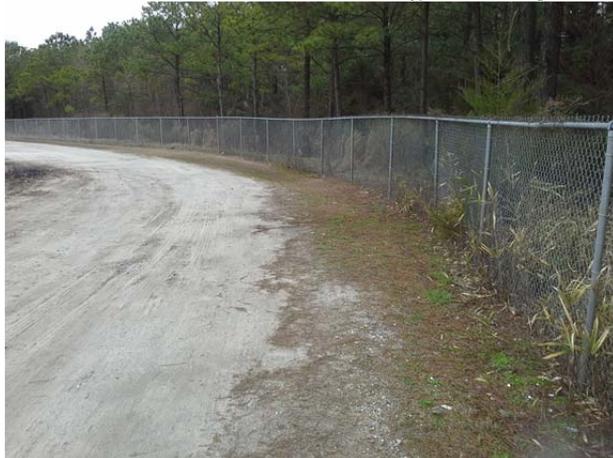
- 11) Windblown debris is collected and returned to the transfer station daily. Windblown debris was minimal and no windblown debris was noted as leaving the Facility during this Facility Compliance Inspection.

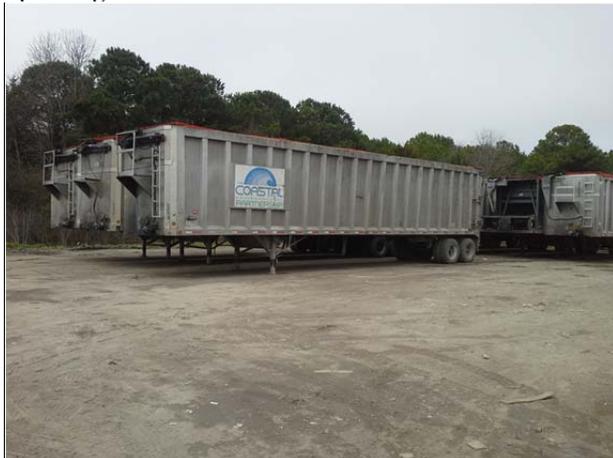
- 12) This Facility maintains an adequate number of trailers on site to properly manage the volume of waste received during operating hours.

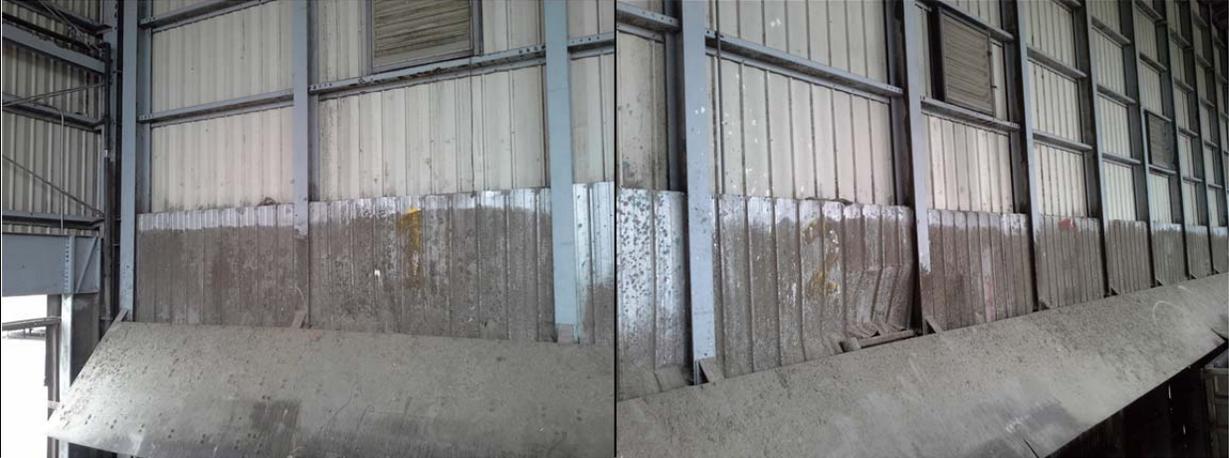
- 14) The Facility is cleaned monthly using a high-pressure washer. The upper interior walls have recently been cleaned with an elevator lift and high pressure wash.

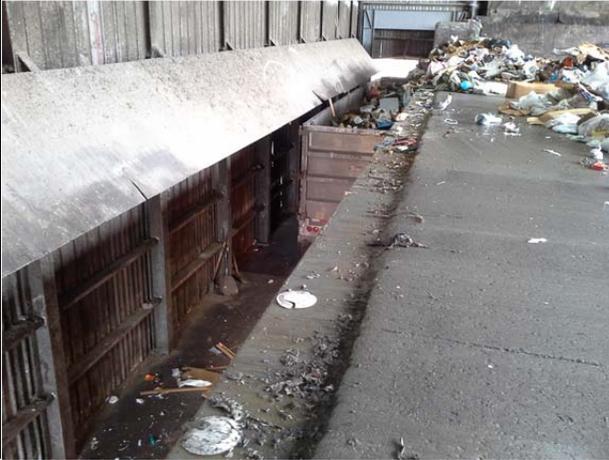
- 15) The tipping floor was reviewed during this Facility Compliance Inspection. The tipping floor is currently well maintained and in good working order.

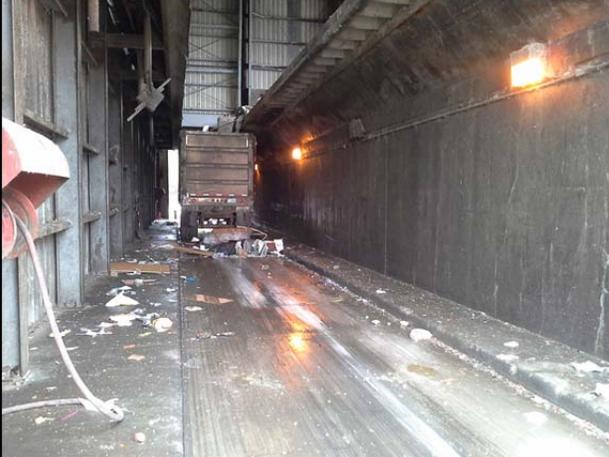
- 24) The area around the secondary scale is policed throughout the day for overflow and windblown debris. *Please continue to ensure that this area of your Facility is cleaned of all overflow and windblown debris as necessary throughout the workday and at the end of each workday.

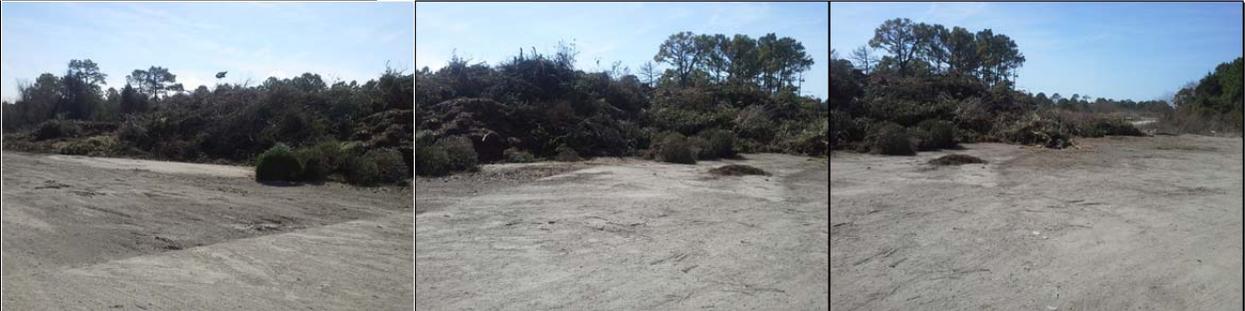
- 26) Scrap tires are collected and placed into trailers for direct haul to the Tire Management Facility.
- 27) Yard waste is collected on site and staged for grinding. All ground waste is hauled to the Coastal Environmental Partnership Compost Facility, permit #25-09, in Craven County for composting before being distributed to the public. The yard waste storage pile is approaching its maximum size. *Plans need to be underway for the processing and removal of this waste from the site.

- 28) *Corrective actions are required as a result of this Facility Compliance Inspection.
