FACILITY COMPLIANCE INSPECTION REPORT
Division of Waste Management
Solid Waste Section

Carteret County/CRSWMA Transfer Facility
 800 Hibbs Road
 Newport, NC

Partial Facility Compliance Inspection without records review

1604T-20141021INSP

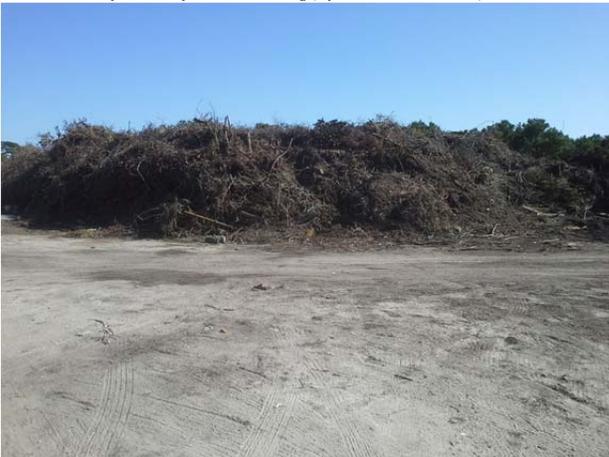
- 5) Proper signage including the Facility permit number, accepted waste types, banned or excluded items, hours of operation, and the emergency contact number is posted at the facility entrance.
- 6) The hours of operation are Monday through Friday 7:30 AM to 4:30 PM and Saturday 7:30 AM to 12:00 PM.
- 7) The Facility is secured by means of a locked gate at the facility entrance.
- 8) The Facility access road is of all-weather construction and is being maintained in overall good condition.
- 9) Yard waste is collected on site and staged for grinding. All ground waste is hauled to the Coastal Environmental Partnership Compost Facility, permit #25-09, in Craven County for composting before being distributed to the public.

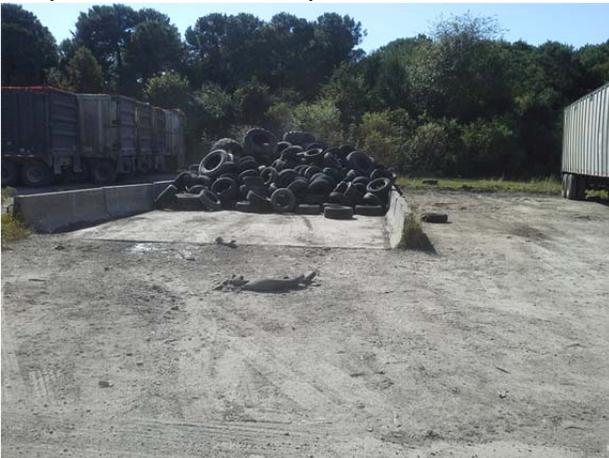
- 10) Scrap tires are collected and placed into trailers for direct haul to the Tire Management Facility.

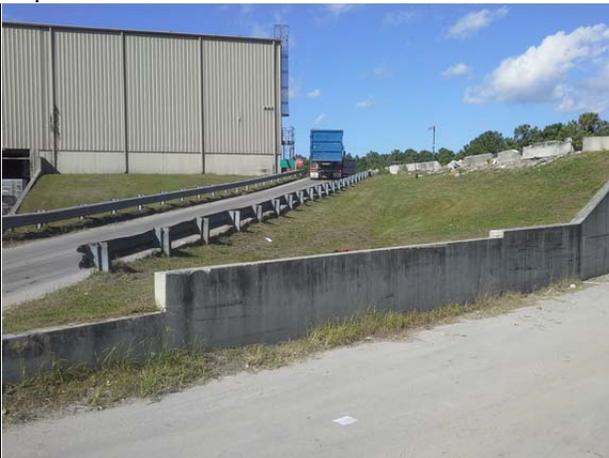
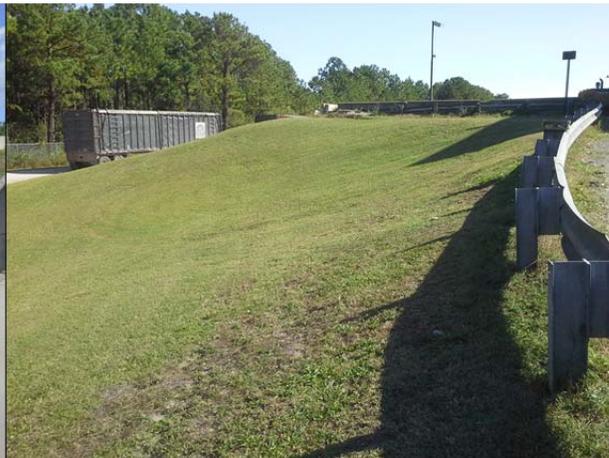
- 11) Windblown debris is collected and returned to the transfer station daily. Windblown debris was minimal and no windblown debris was noted as leaving the Facility during this Facility Compliance Inspection.
- 12) Personnel were on-site collecting windblown debris during this Facility Compliance Inspection.
- 13) Access around the Facility is generally stable; no areas of erosion were observed during this Facility Compliance Inspection.

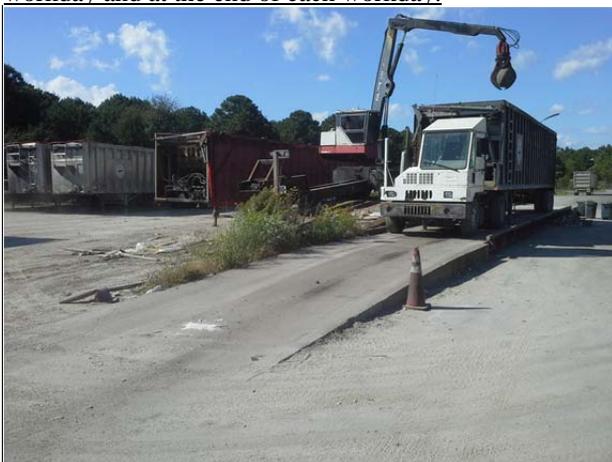
- 22) This Facility maintains an adequate number of trailers on site to properly manage the volume of waste received during operating hours.
- 23) The area around the secondary scale is policed throughout the day for overflow and windblown debris. *Please continue to ensure that this area of your Facility is cleaned of all overflow and windblown debris as necessary throughout the workday and at the end of each workday.

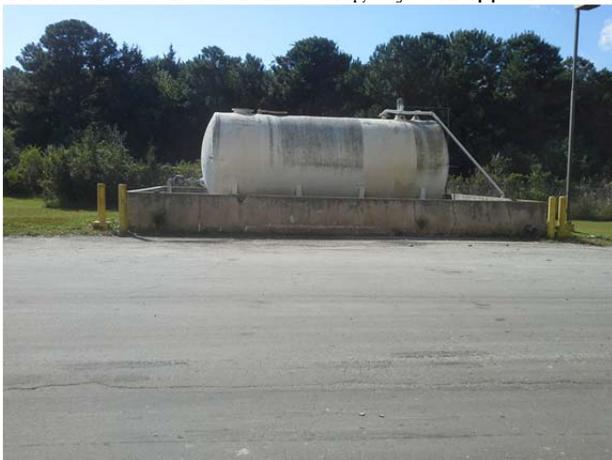
- 26) This Facility is currently receiving +/- 415 tons of waste per day.
- 27) Leachate is collected on-site in an above ground storage tank and is pumped down and hauled for treatment as needed. The leachate collection and storage system appear well maintained at this time.
