FACILITY COMPLIANCE INSPECTION REPORT
Division of Waste Management
Solid Waste Section

Date of Site Inspection: July 16, 2015 **Date of Last Inspection:** 2/20/2014 (routine) and 3/7/2014 (follow-up)

Duke Energy Carolinas, LLC - Marshall Steam Station
 Flue Gas Desulfurization (FGD) Residue Landfill
 8320 East NC Highway 150
 Terrell, North Carolina 28682

Comprehensive Inspection

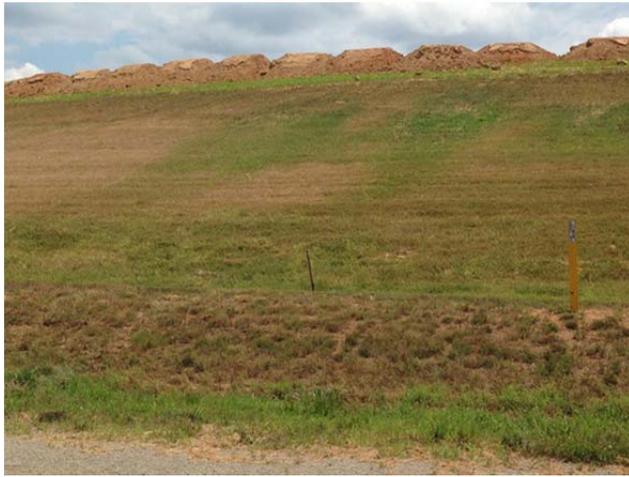
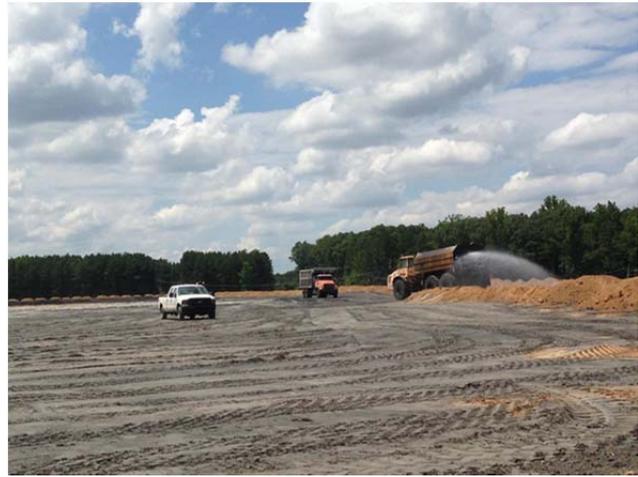
12. Edge-of-waste markers delineating the permitted disposal area were visible and maintained in good condition. The markers are offset from the edge of the landfill liner.

Side slope of the landfill
