**FACILITY COMPLIANCE INSPECTION REPORT**  
**Division of Waste Management**  
**Solid Waste Section**

Duke Energy Carolinas, LLC - Marshall Steam Station  
 Industrial Landfill No. 1  
 8320 East NC Highway 150  
 Terrell, North Carolina 28682

Comprehensive Inspection

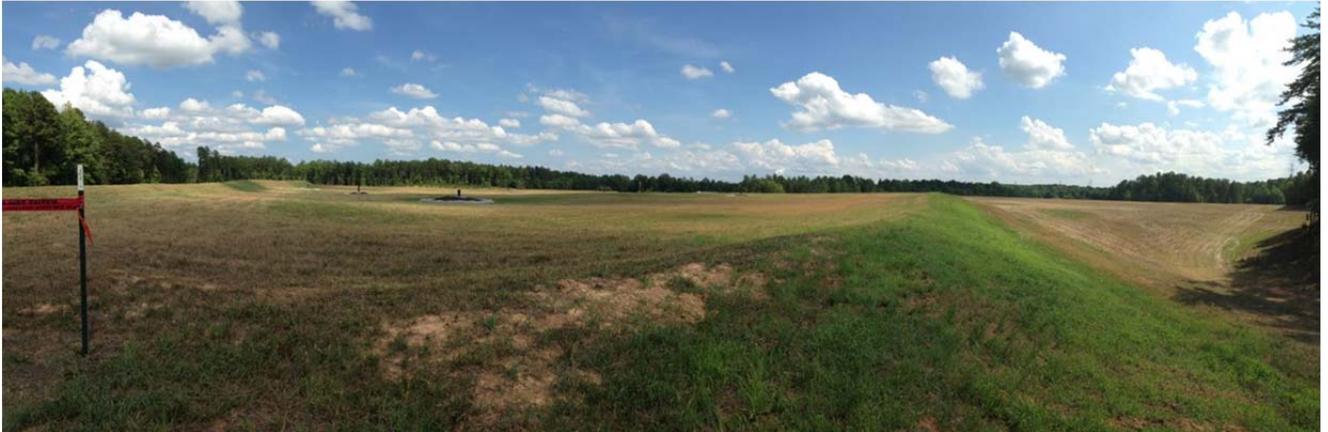
Top of the landfill with interim cover (on left). Future expansion (on right).

15. There was no water observed ponded over waste.
16. Chimney drains convey the flow of leachate to the leachate control system.
17. Dust was well controlled at the time of the inspection.
18. Exterior landfill slopes were vegetated. There was no erosion observed on exterior landfill slopes. Reseeding is done as needed.

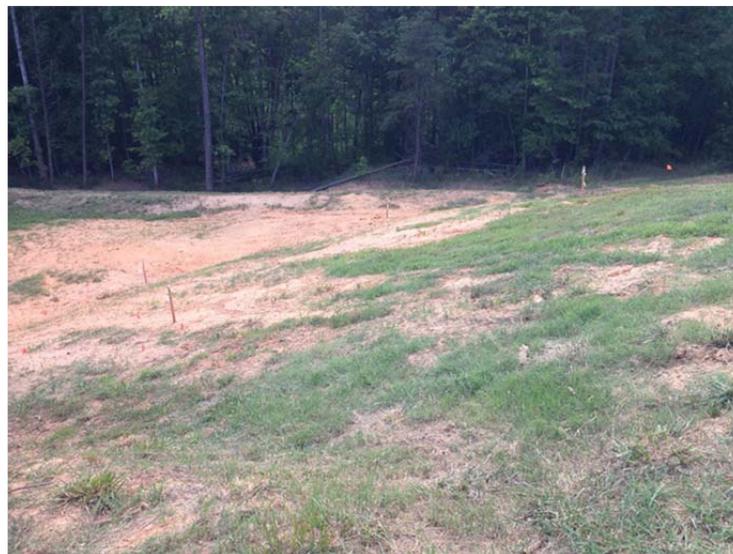
CCB0072 - Area of Possible Slope Nonconformity

19. On June 10, 2015, Duke Energy notified the SWS of an apparent bulge or non-conformity of the southwest corner of the covered Structural Fill (CCB0072) in the future Cell 3/4 Industrial Landfill area at Marshall Station. Per the investigation plan, approved by the SWS on June, 11, 2015, AECOM Geotechnical Engineers performed a field investigation of the area. In a memorandum dated July 16, 2015, AECOM concluded that there was no evidence that a significant slope failure had occurred or was imminent. They recommended regrading the area to minimize future infiltration in the area and restabilization with vegetation. At the time of the inspection, the area had been regraded but not yet reseeded. **Disturbed areas should be reseeded and vegetation sufficient to control erosion must be established. The area should be monitored weekly for any indication of exposed ash or instability.**
