FACILITY COMPLIANCE INSPECTION REPORT
Division of Waste Management
Solid Waste Section

Waste Management of the Carolinas, Inc. – Chatham County Transfer Station
 361 Waste Treatment Plant Road
 Siler City, NC 27344

Comprehensive Inspection

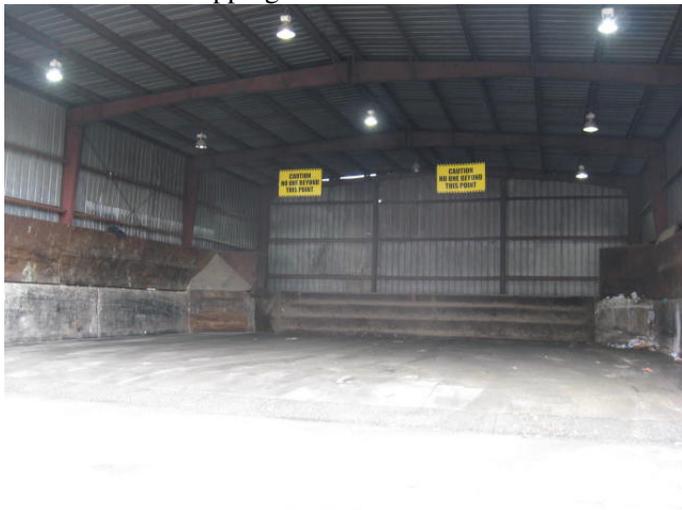
Transfer station tipping floor

26. The transfer station tipping floor and load-out bay appeared to be routinely cleaned.
27. Ensure the sheet metal on the upper left side of the transfer station building is repaired.

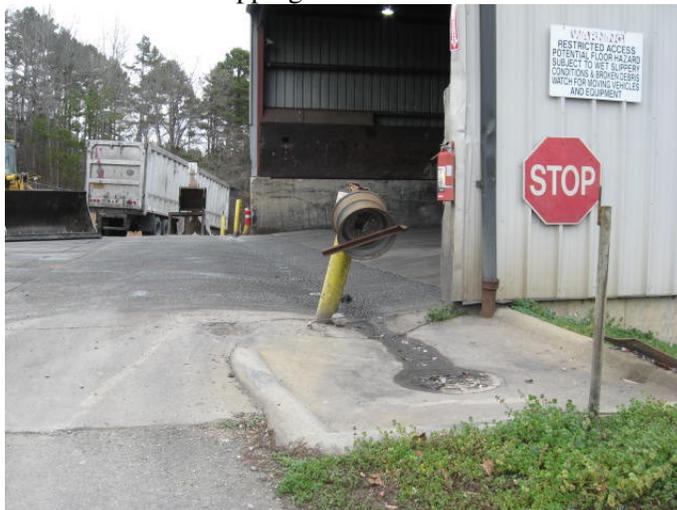
23. The leachate floor drain was functional and appeared to flow freely. The leachate catch basin is sloped from left to right such that leachate is gravity-fed to the leachate drain located on the far right of the entrance to the transfer station building.

Transfer station tipping floor leachate drain

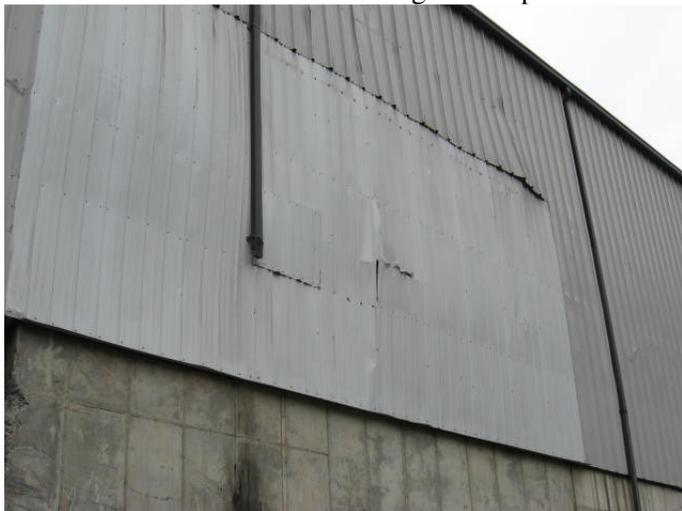
Left side of transfer station building to be repaired

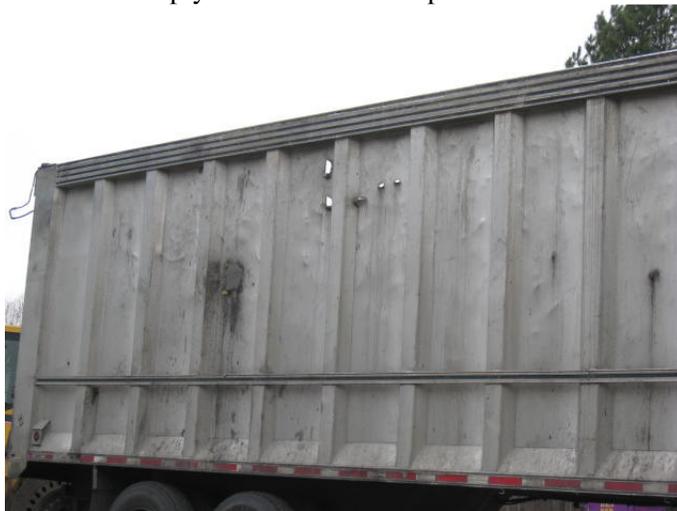
17. Holes were observed in the sheet metal siding of the transfer trailers located outside of the building. Ms. Durham was asked to contact Stafford Logistics regarding required maintenance of the transfer trailers.

Holes in empty transfer trailer - representative

18. Transfer trailers shall be maintained to ensure that they are leak resistant.
19. The materials recovery operation is not conducted (operations plan pg 6, section 4.8 states the procedure if conducted).

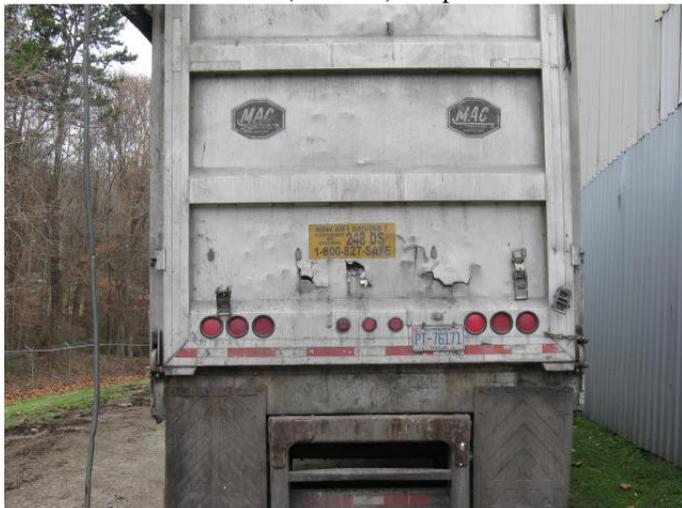
Holes in transfer trailer (trailer 1) - representative

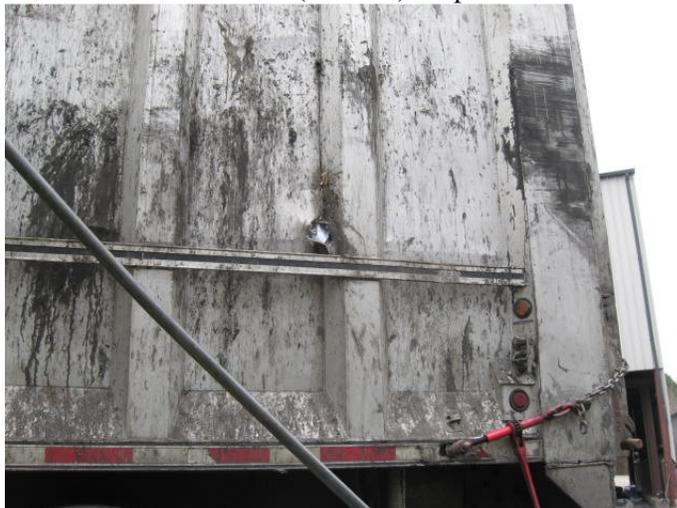
Hole in transfer trailer (trailer 2) - representative
