FACILITY COMPLIANCE INSPECTION REPORT
Division of Waste Management
Solid Waste Section

Date of Site Inspection: August 15, 2014

Chatham County Permanent Household Hazardous Waste Collection Facility
 39 County Services Road
 Pittsboro, NC 27312

Comprehensive Inspection

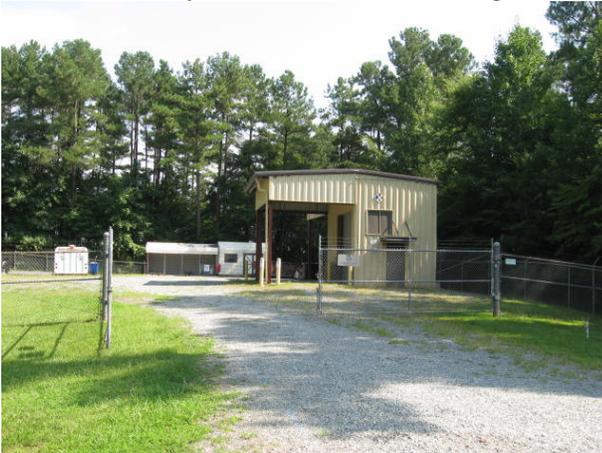
Chatham County HHW collection building

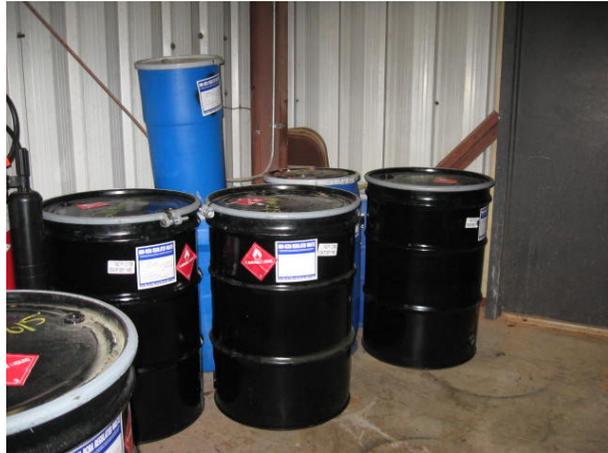
19. During the inspection HHW was stored on site in containers. Accumulated material not shipped-out the day of a collection event is routinely stored for ~ 90 days. Accumulation labels affixed to 50-gallon drums were observed.

Accumulated materials stored in drums

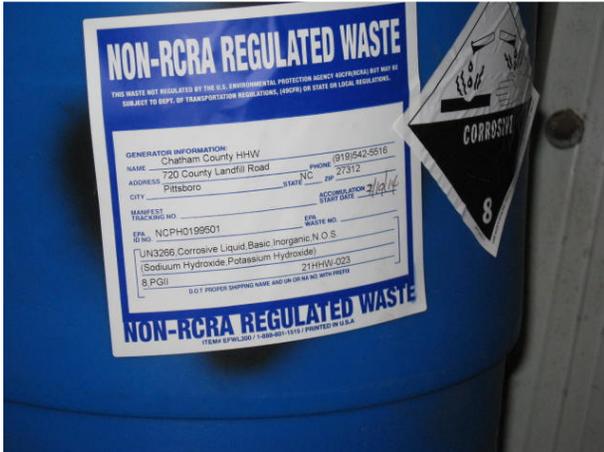
Accumulation label – start date: 07/19/14

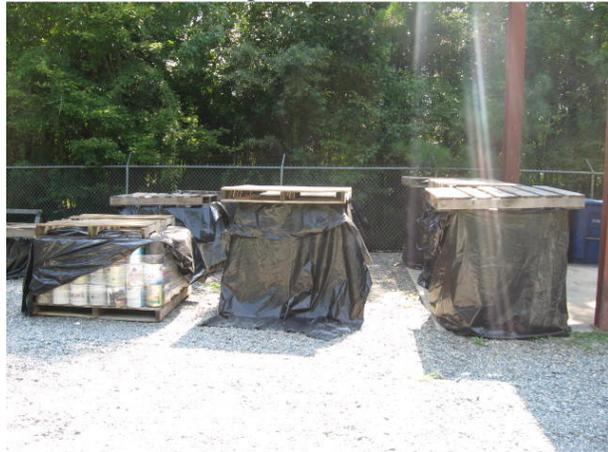
20. Fluorescent lights appeared to be stored appropriately. If applicable, ensure fluorescent light ballasts are handled and stored appropriately.
21. Several pallets stacked with paint cans and covered with plastic tarp were stored adjacent to the HHW collection building.

Pallets stacked with paint cans
