FACILITY COMPLIANCE INSPECTION REPORT
Department of Environmental Quality
Division of Waste Management - Solid Waste Section

Date of Site Inspection: October 8, 2015

Chatham County Permanent Household Hazardous Waste Collection Facility
 39 County Services Road
 Pittsboro, NC 27312

Comprehensive Inspection

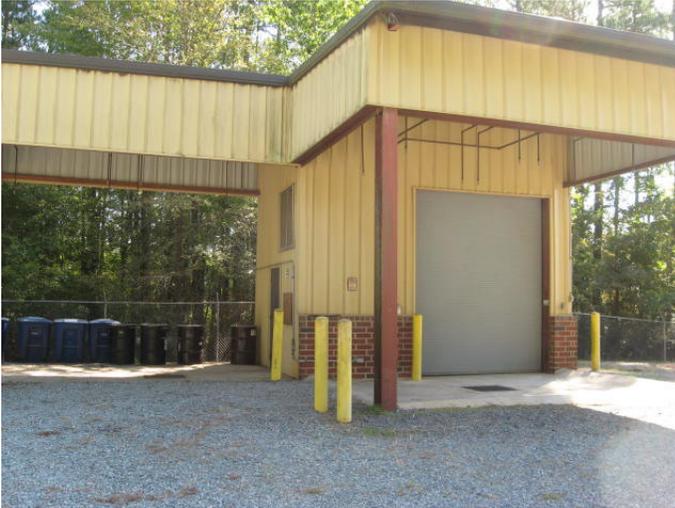
11. A record of material brought to the HHW facility (origin of loads) by residents was verified for March through September 2015.
12. The facility building has a secondary containment sump and automatic fire suppression system. There are two concrete pads outside of the building each with secondary containment sump and automatic fire suppression system, covered by an all-weather awning. There is a handheld fire extinguisher located inside of the building and another located outside.

HHW/facility building

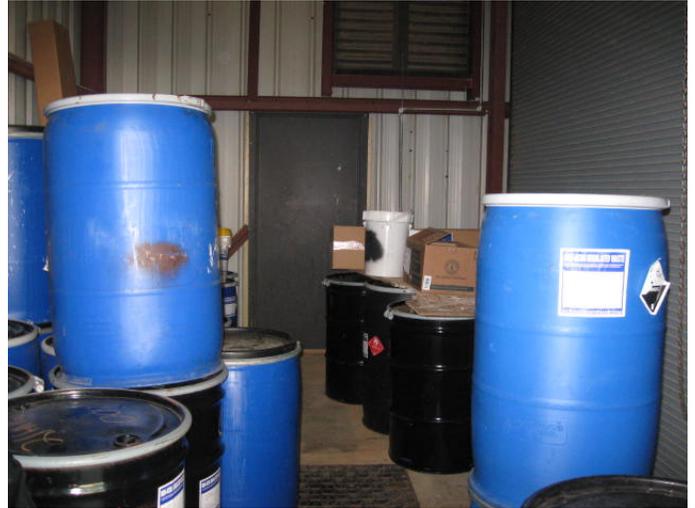
20. During the inspection HHW was stored on site in containers and on pallets. Accumulation labels affixed to 50-gallon drums and pallets were observed, dated September 19, 2015.

Accumulation labels affixed to 50-gallon drums

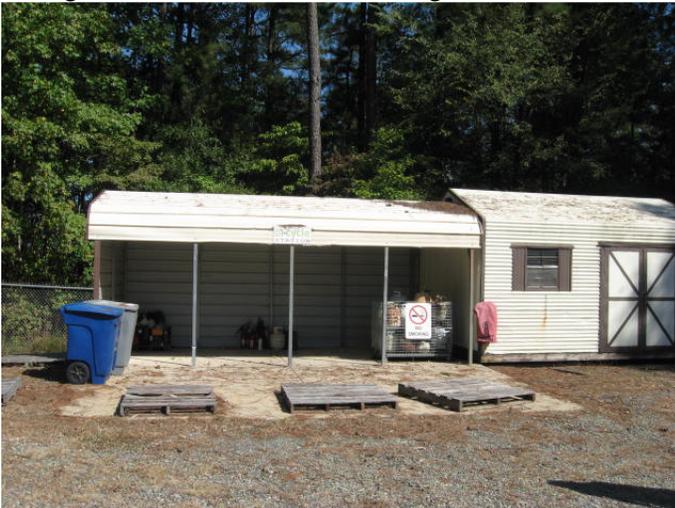
23. A dumpster with water-tight lid is on site for non-HHW solid waste.
24. The facility collects lead-acid batteries stored atop a pallet under an all-weather awning.

25. Fire extinguishers and propane tanks collected are also stored under the all-weather awning.
26. The facility maintains records of the amount of HHW received. The material hauled-off by ECOFLO, Inc. mirrors the quantity of HHW received. ECOFLO, Inc. sends the facility a manifest of the materials picked-up. Manifests for material hauled-off were verified for May 4, 2015, July 10, 2015, and September 11, 2015.

Storage shed with all-weather awning
