FACILITY COMPLIANCE INSPECTION REPORT
Division of Waste Management
Solid Waste Section

Date of Site Inspection: January 12, 2015

Brooks Compost Facility – Large, Type 3 Solid Waste Compost Facility
 1195 Beal Road
 Goldston, NC 27252

Comprehensive Inspection

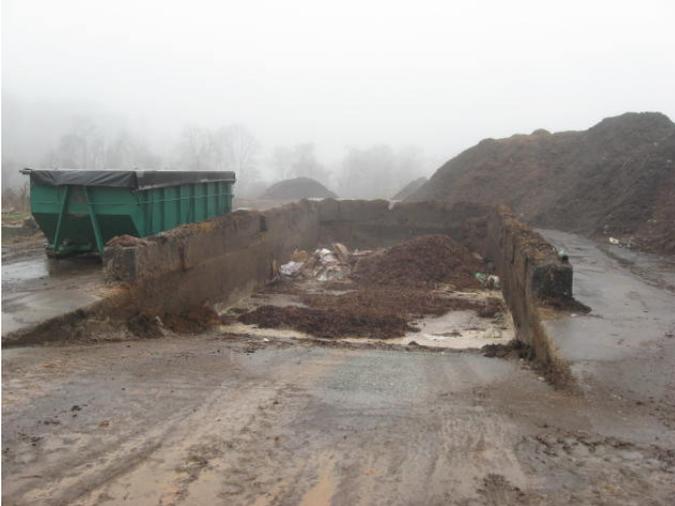
Bulking and mixing pit

7. Liquid material is dumped into a bulking and mixing pit. Solids with a high concentration of liquid are placed on an adjacent concrete pad.
8. Liquid material is mixed with absorbent bulking material and placed on the concrete pad.

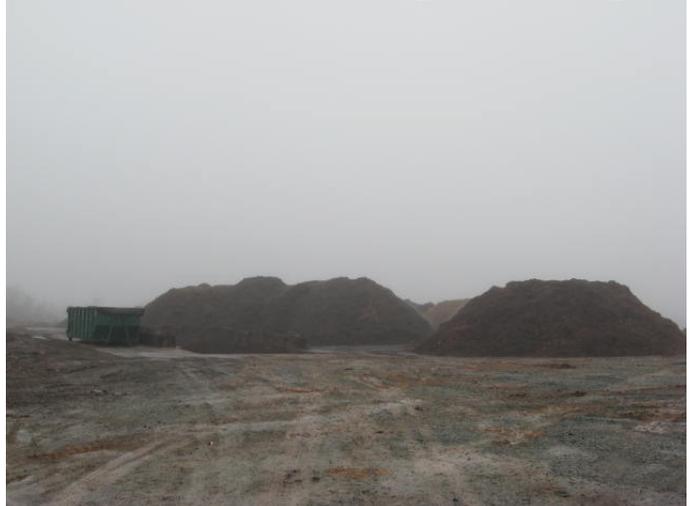
Solids w/high concentration of liquid on concrete pad.

9. The concrete pad contains drain grates. The leachate is directed to the bulking and mixing pit or to two 3,500 gallon concrete storage tanks.
10. The concrete storage tanks are used to settle-out sludge and particulate material. A 10,000 gallon steel storage tank is used to store the leachate drained from the concrete tanks. The leachate is pumped-out and used on the active windrows.

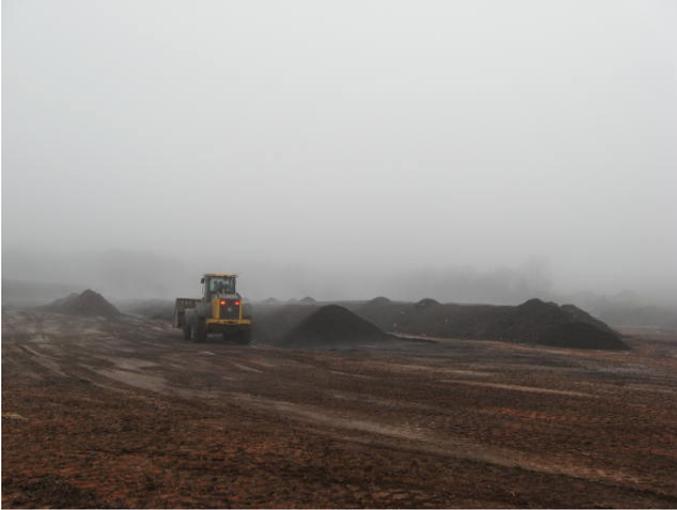
Active windrow construction

17. During the inspection the facility had 40 active windrows (including “test” windrows).
18. The facility uses a windrow-turning machine to turn the active windrows. Windrows are constructed with a front end loader.

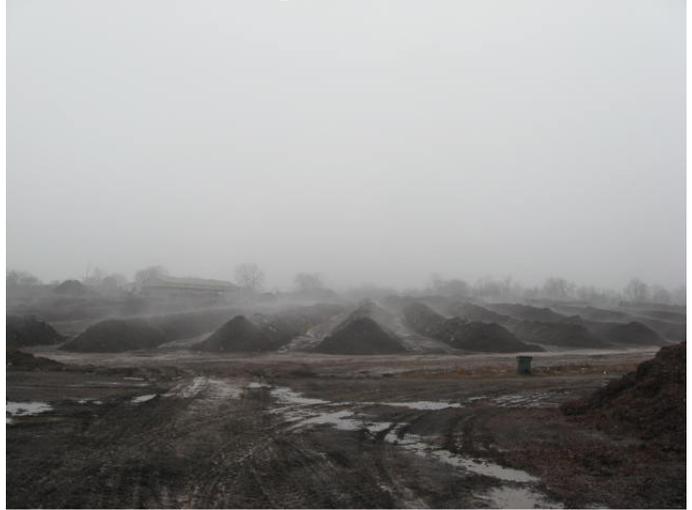
Active windrows – representative view

15. During the fall and winter months, the facility receives leaves from the town of Cary and Siler City.
16. Active windrows appeared to be within required dimensions. Eggshell/hatchery waste windrows are commonly 350 feet long and food waste windrows 200 feet.

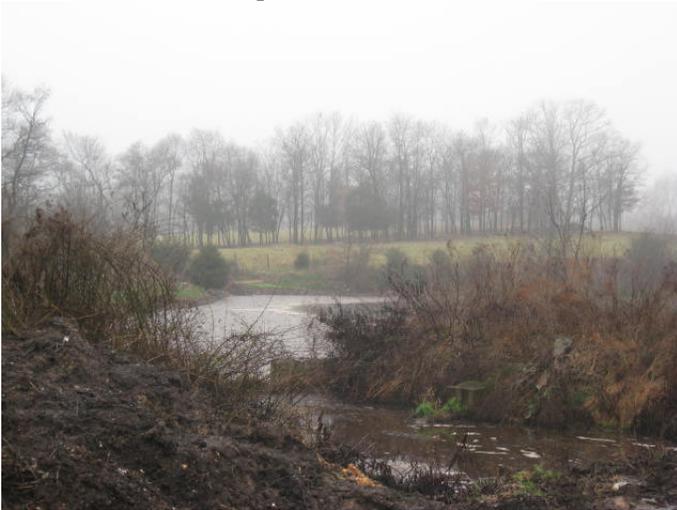
Stormwater retention pond and sedimentation basin

39. Erosion and sedimentation controls appeared to function accordingly.
40. The facility has a clay-lined stormwater pond. Stormwater is pumped-out to be used in the active windrow process. The facility does not discharge stormwater from the containment pond.

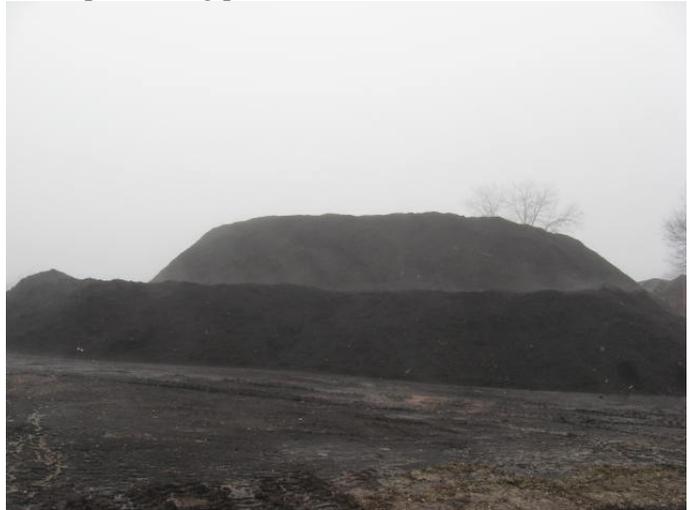
Compost curing pile No. 3

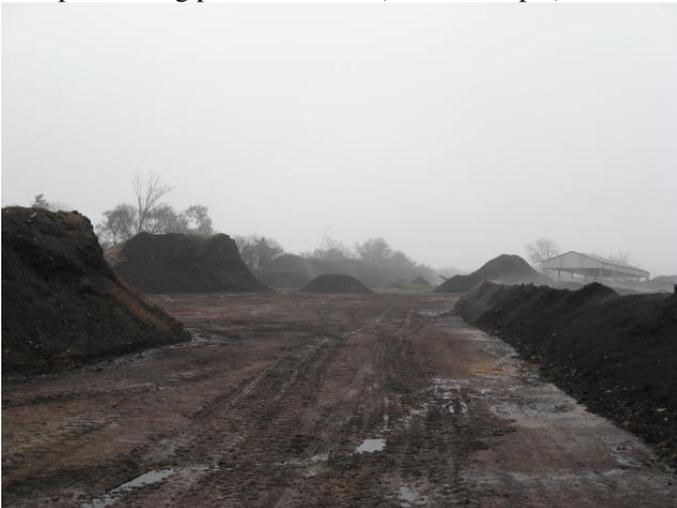
Compost curing pile/area No. 2 (left side of pic)

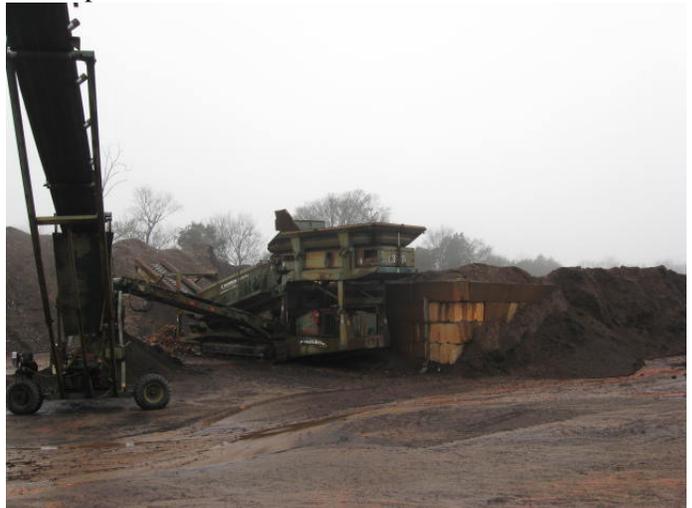
Compost screener

21. Cured compost is screened prior to sale. Generally, compost is screened as needed.
22. Stockpiled finished product is limited to a height of 60 feet.
