**FACILITY COMPLIANCE INSPECTION REPORT**  
**Division of Waste Management**  
**Solid Waste Section**

**Date of Site Inspection:** February 5, 2015

Fort Bragg Closed MSWLF  
 Longstreet Road, Fort Bragg

Joint Inspection with DEMLR and Bragg Staff

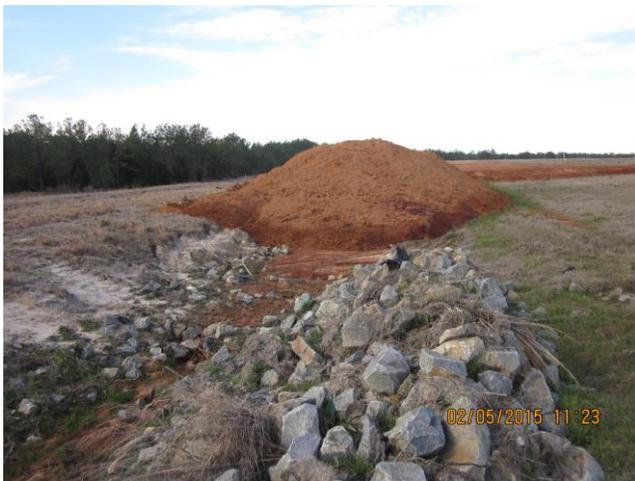
3. Bragg solid waste personnel had begun removing the rip rap stone and filling the south side drainage ditch. The south ditch was approximately 2/3 complete at the time of this inspection. **This area did not appear to have changed from the November inspection of the site.**

South side drainage ditch, middle to east end.

4. Measures to prevent onsite erosion from the fill activity and to assist in establishing vegetative cover on this area need to be underway **as recommended in the November inspection report.**

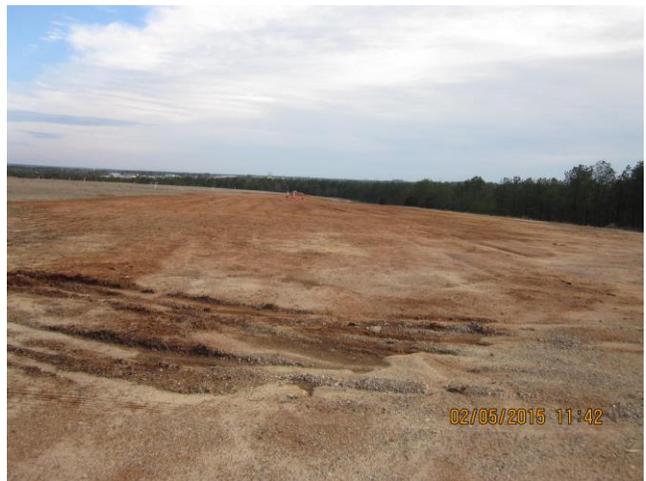
South side drainage ditch repair west end.
