FACILITY COMPLIANCE INSPECTION REPORT
Division of Waste Management
Solid Waste Section

Date of Site Inspection: April 21, 2015

Fogleman and Fogleman Landfill and Recycling Facility – LCID Landfill and Processing Facility
 4005 Intermere Road
 Durham, NC 27704

Partial Inspection

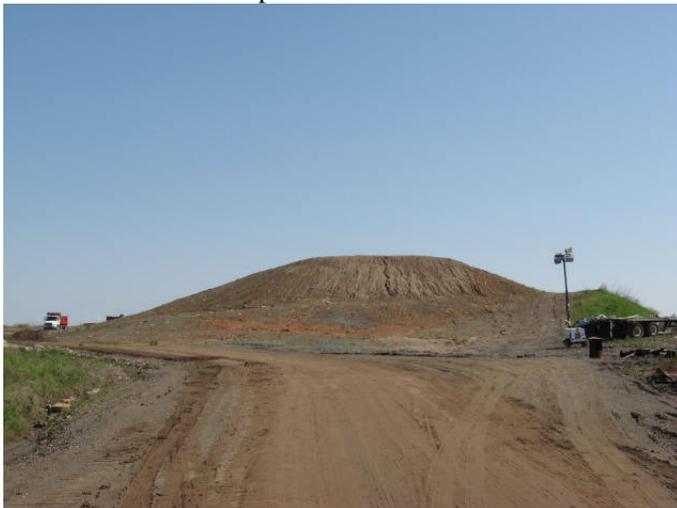
19. The southwest and east-facing side slopes (front and right side of landfill) contain soil cover/have been repaired. The northeast side slope (rear of landfill) has been graded accordingly and soil applied, although due to recent heavy rains a top layer of the soil was washed away. The northwest and north facing side slopes (left rear of landfill area) contain exposed material although the [two] areas are active and are continually being re-graded and covered with soil.

Landfill front side slope – soil cover

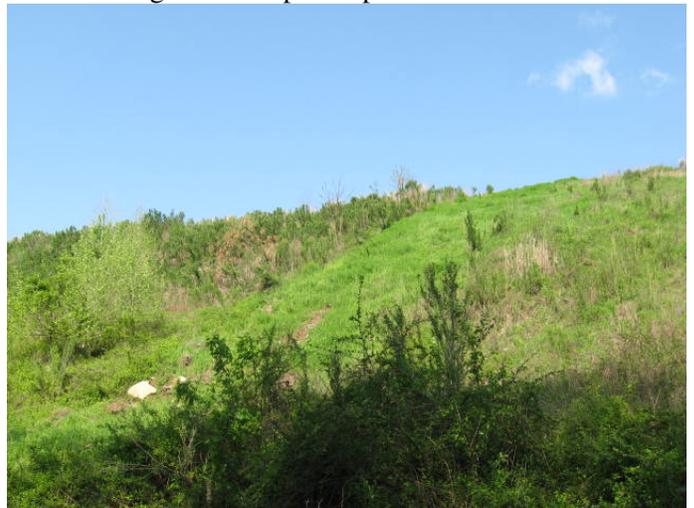
Landfill right side slope – repaired and seeded area

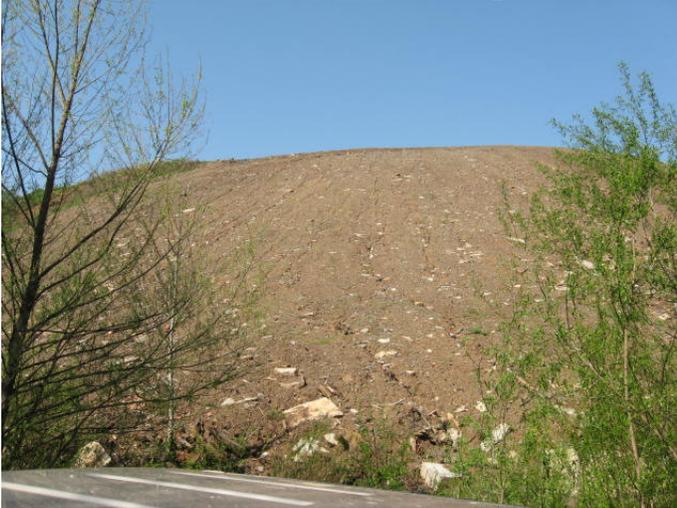
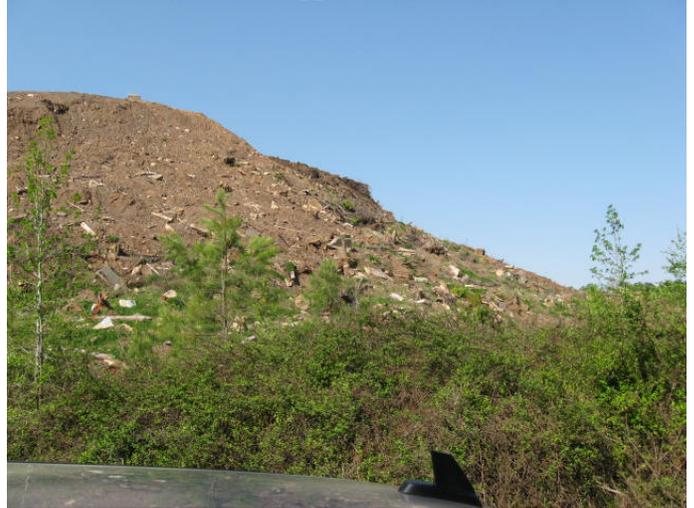
Landfill rear side slope area – reworked/to rework again, to reapply soil cover

- 20. Mr. Fogleman stated that he intends to have the remaining side slopes reworked to create a manageable grade and all material adequately covered with soil, weather permitting, within the next two months. Once complete, he will operate a manageable working face that will be graded for ease of maintenance and soil cover stability.
- 21. Repair erosion rills along landfill side slopes.
- 22. Mr. Fogleman stated that side slope bare areas will be sown with grass seed.
- 23. Woody vegetation should be removed from the landfill cap.
- 24. The permit expiration date is December 19, 2016.
- 25. Permit renewal application shall be submitted to the SWS by September 19, 2016.

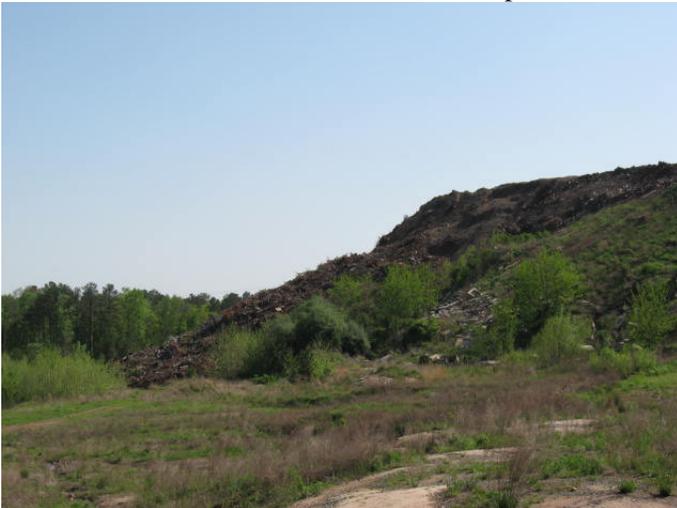
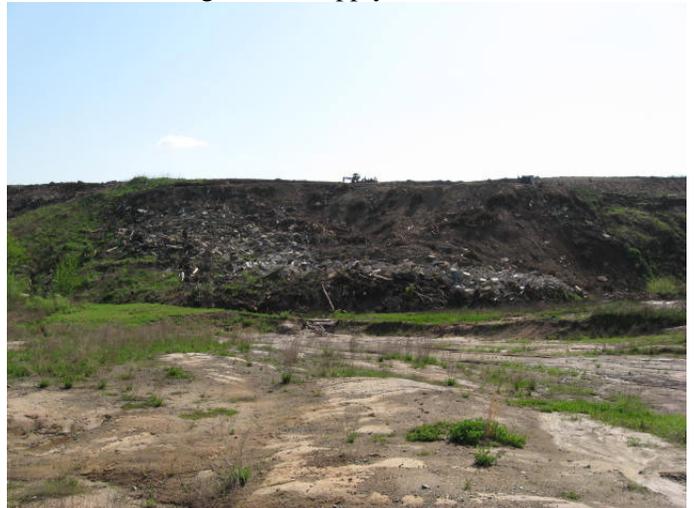
Landfill left rear side slope area – active areas, to rework grade and apply soil cover

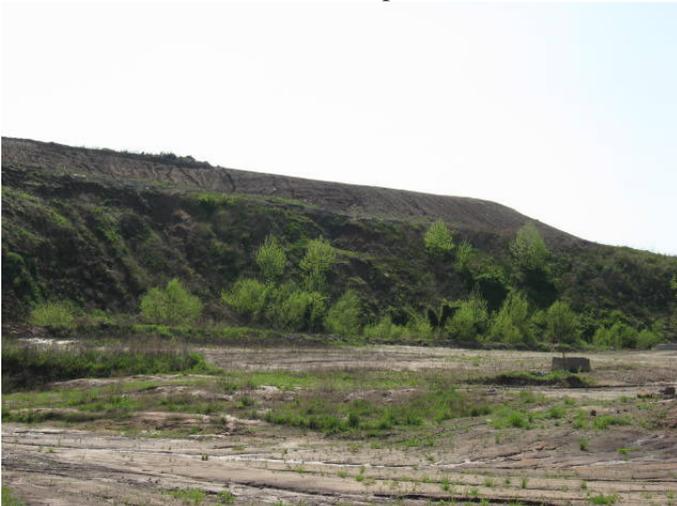
Landfill left middle area side slope

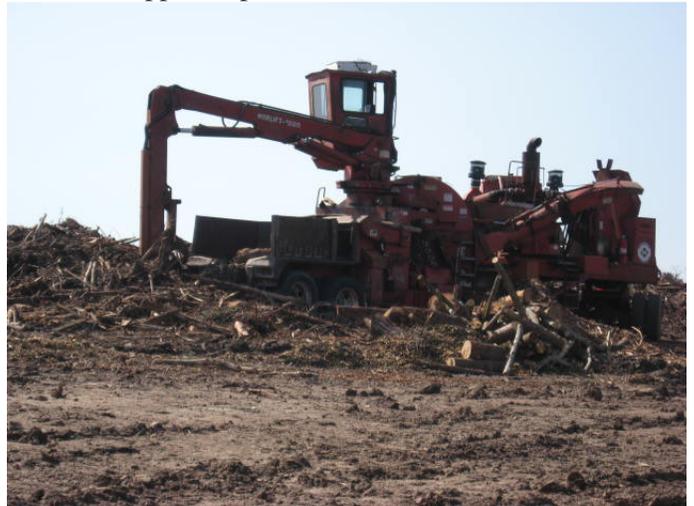
4. The recycling operation also pertains to sorting material received, within the landfill footprint, for grinding and crushing.
5. Land clearing debris (LCD) is sorted atop the landfill cap, adjacent to the working face. Selected LCD is staged to be chipped. The material is sold for boiler fuel.

Wood chipper atop landfill
