FACILITY COMPLIANCE INSPECTION REPORT
Division of Waste Management
Solid Waste Section

Date of Site Inspection: August 14, 2014

Waste Industries LLC – LCID Landfill and Wood and Inert Debris Recycling Area
 148 Stone Park Court
 Durham, NC 27703

Comprehensive Inspection

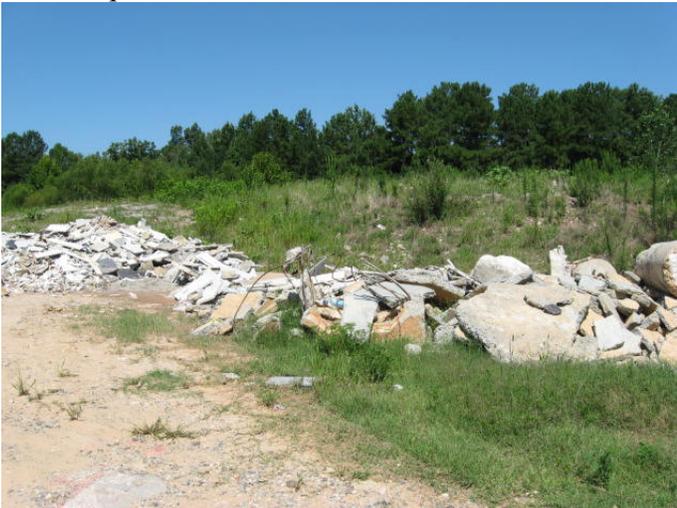
Rebar required to be cut flush with concrete

16. Cell No. 2 is currently active. Unpermitted material shall not be received. Remove painted block, electrical wiring, and metal from the working face and cut rebar flush with concrete.

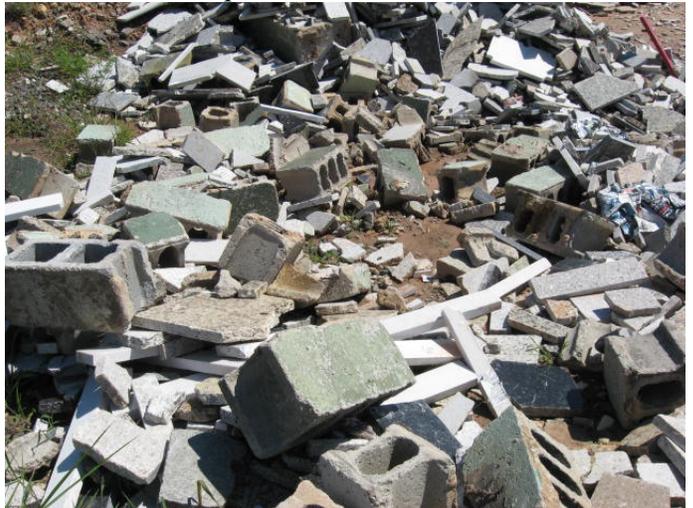
Painted block required to be removed from landfill
