FACILITY COMPLIANCE INSPECTION REPORT
Division of Waste Management
Solid Waste Section

FACILITY NAME AND ADDRESS:
 City of Rocky Mount LCID Landfill
 3873 Old Battlefield Rd.
 Rocky Mount, North Carolina 27802

PURPOSE OF SITE VISIT:
 Comprehensive inspection

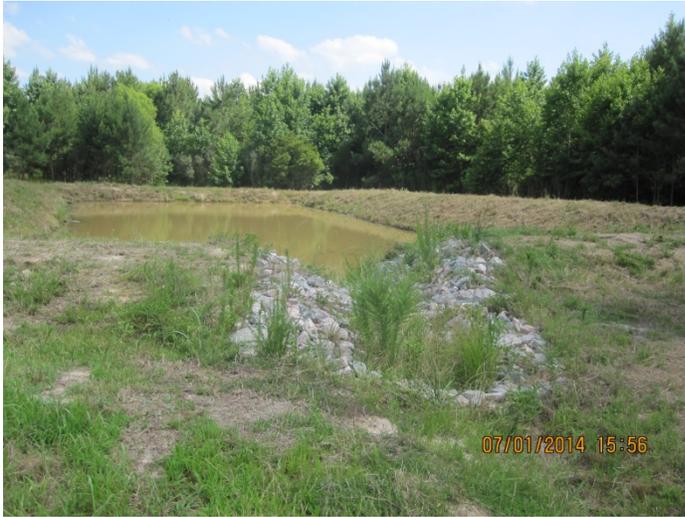
Sedimentation basin on the southern side of the site

- 13) The Operations Plan is kept in a box at the gate.
- 14) Plans indicated that a sedimentation basin was to be constructed on the eastern side of the landfill. This was never constructed but does not seem to have caused a problem. A new cell is proposed to be constructed in the same area where this basin was supposed to be located. A new basin is planned on the south side of the facility to handle run off from the new and existing cell. **The new basin has been constructed.**

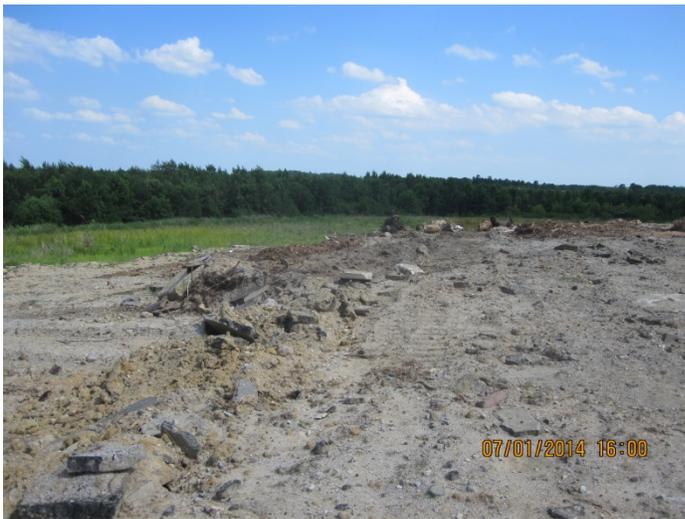
Top of the facility

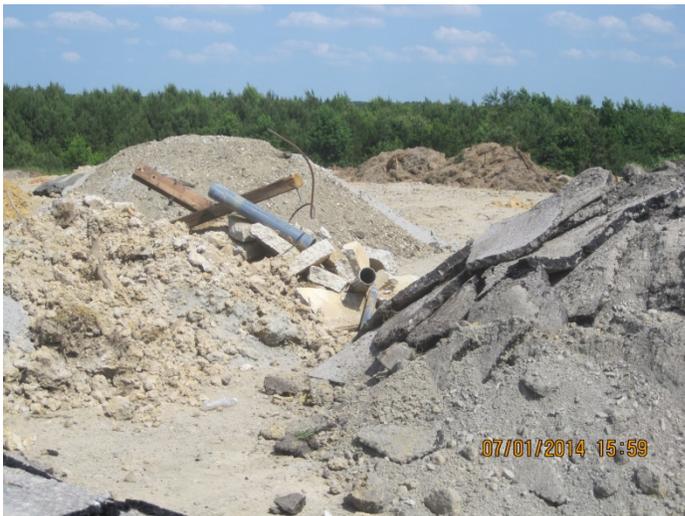
Small amount of non-conforming waste on the top of the landfill, this material must be removed and properly disposed.

- 9) Slopes that will not receive waste should be stabilized with mulch or grass
- 10) Keep all nonconforming waste out of the facility. Any nonconforming waste needs to be removed and receipts provided to Ben Barnes, Solid Waste Section, P O Box 1568 Elm City, North Carolina 27822.
