**FACILITY COMPLIANCE INSPECTION REPORT**  
**Division of Waste Management**  
**Solid Waste Section**

**Date of Site Inspection:** August 10, 2015      **Date of Last Inspection:** April 24, 2014

Halifax Coal Ash Landfill  
 921 Liles Road  
 Halifax, NC 27839

Comprehensive Inspection

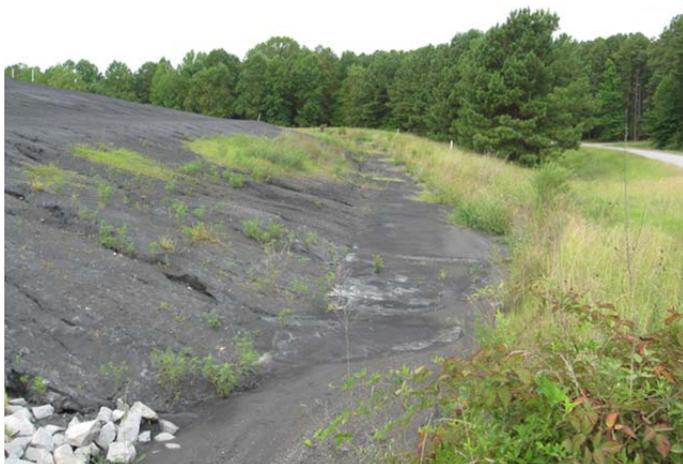
13. Significant erosion was observed on side slopes such that coal ash has washed into perimeter ditches and has washed into the sediment basin. Ash was observed at the inlet to the sediment basin. **Within 60 days of receipt of this inspection report, side slopes should be regraded to prevent erosion, covered with soil sufficient to establish vegetation, and seeded and mulched. Additionally, ash should be removed from ditches and sediment basins to restore them to their designed capacity.**

Toe of the northern slope; ash in perimeter ditch

**Within 60 days of receipt of this inspection report, side slopes should be regraded to prevent erosion, covered with soil sufficient to establish vegetation, and seeded and mulched. Additionally, ash should be removed from ditches and sediment basins to restore them to their designed capacity.**

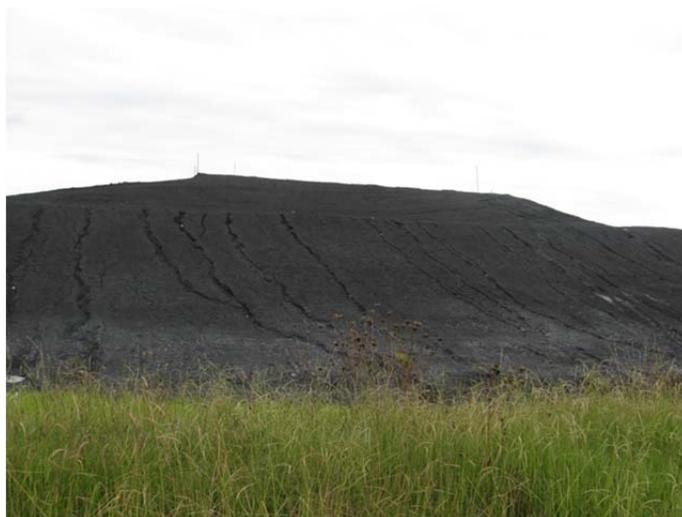
The facility is in violation of the above rule in that it failed to prevent the erosion of the side slopes by not providing soil cover and/or permanent vegetation as noted in Ops Plan 2.5.6.2.

Erosion on western slope

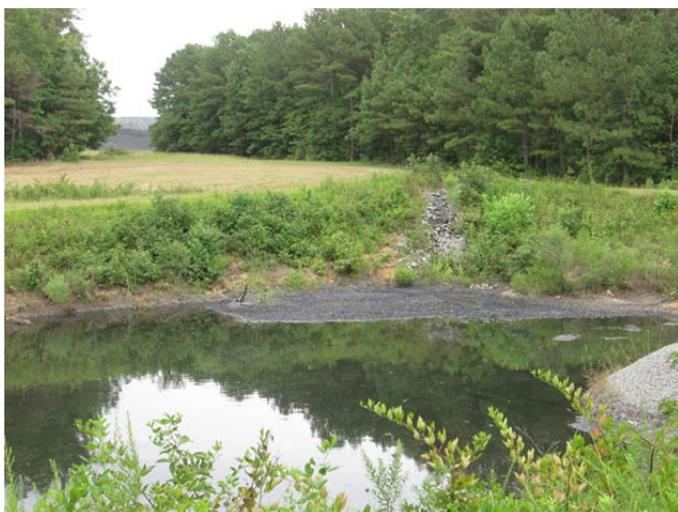
Inlet to sediment basin with visible ash.

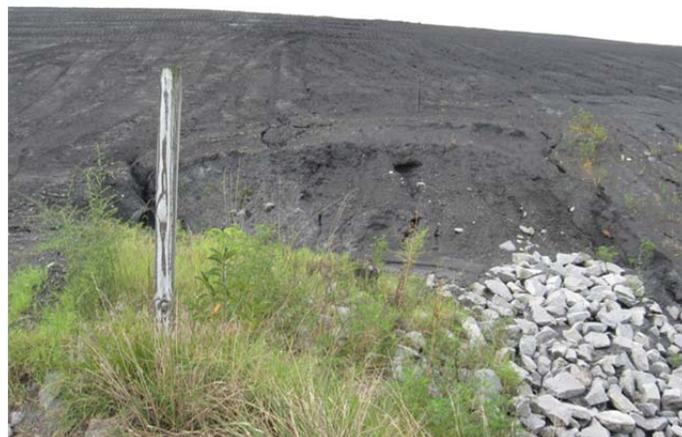
Top of reworked slope with erosion at bottom.
