**FACILITY COMPLIANCE INSPECTION REPORT**  
**Division of Waste Management**  
**Solid Waste Section**

**Date of Site Inspection: August 20, 2014**

Central Carolina Monofill  
 1616 McKoy Town Road  
 Cameron, North Carolina 28326

Comprehensive Inspection

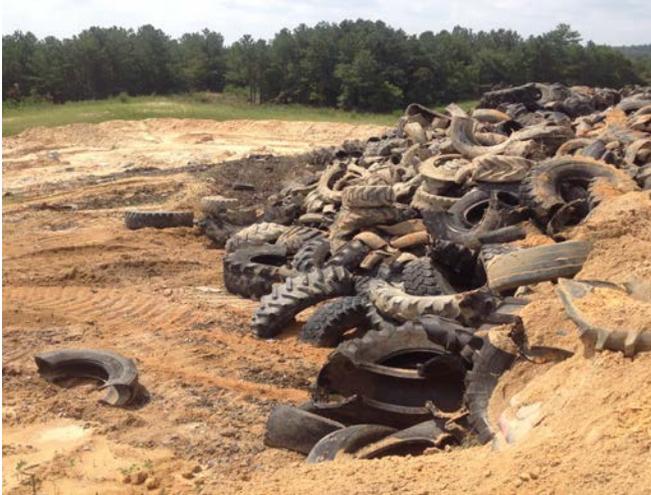
8. The erosion and sedimentation control measures
9. The active working face was reviewed and is being kept small and manageable.
10. Previously covered areas appear to be adequately covered at this time.

Working Face

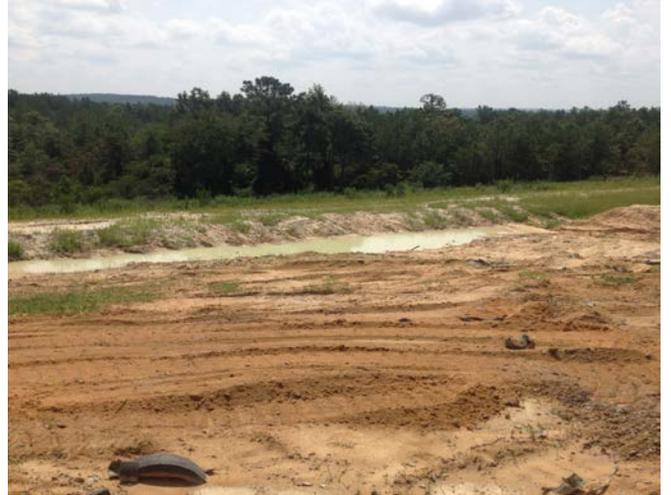
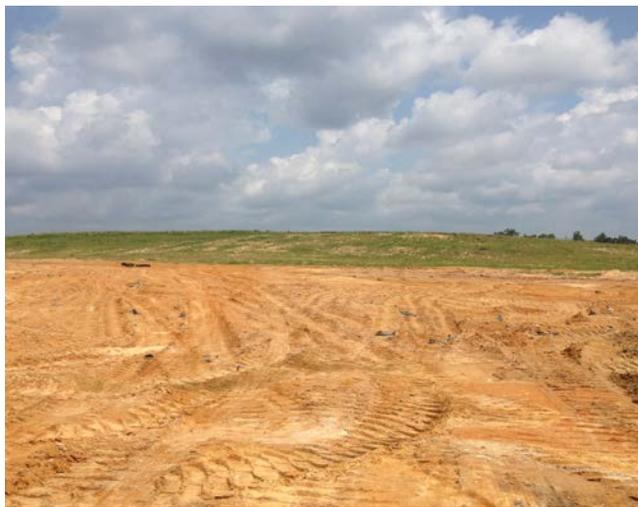
11. Ground cover efforts are continuing and no off-site erosion was noted in active areas.
12. The perimeter slopes are being graded to a maximum of a 3:1 slope. I would recommend routinely checking slopes to ensure proper sloping is being provided.

Active Landfill

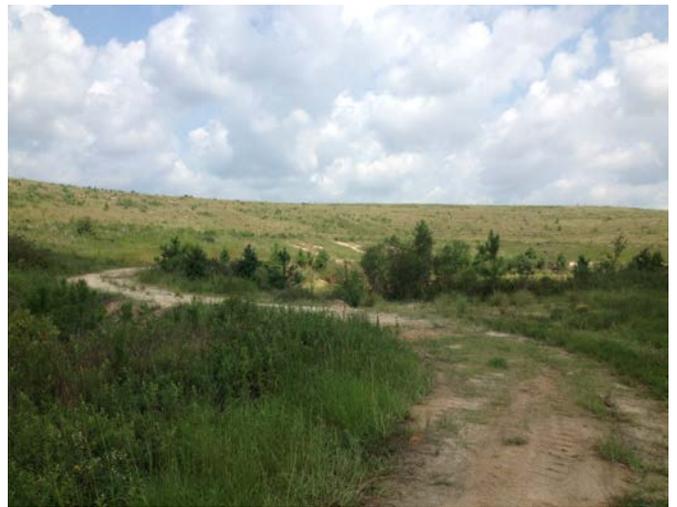
6. The closed landfill was inspected and is being maintained properly at this time. Edge of Waste Markers need to be maintained and replaced as needed over time.

Closed Landfill

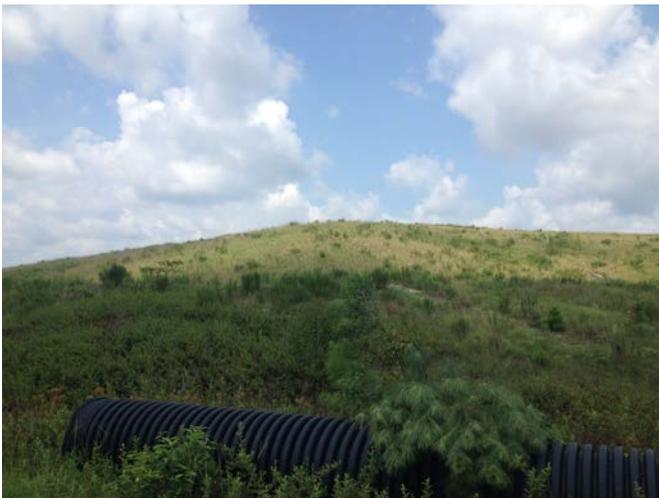
7. The vegetative cover on the closed portion of the landfill was reviewed and no off-site erosion was noted. The operator has been mowing and cutting small trees as part of their continued maintenance. Good Job!

Closed Landfill

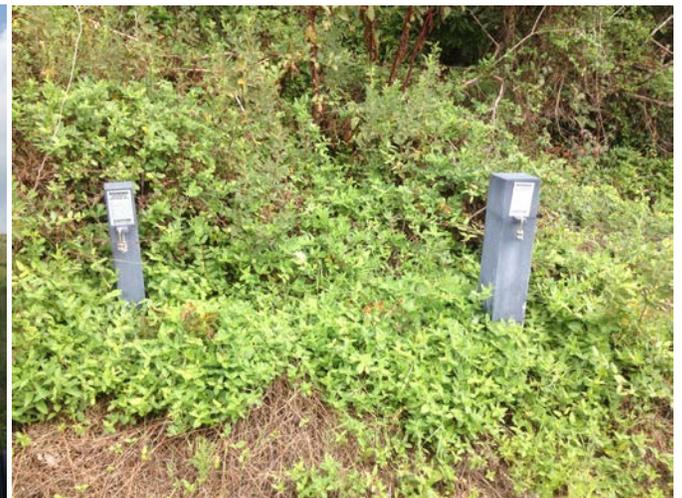
15. Ground water monitoring wells need to be maintained properly. Wells should be visible and the vegetation mowed frequently.
16. Ground Water monitoring is being conducted semi-annually as required.

17. Damaged monitoring wells GW-2S and GW-2D need to be replaced and there is a plan in place to have them reinstalled.
18. GW-7D well tag is missing and needs to be replaced.

19. The area around MW-8 needs to be cleared and maintained with low growing vegetation.
20. The Certified Landfill Operations Specialist are as follows:

Monitoring Wells needing maintenance
