FACILITY COMPLIANCE INSPECTION REPORT
Division of Waste Management
Solid Waste Section

UNIT TYPE:											
Lined MSWLF		LCID		YW		Transfer		Compost		SLAS	COUNTY: JOHNSTON PERMIT NO.: 5103-CDLF-1998 FILE TYPE: COMPLIANCE
Closed MSWLF		HHW		White goods		Incin		T&P		FIRM	
CDLF	<input checked="" type="checkbox"/>	Tire T&P / Collection		Tire Monofill		Industrial Landfill		DEMO		SDTF

Date of Site Inspection: May 21, 2014

Johnston County MSWLF, Closed MSWLF and CDLF
 680 County Home Road
 Smithfield, NC 27577

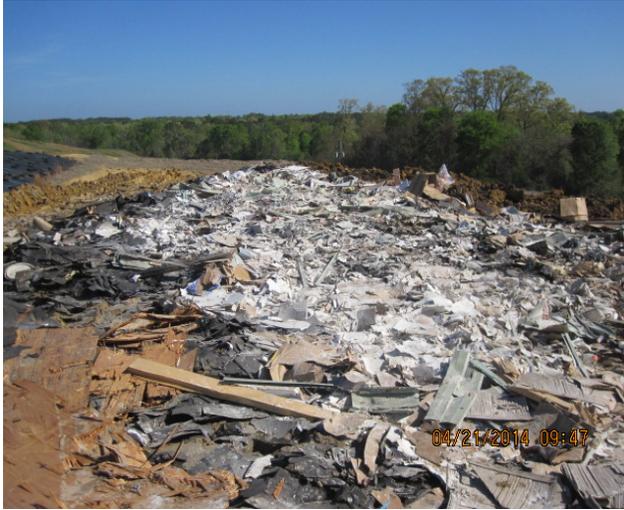
1. The working face at the C&D landfill was kept small and appeared to be well compacted with no unacceptable wastes observed.
2. **Insure that all waste is covered with a minimum of 6 inches of soil.**

Working face kept small and well compacted

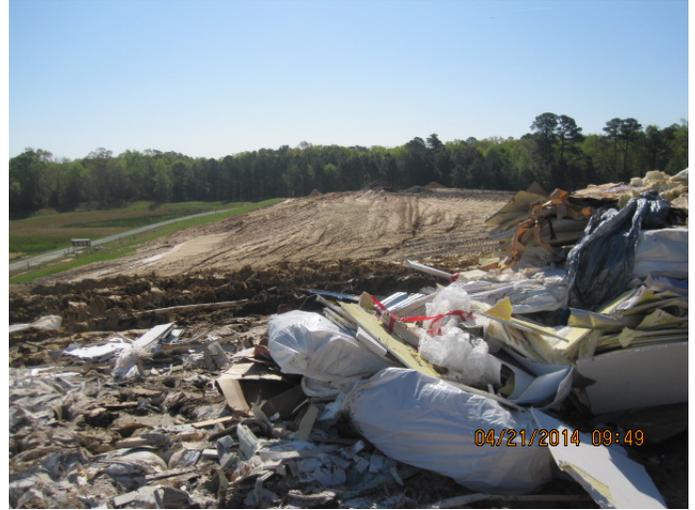
Newly dumped load at working face
