FACILITY COMPLIANCE INSPECTION REPORT
Division of Waste Management
Solid Waste Section

Date of Site Inspection: 29 July 2014

Jones County Landfill
 Landfill Rd (NC SR#1343)
 Trenton, NC

Closed: Unlined MSW Landfill

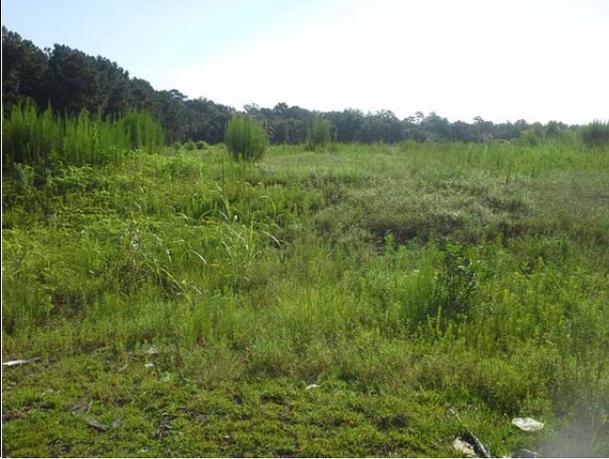
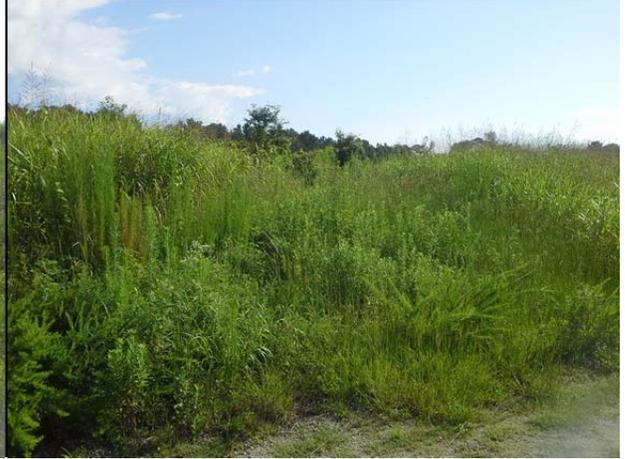
- 1) This Facility is a closed MSW Landfill.
- 2) This Facility is secured by a locked gate at the facility entrance.
- 3) Proper signage is posted at the Facility entrance.
- 4) The Facility access road is of all-weather construction and is being well maintained at this time.
- 5) Permanent, highly visible, edge-of-waste markers delineating the waste disposal footprint are being maintained as required.
- 6) High visibility markers are maintained adjacent to the Facility groundwater monitoring wells to prevent damage by maintenance equipment.
- 7) A cover crop of native warm season grasses has been established throughout the landfill.
- 8) The landfill cover crop is mowed annually and is in need of mowing. *Plans need to be underway for the mowing of the Landfill cover crop as soon as possible.

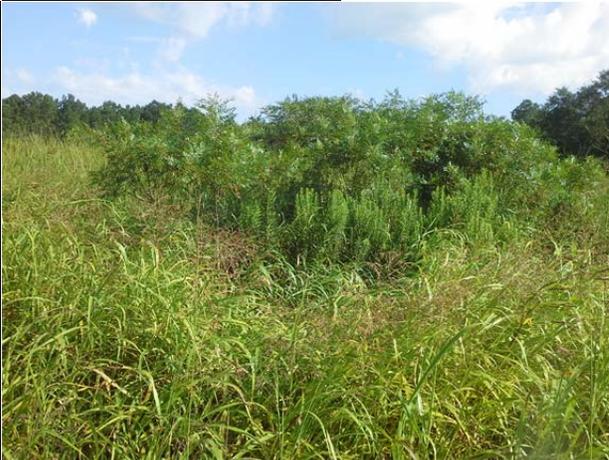
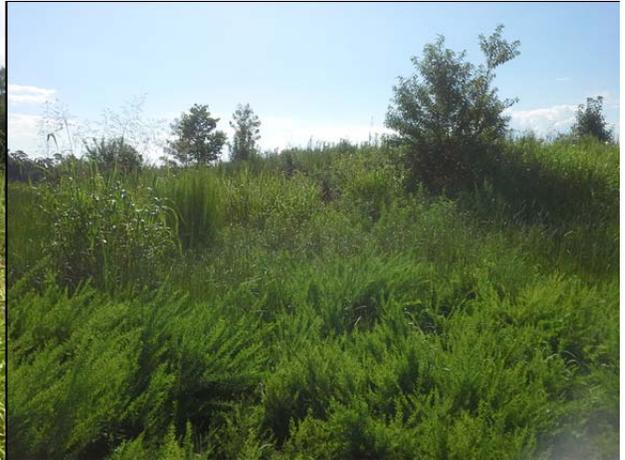
- 9) Small trees and other woody vegetation have been allowed to grow in various areas of the landfill. *Please remove all trees and other woody vegetation from the landfill.

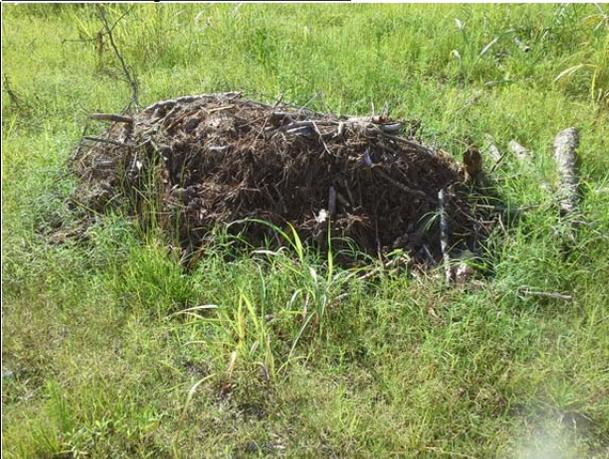
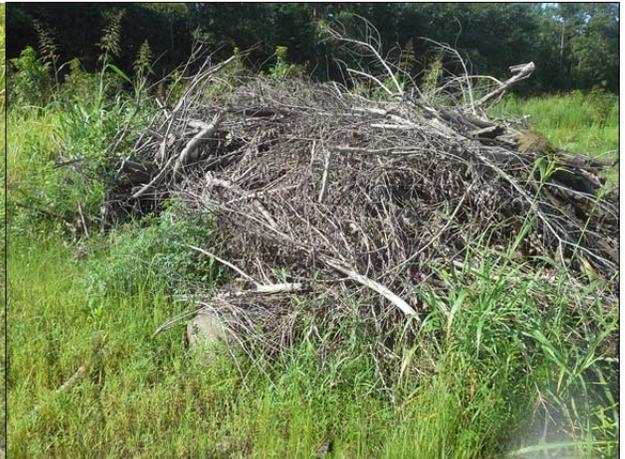
- 10) Several loads of unpermitted waste consisting of yard waste and yard trash has been disposed on site. *Please collect this unpermitted waste and dispose of it at a Facility permitted to receive such wastes. Measures should be taken to ensure that this site is secured from the unlawful disposal of solid waste.

- 11) *Corrective measures are required as a result of this Facility Compliance Inspection.
