FACILITY COMPLIANCE INSPECTION REPORT
Division of Waste Management
Solid Waste Section

Date of Site Inspection: November 21, 2014 **Date of Last Inspection:** December 18, 2013

Waste Management of Raleigh-Durham Transfer Station
 10411 Globe Road
 Morrisville, NC 27560

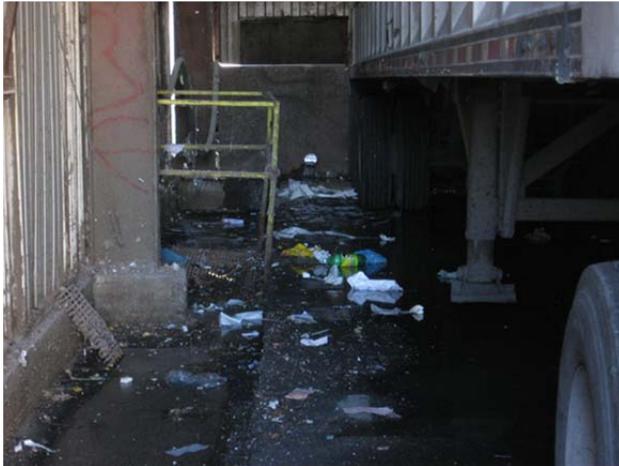
12. The grate covering the leachate collection sump was in place at the time of the inspection.

Loading Bay & Leachate collection trench

13. Excess waste in the loading bay is cleaned up after every load.
14. Ensure that the drain on the outside of the loading bay is cleaned out frequently and well maintained so that waste does not enter into the stormwater basin below the drainage outfall.
15. Continue to watch the area behind the push wall. The area adjacent to the door was being well maintained but the less accessible area behind the wall is in need of routine cleaning as well.
16. The perimeter walls of the transfer station need to be maintained in a clean, sanitary condition. Waste that has perched above the loading bay must be removed at the end of every day.

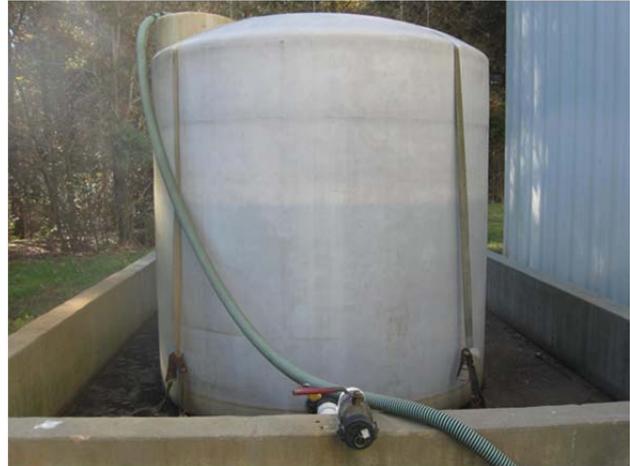
11. Leachate is collected in a 3000-gallon above ground tank. The liquid is hauled as needed by a contractor. The tank had last been emptied on October 29, 2014 by Separator Solutions.

Leachate collection tank

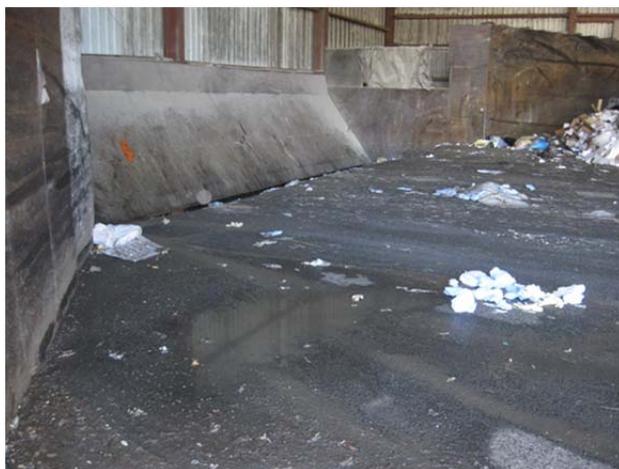
7. Waste trailers are delivered to the disposal facility by CEI, Inc., which handles all trailer movement at that facility.
8. Waste on the tipping floor was being managed in accordance with the facility Permit to Operate and approved Operations Plan. No unacceptable items were observed at the time of the inspection.

Tipping floor/Pit

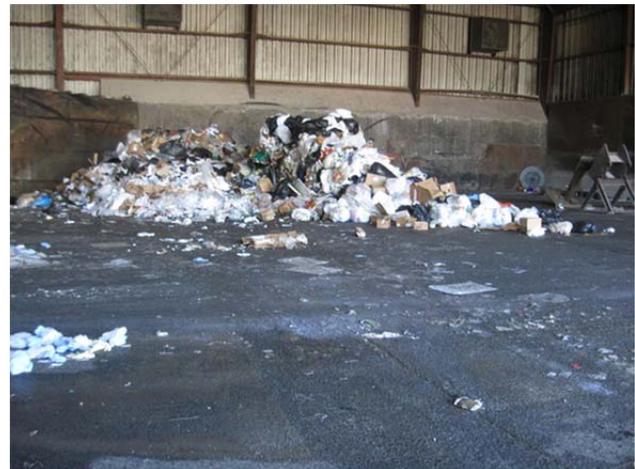
Tipping floor
