FACILITY COMPLIANCE INSPECTION REPORT
Division of Waste Management
Solid Waste Section

Date of Site Inspection: 20 February 2015 **Date of Last Inspection:** 13 August 2014

Garner LCID Site
 Lake Road
 Havelock, NC 28557

Comprehensive Facility Compliance Inspection

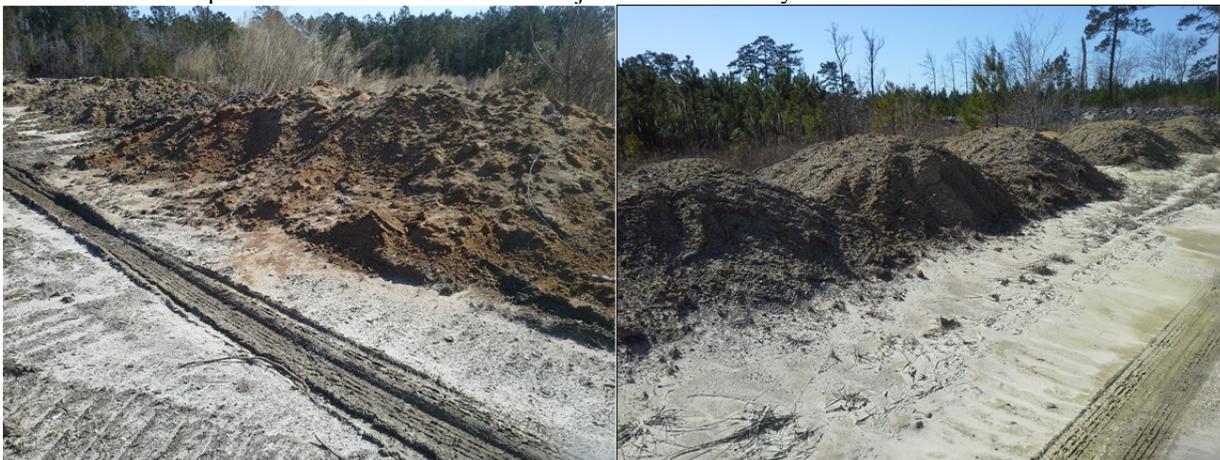
- 9) Soil has been stockpiled for use as cover in an area adjacent to the Facility access road.

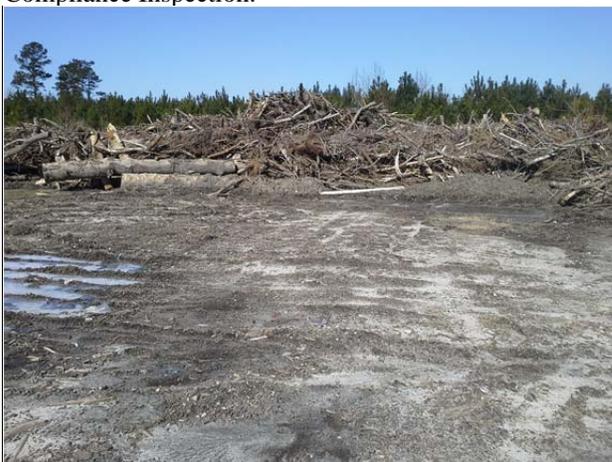
- 10) The waste type being disposed is LCID waste only; no unacceptable waste streams were observed during this Facility Compliance Inspection.

- 11) *Please ensure that all waste is covered monthly, or when the active working area reaches one acre in size, whichever occurs first.
- 12) The landfill footprint boundaries have not been marked. *Please install permanent markers delineating the landfill waste footprint boundaries and all required buffers as listed in 15A NCAC 13B .0564 (9) on your LCID notification form.
- 13) Portions of the outside slopes have been covered and graded. *Please ensure that all outside slopes are covered, compacted, and graded at a slope not greater than 3:1. Please seed and mulch all newly covered and graded areas to establish a groundcover suitable to prevent erosion of your landfill cap system.

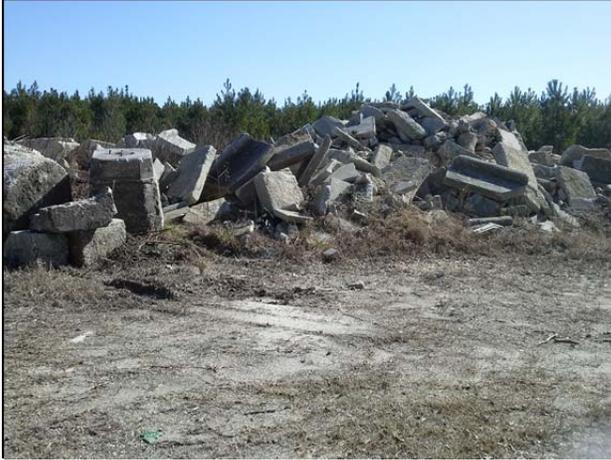
- 15) Inert debris consisting of scrap concrete and asphalt is being stockpiled on the property in an area separate from, but adjacent to, the landfill for later crushing and re-use. *Please note that the State rules regarding recovered materials state that for a material to qualify as a recovered material, the majority of the material (51% or more) must be sold, used, or re-used within twelve months.
