FACILITY COMPLIANCE INSPECTION REPORT
Division of Waste Management
Solid Waste Section

Date of Site Inspection: September 18, 2014

J.L. Morrow, Jr., Construction Company LCID Landfill
 4423 Mebane Oaks Road
 Mebane, NC 27302

Comprehensive Inspection (to ensure that the notified land clearing and inert debris (LCID) landfill is in compliance with 15A North Carolina Administrative Code (NCAC) 13B .0563, .0564, and .0566)

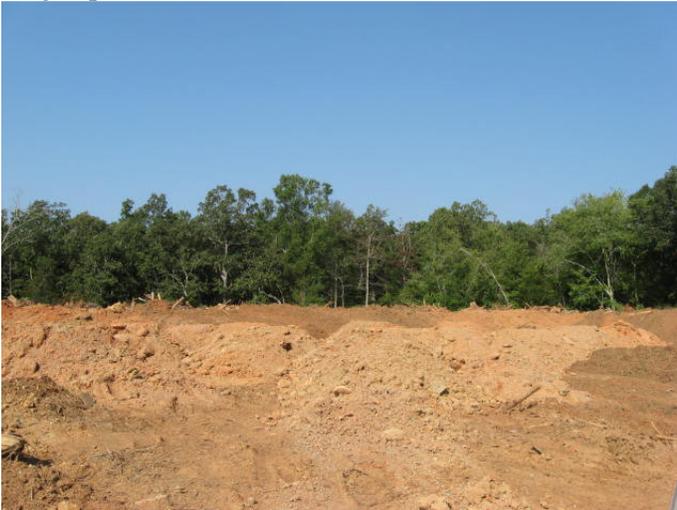
Staged piles of soil to be used as cover material

7. Piles of soil were observed on site, staged to be placed atop material.
8. Side slopes should be graded and covered with soil such that a 3:1 slope ratio is obtained or a ratio of which no indication of erosion or runoff is observed.

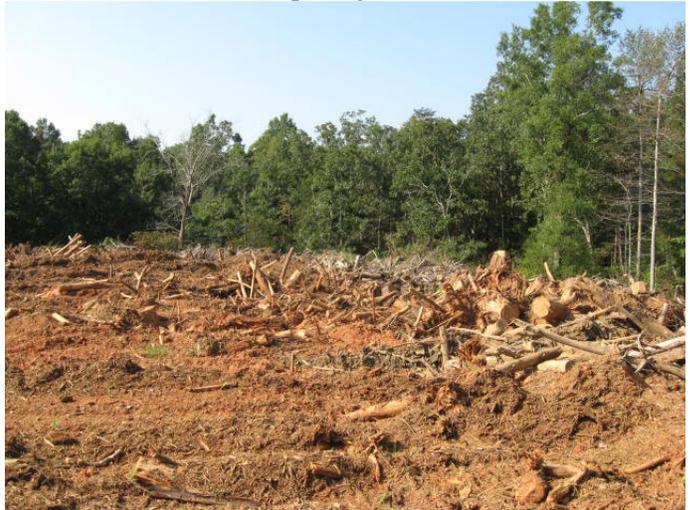
6. Much of the material observed during the previous inspection (07/31/14) has been covered with soil. However, additional material requires soil cover. Mr. Morrow stated (email, 09/09/14) that the bulldozer used on site requires repair. Mr. Morrow stated (email, 09/18/14) that all material will be covered in a few weeks.

Additional material requiring soil cover

5. Per 15A NCAC 13B .0566(4), "Adequate soil cover shall be applied monthly, or when the active area reaches one acre in size, whichever occurs first."

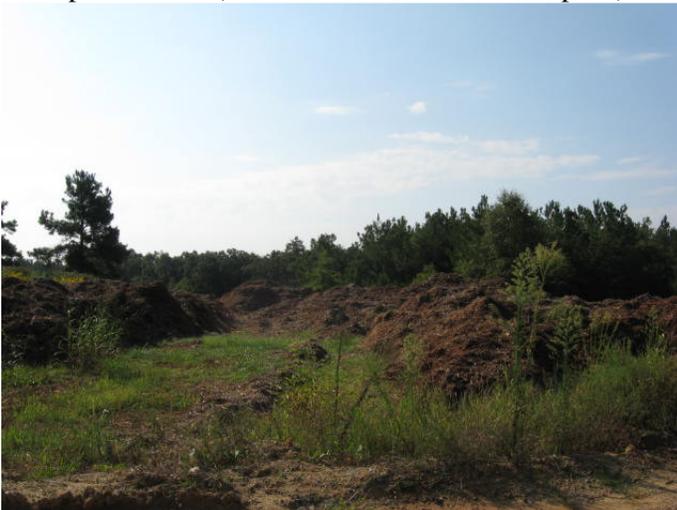
Stockpiled mulch (outside of LCID landfill footprint)

11. Maintain adequate buffer (~ 50' minimum) between the LCID landfill and stored materials for reuse.
12. Stockpiled mulch should be routinely turned.
13. Inert debris shall be reused or covered with soil and graded accordingly. It is suggested that, if inert debris is used as beneficial fill material, the area be designated by permanent markers and appropriate signage.

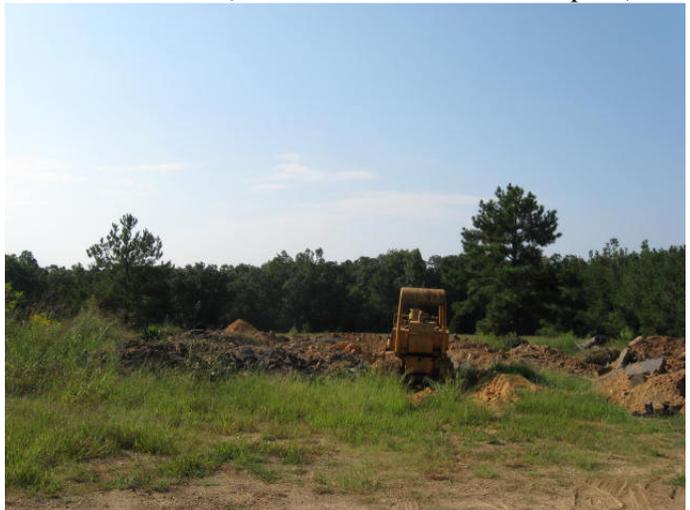
Inert debris area (outside of LCID landfill footprint)
