FACILITY COMPLIANCE INSPECTION REPORT
Division of Waste Management
Solid Waste Section

Date of Site Inspection: February 5, 2015

Inert Disposal - Stump Dump LCID Landfill
 1017 Center Grove Church Road
 Moncure, NC 27559

Comprehensive Inspection (to ensure that the notified land clearing and inert debris (LCID) landfill is in compliance with 15A North Carolina Administrative Code (NCAC) 13B .0563, .0564, and .0566)

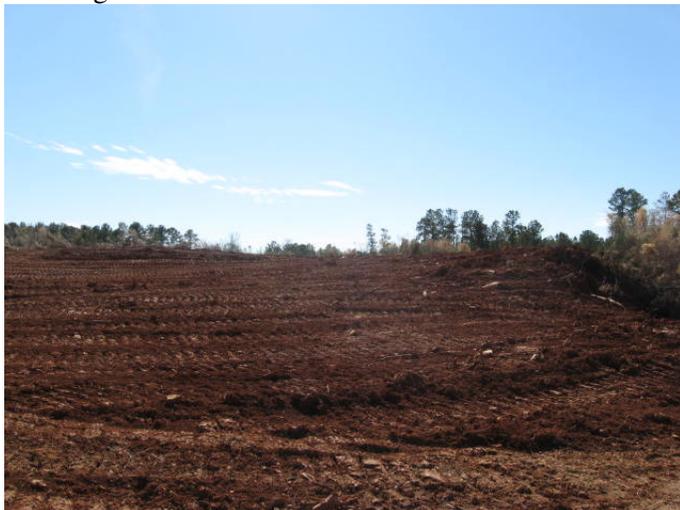
6. The working face was adequately covered with soil.
7. Side slope repairs appeared complete. The repaired areas were adequately covered with soil.
8. The facility is responsible for ensuring that the LCID landfill is/remains < 2 acres in size.

Working face area covered with soil

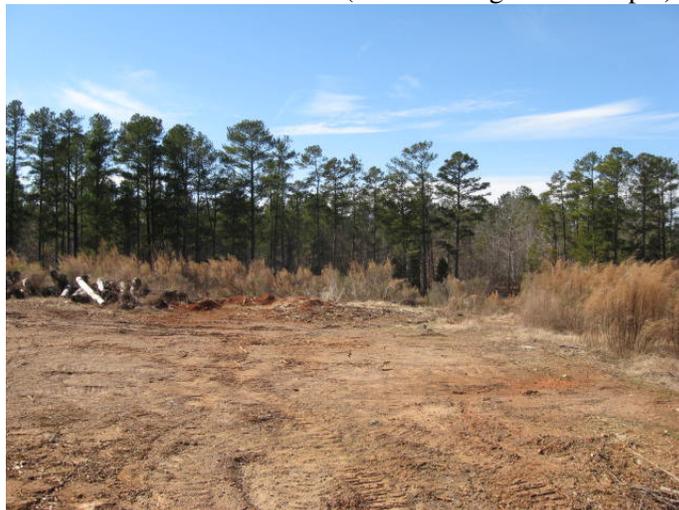
Per 15A NCAC 13B .0563(1)(a), "The facility is to be operated for the disposal of land clearing waste, inert debris, untreated wood, and yard trash." Per 15A NCAC 13B .0566(2), "The facility shall only accept those solid wastes which it is permitted to receive." On December 12, 2014, SWS conducted an inspection of the Inert Disposal - Stump Dump LCID Landfill. A load of demolition debris was off-loaded at the LCID landfill adjacent to the working face. Mr. Candelori stated that the demolition debris is from a tobacco barn. On January 2, 2015, Mr. Patrone received an email from Steve Candelori stating that the demolition debris was hauled to a facility permitted to receive the waste material and that reusable [wood] material was given to a local building manufacturer for reuse. On February 5, 2015, Mr. Patrone conducted an inspection of the Inert Disposal - Stump Dump LCID Landfill. The demolition debris has been removed. On February 16, 2014, Mr. Patrone received an email from Gina Candelori containing two disposal receipts, totaling 5.48 tons, for material brought to Shotwell Transfer Station II, Inc./APEX C&D Transfer Facility (ID# 92-29) and a written statement from Jeff Gannon, Green Door Design/Build, that a load of material (tobacco barn) was brought to his business for reuse [company builds small buildings/spaces]. The violation is resolved.

Demolition debris removed (firewood logs at left of pic)

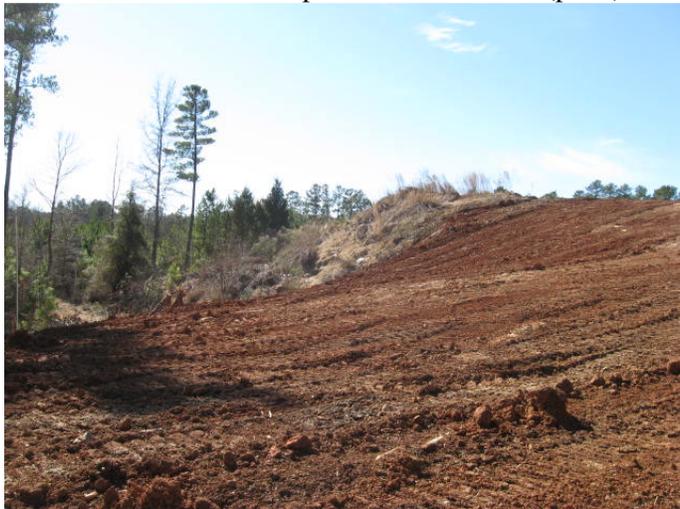
Per 15A NCAC 13B .0566(4), "Adequate soil cover shall be applied monthly, or when the active area reaches one acre in size, whichever occurs first." On December 12, 2014, SWS conducted an inspection of the Inert Disposal - Stump Dump LCID Landfill. Solid waste along a portion of the left side and left rear external side slopes was not adequately covered with soil. Solid waste at the working face was not covered with soil. Mr. Candelori acknowledged that most of the solid waste in question has not been adequately covered with soil monthly. On February 5, 2015, Mr. Patrone conducted an inspection of the Inert Disposal - Stump Dump LCID Landfill. The left side and left rear external side slopes and working face/area were adequately covered with soil. The violation is resolved.

Left rear external side slope covered with soil (pic 1)

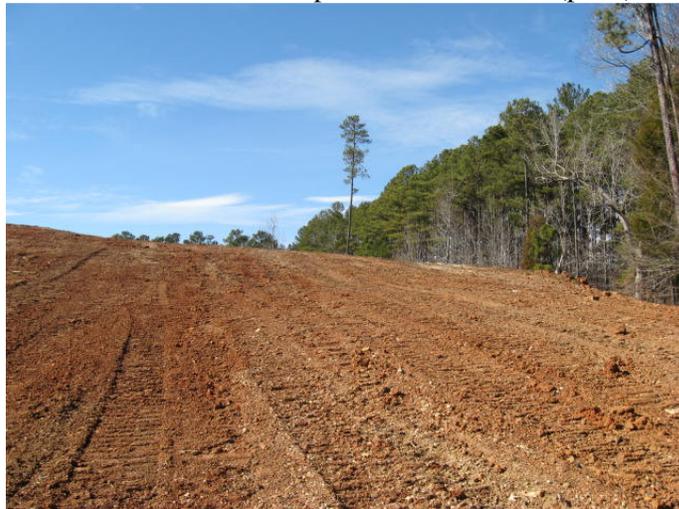
Left rear external side slope covered with soil (pic 2)

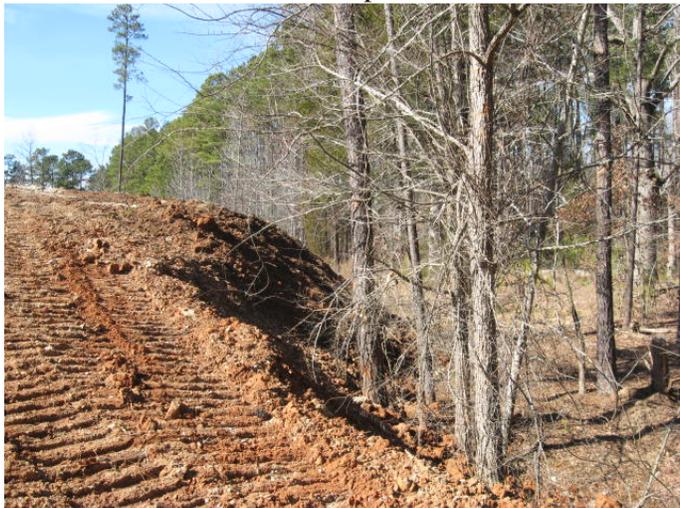
Left rear side, external side slope covered with soil

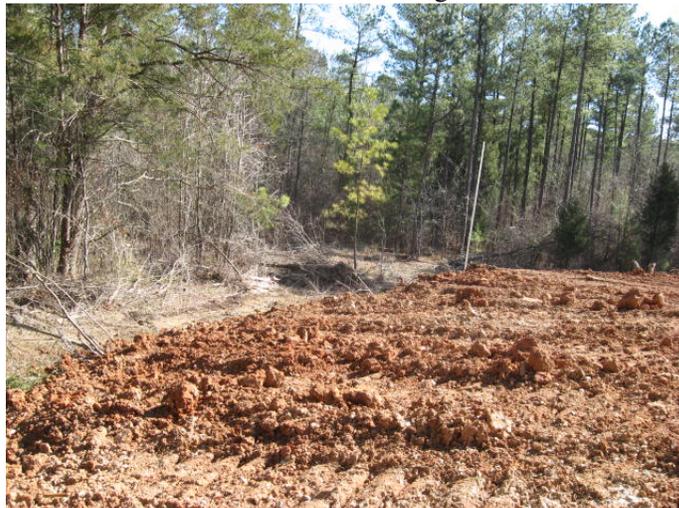
Left rear of landfill, soil cover to edge of waste marker
