**FACILITY COMPLIANCE INSPECTION REPORT**  
**Division of Waste Management**  
**Solid Waste Section**

**ADDITIONAL COMMENTS**

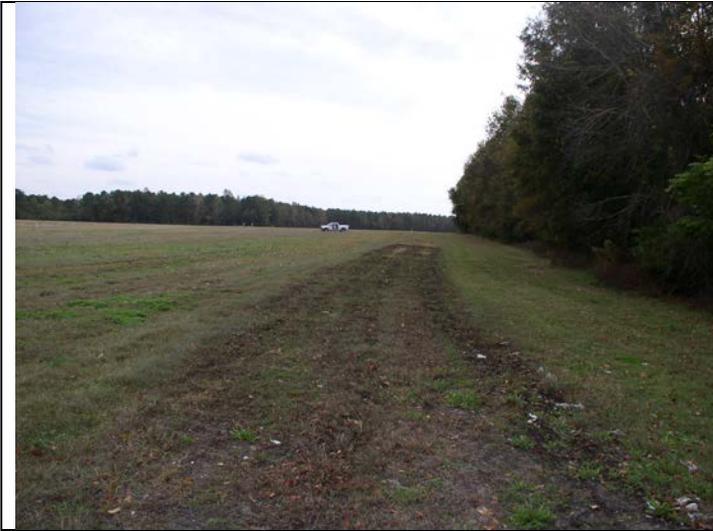
4. All septage discharges appeared to be withi the permitted boundaries of the site.
5. An old grease burn still present along the western edge (bordered by trees) of the field. You need to increase the dilution of domestic septage / water to grease septage such that there is no crop damage after the application.

Old grease burn along the western edge of the field.

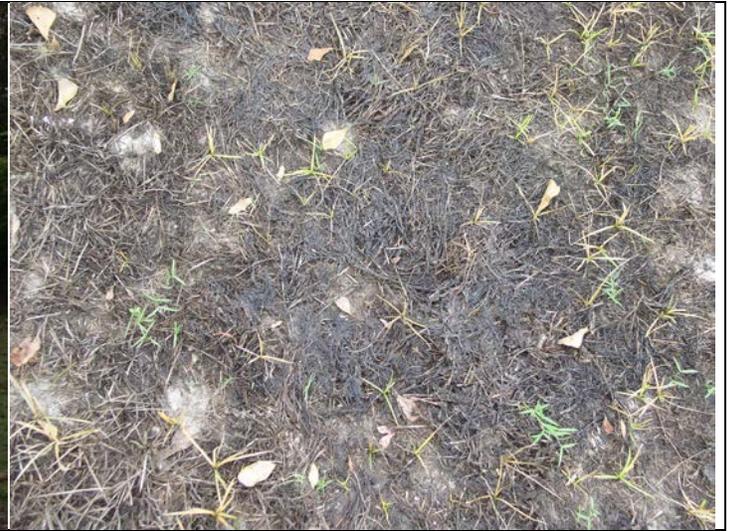
Close-up of the old grease burn.
