**FACILITY COMPLIANCE INSPECTION REPORT**  
**Division of Waste Management**  
**Solid Waste Section**

<b>UNIT TYPE:</b>												
Lined MSWLF		LCID		YW		Transfer		Compost		SLAS	<b>X</b>	<b>COUNTY: Edgembe</b> <b>PERMIT NO.: SLAS-33-05</b> <b>FILE TYPE: COMPLIANCE</b>
Closed MSWLF		HHW		White goods		Incin		T&P		FIRM		
CDLF		Tire T&P / Collection		Tire Monofill		Industrial Landfill		DEMO		SDTF

**Date of Site Inspection:** 11/7/2013    **Date of Last Inspection:** 4/10/2013

*Curtis L. Matthews*  
*Matthews Septic Tank Service*  
*PO Box 85*  
*Farmville, NC 27828*

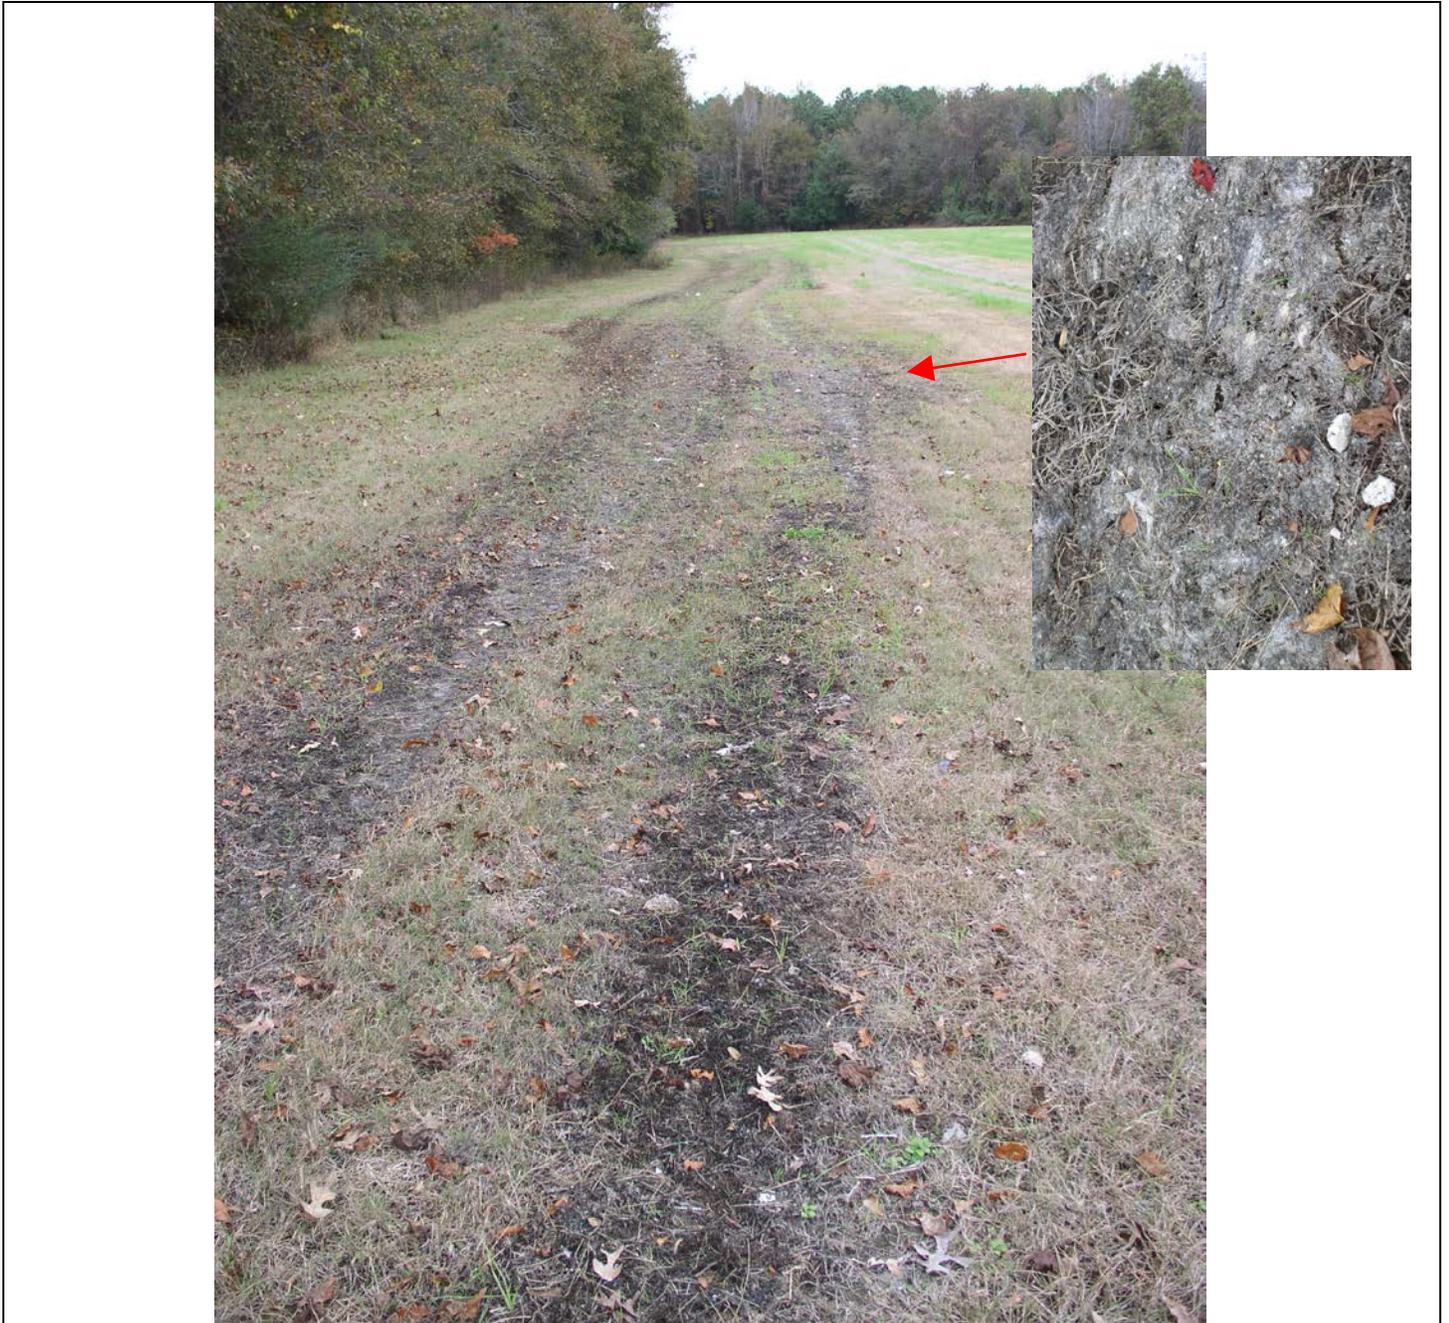
- 1) An old grease burn was noticed along the western edge (bordered by trees) of the field. The grease burn is in violation of NC Septage Management Rule .0838 (a) (15) which states in part that "Grease septage shall be diluted at least 1:1 from its concentration when pumped with domestic septage or water if land applied over perennial vegetation. This dilution shall be increased if crop damage occurs." You need to increase the dilution of domestic septage / water to grease septage such that there is no crop damage after the application.

1. Signage present.
2. Access path to site was in good shape.
3. All boundary markers were up.
4. No discharges noticed outside of the permitted boundaries.
5. An old grease burn was noticed along the western edge (bordered by trees) of the field. You need to increase the dilution of domestic septage / water to grease septage such that there is no crop damage after the application.

6. Small grain present on the field.
7. pH not checked. No application at time of inspection.
8. No objectionable odors noticed today.
9. No change noticed with any of the setbacks.
10. Records not checked.
11. As noted above, you need to increase the dilution of domestic septage / water to grease septage such that there is no grease burn. I collected a soil sample from the field.
