**FACILITY COMPLIANCE INSPECTION REPORT**  
**Division of Waste Management**  
**Solid Waste Section**

<b>UNIT TYPE:</b>												
Lined MSWLF		LCID		YW		Transfer		Compost		SLAS	<b>X</b>	<b>COUNTY: Martin</b> <b>PERMIT NO.: SLAS-59-06</b> <b>FILE TYPE: COMPLIANCE</b>
Closed MSWLF		HHW		White goods		Incin		T&P		FIRM		
CDLF		Tire T&P / Collection		Tire Monofill		Industrial Landfill		DEMO		SDTF

**Date of Site Inspection:** 11/6/2013    **Date of Last Inspection:** 5/31/2013

*Brent Roberson  
 Roberson Septic, LLC  
 PO Box 1596  
 Williamston, NC 27892*

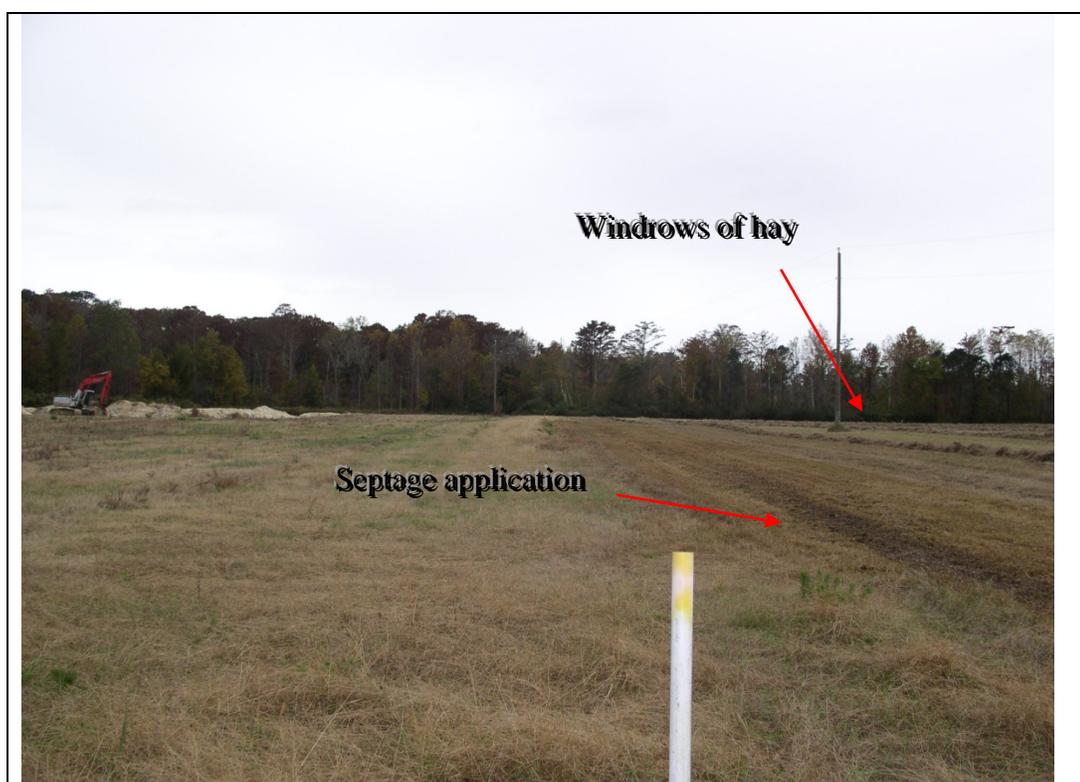
1. Proper signage present at the pond before you get to the site.
2. The path to the site was in good shape.
3. Field markers present and up.
4. Some septage was noticed outside of the eastern side (side closest to the sand pit) of the field. Be sure to pay attention to your field markers so as to not go outside of the permitted boundary.
5. Any cut vegetation needs to be removed before applying septage to that area. The cut vegetation (hay) becomes matted down from the septage applications and truck traffic. The matted material then stresses or kills the bermudagrass. At time of inspection, an application of septage was about to be applied on top of the hay that was been cut. \* Need to speed up when applying septage. There was still some ponding of the septage after the application had been completed.
