**FACILITY COMPLIANCE INSPECTION REPORT**  
**Division of Waste Management**  
**Solid Waste Section**

<b>UNIT TYPE:</b>												
Lined MSWLF		LCID		YW		Transfer		Compost		SLAS	<b>X</b>	<b>COUNTY: Pitt</b> <b>PERMIT NO.: SLAS-74-18</b> <b>FILE TYPE: COMPLIANCE</b>
Closed MSWLF		HHW		White goods		Incineration		T&P		FIRM		
CDLF		Tire T&P / Collection		Tire Monofill		Industrial Landfill		DEMO		SDTF

*Jamey Way  
 Tarboro Septic Tank NC LLC  
 211 Barrington Dr.  
 Tarboro, NC 27886*

**PURPOSE OF SITE VISIT:** *Routine*

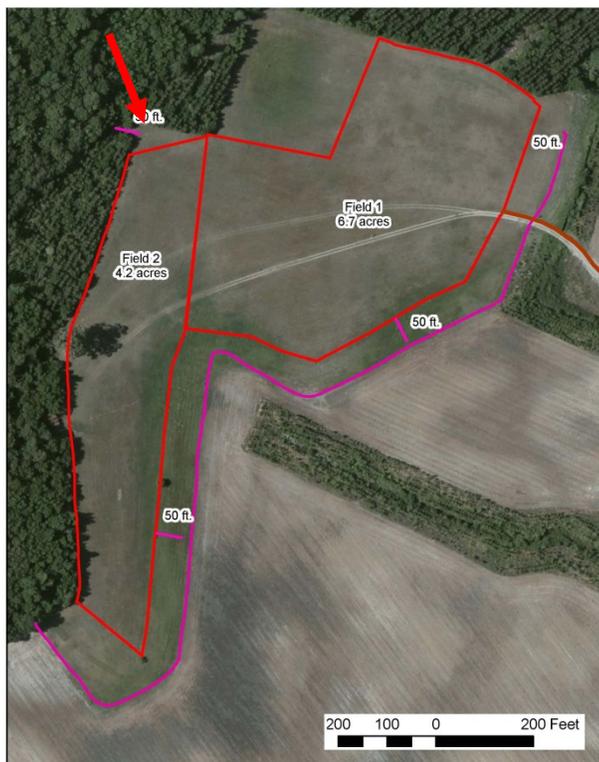
1. Sign for the septage land application site had been knocked down. Need to place sign back up.
2. Access road in good shape.
3. Markers present.
4. Septage outside of the border along the northwest corner of Field 2. See pictures below.

Septage applied outside of the permitted boundary.

- 1) There is no evidence that the small grain has been planted. This is a violation of Rule .0838(a)(18) that states "Approved nutrient management plans shall be followed." Your nutrient management plan has that the fields will be overseeded with rye (small grain) between September and early November of each year.
- 2) Septage had been applied outside of the northwest corner of Field 2. This is a violation of Rule .0838(a) that states "All septage discharges, including aerial drift from discharges, shall be made within the permitted boundaries of the land application site." Need to insure that all septage discharges are within the permitted boundaries of the two fields.
