**FACILITY COMPLIANCE INSPECTION REPORT**  
**Department of Environmental Quality**  
**Division of Waste Management - Solid Waste Section**

**Date of Site Inspection:** January 15, 2016    **Date of Last Inspection:** August 10, 2015

Halifax Coal Ash Landfill  
 921 Liles Road  
 Halifax, NC 27839

Partial Inspection – Follow-up

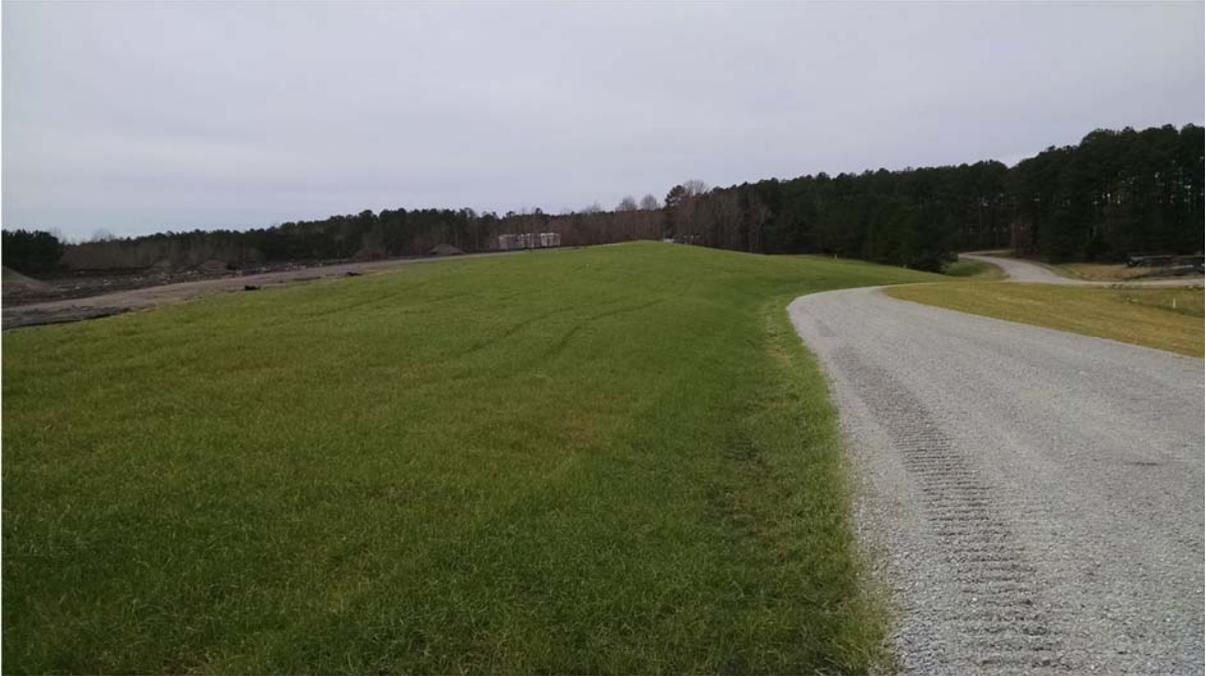
Northern slope of landfill has been covered and seeded per the Intermediate Cover Plan.

The northern slope of the landfill has had soil cover placed, and been graded and seeded per the Cover Plan. Other slopes have been regraded to reduce erosion. **Continue to place intermediate cover on all slopes in accordance with the Cover Plan. Unresolved.**

11. During the August 10, 2015 inspection, significant erosion was observed on side slopes such that coal ash had washed into perimeter ditches and had washed into the sediment basin. On October 20, 2015 the Division of Waste Management, Solid Waste Section (Section) received *Halifax County Ash Monofill (NC Permit 42-04-INDUS-1994), Conceptual Filling and Intermediate Cover Plan*, prepared for Halifax County, prepared by Smith-Gardner. On October 22, 2015, the Solid Waste Section concurred with the plan. The northern slope of the landfill has had soil cover placed, and been graded and seeded per the plan. Other slopes have been regraded to reduce erosion. **Continue to place intermediate cover on all slopes in accordance with the Cover Plan.**
