Date of Site Inspection: 02/04/16

McDowell County Transfer Station
3809 NC Hwy 226 South
Marion, NC 28752

Comprehensive Compliance Inspection

FACILITY COMPLIANCE INSPECTION REPORT
Division of Waste Management
Solid Waste Section

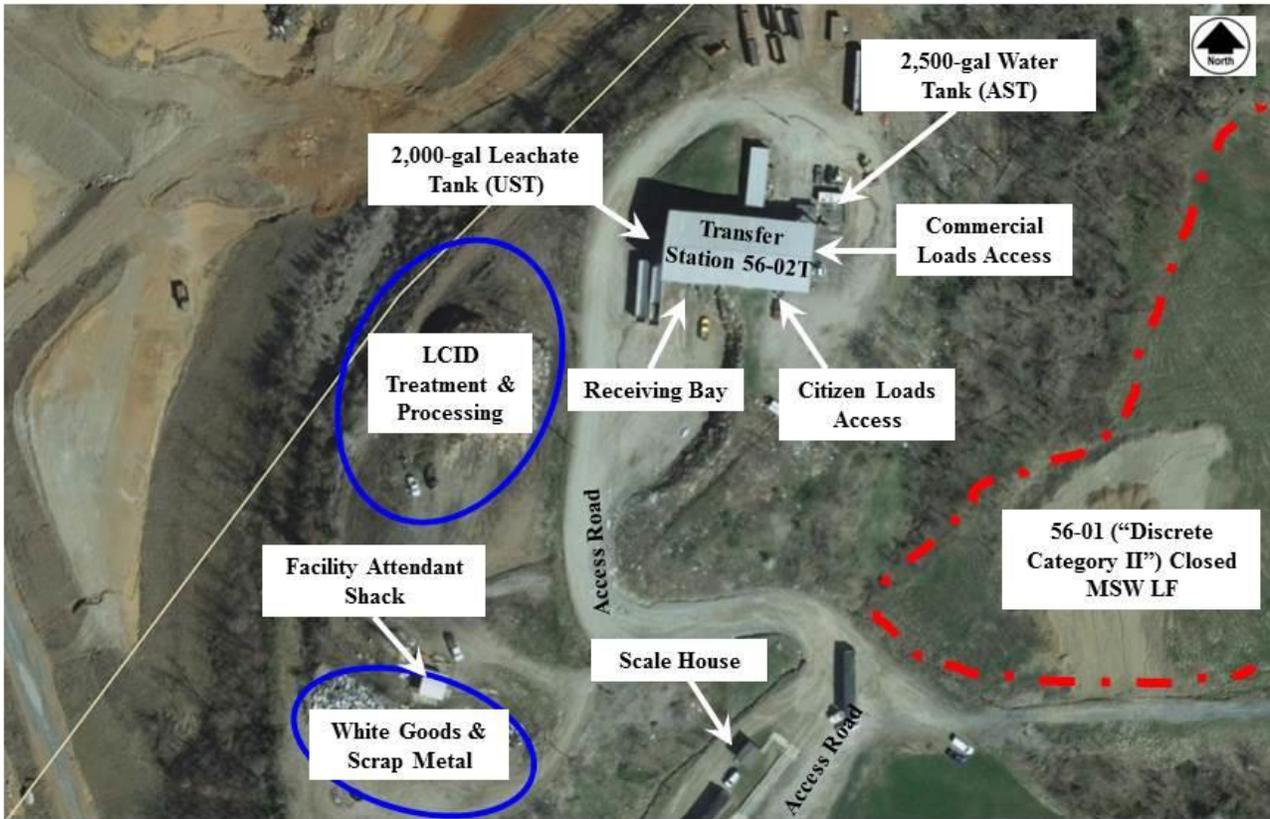
9. **The tipping floor is developing cracks that are in need of repair.**
10. The service area for the transfer station is limited to McDowell County.
11. **The interior walls of the receiving bay of the transfer facility have some debris buildup and will need to be cleaned. (Photo #1)**

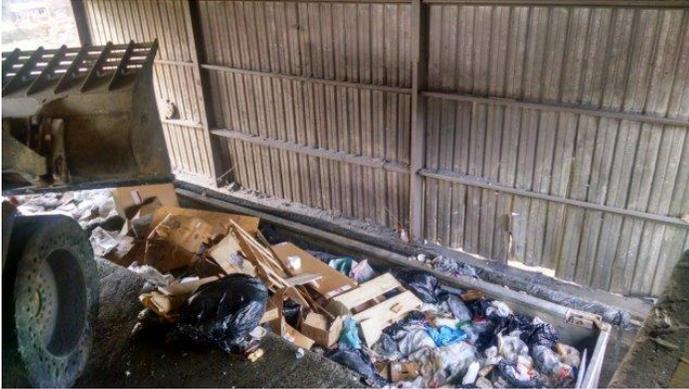
1. Looking down the west interior wall of the receiving bay of the transfer station which is coated in grime that is in need of cleaning.

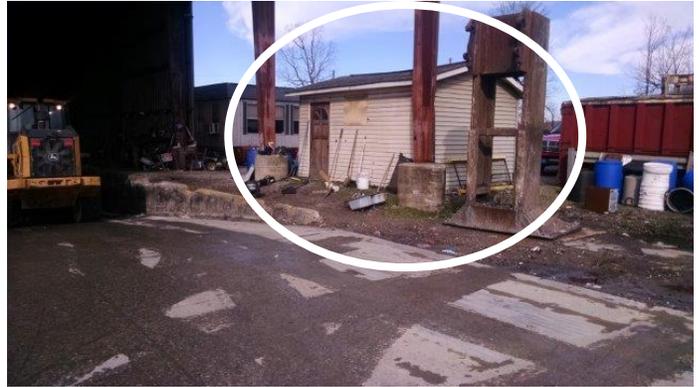
2. Building that houses a 2,500-gallon water supply tank is used to supply wash-down waster for the transfer station. (Tipping floor of the transfer station it to the (L).

12. A 2,500-gallon water supply tank on site is used to supply wash-down waster for the transfer station. (Photo #2) Municipal water is not available. The water pressure from this tank is not sufficient to properly clean the facility. The facility relies on the Marion Fire Department to supply water and equipment to clean the transfer station.

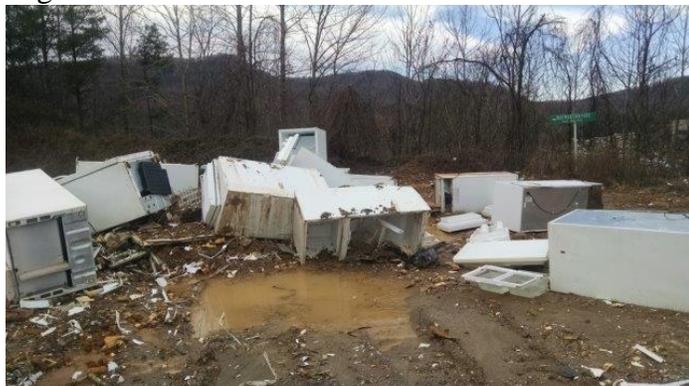
23. White goods are staged west of the scale house. (Photo #3) This operation is overseen by an attendant who also oversees the white goods and treatment and processing operations.
24. *Tri Sate Scrap Metal, Inc.* out of Asheville, NC collects all white goods and transports them to their Asheville facility for final processing.
25. *Tri Sate Scrap Metal, Inc.* out of Asheville, NC collects all of the CFCs (refrigerant gases) from the relevant white goods and transports them to their Asheville facility for final processing.

3. White goods staging area.

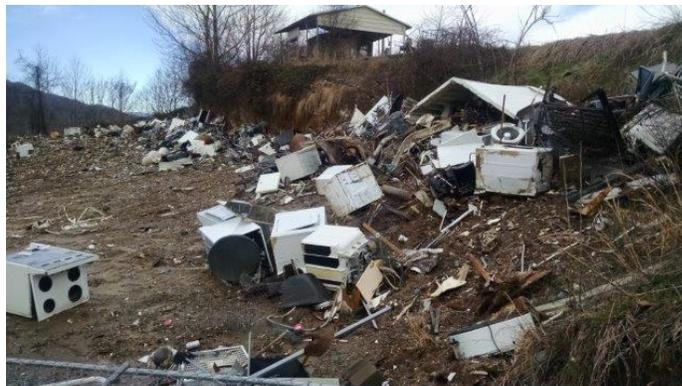
21. Scrap metal is staged west of the scale house. This operation is overseen by an attendant who also oversees the white goods and treatment and processing operations. (Photo # 4)
22. *Tri Sate Scrap Metal, Inc.* (a.k.a. *Mountain Metals Recycling*) out of Asheville, NC collects all scrap metal and transports it to their Asheville facility for final processing.

4. Scrap metal staging area. (Note the attendant's shack on the hill overlooking the scrap metal area.)

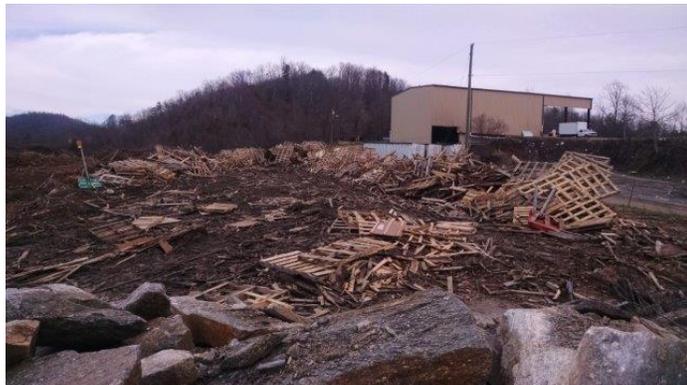
26. Wood wastes (land clearing debris, yard and garden wastes, and clean unpainted wood wastes) are ground by outside contractors with the lowest bid. This is done on an "as needed" basis which is happening about once a year. *Cason Company* of Marion completed the most recent grinding event. (Photo #5) In accordance with their contract, *Cason Company* is responsible for final disposition of the ground wastes. The cost of this grinding event for McDowell County was \$16.25 / ton.

5. Wood grinding operations. (Note the transfer station in the background.)

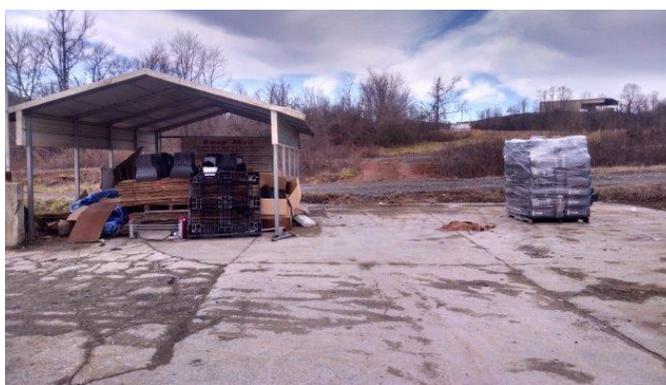
6. Staging area for electronics.

27. Electronic wastes are east of the landfill offices for segregation, palletizing and loading onto semi-trailers in preparation for shipment to *Global Electric Electronic Processing (GEEP) of North Carolina* out of Durham, NC 919-544-1443. (Photo #6)
