**FACILITY COMPLIANCE INSPECTION REPORT**  
**Division of Waste Management**  
**Solid Waste Section**

<b>UNIT TYPE:</b>											
Lined MSWLF		LCID		YW		Transfer	<b>X</b>	Compost		SLAS	<b>COUNTY: Wilson</b>  <b>PERMIT NO.: 9808T- TRANSFER-2000</b>  <b>FILE TYPE: COMPLIANCE</b>
Closed MSWLF		HHW		White goods		Incin		T&P		FIRM	
CDLF		Tire T&P / Collection		Tire Monofill		Industrial Landfill		DEMO		SDTF

**Date of Site Inspection: February 26, 2016**

Waste Industries Black Creek Road Transfer Facility  
3031 Black Creek Road  
Wilson, NC 27893

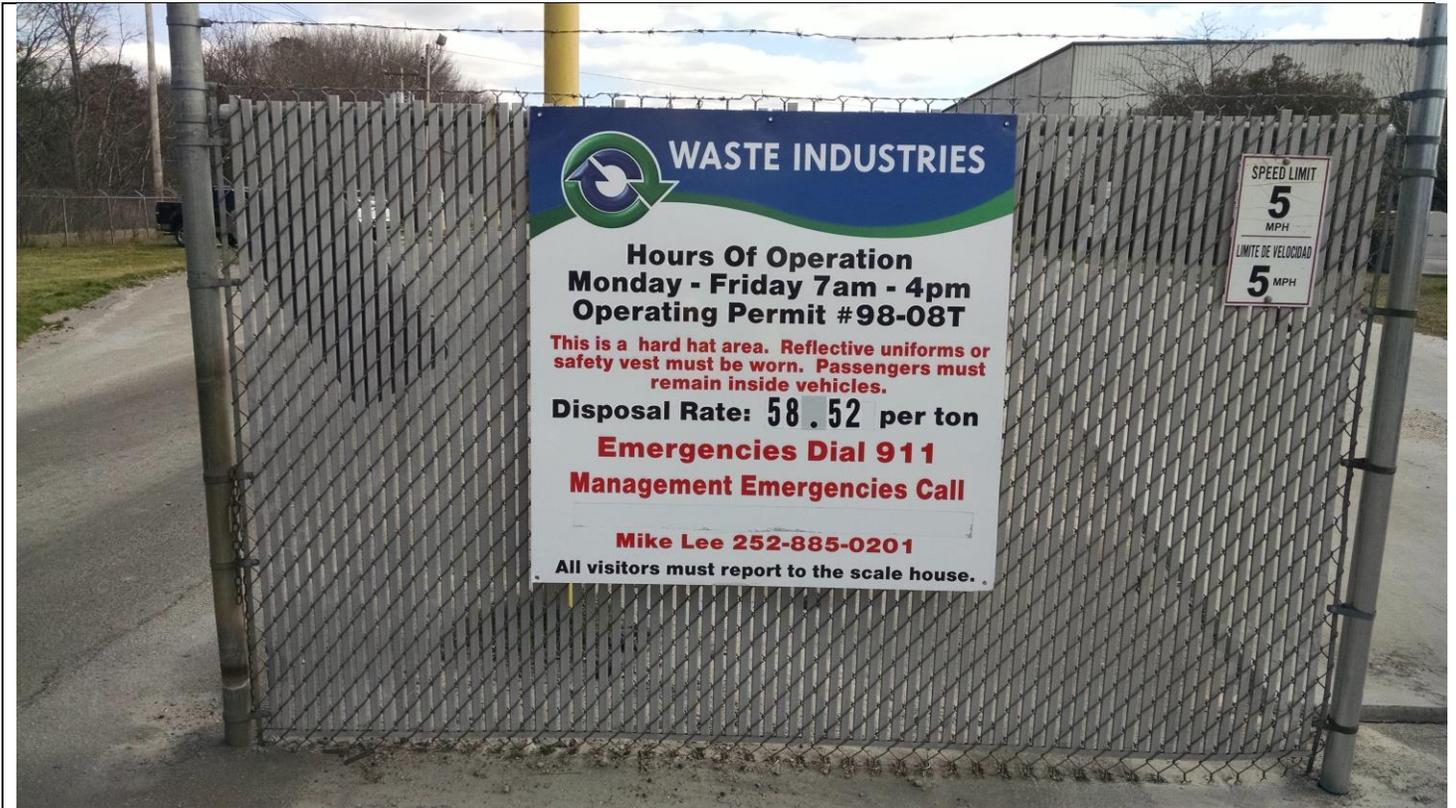
Signage:

- 4 - The operating hours are Monday thru Friday 7:00 AM to 4:00 PM.
- 5 - Facility has proper signage with required information per permit conditions.
- 6 - Waste screening is being conducted periodically and records kept, screening records were good. The Ops Plan specifies that each load be inspected by a spotter.

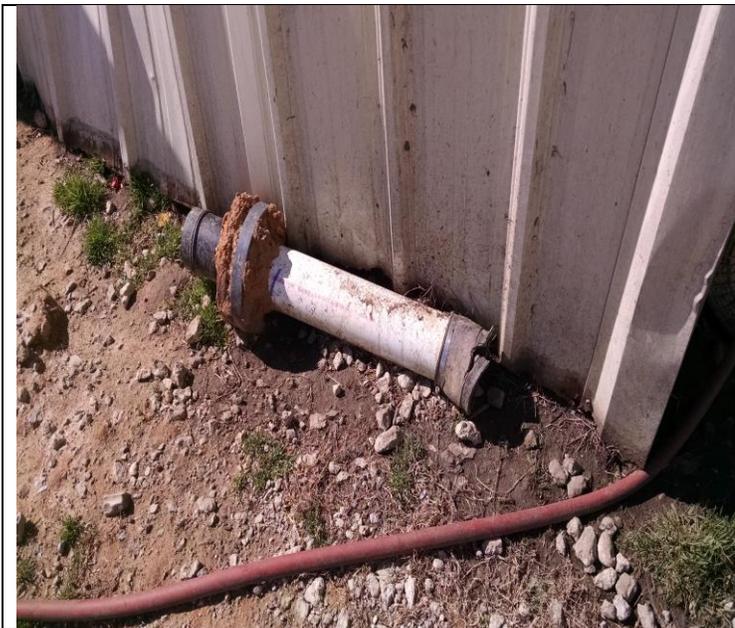
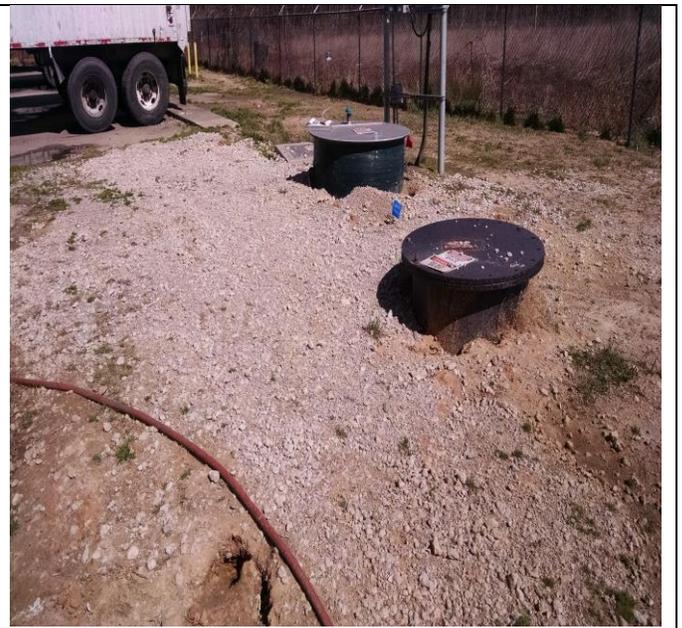
Drainage Repairs:

- 9 - The tipping floor was clean and drainage was working like it should. New pipe work has been done to prevent the prior clogging issues.as mentioned in prior inspection reports.

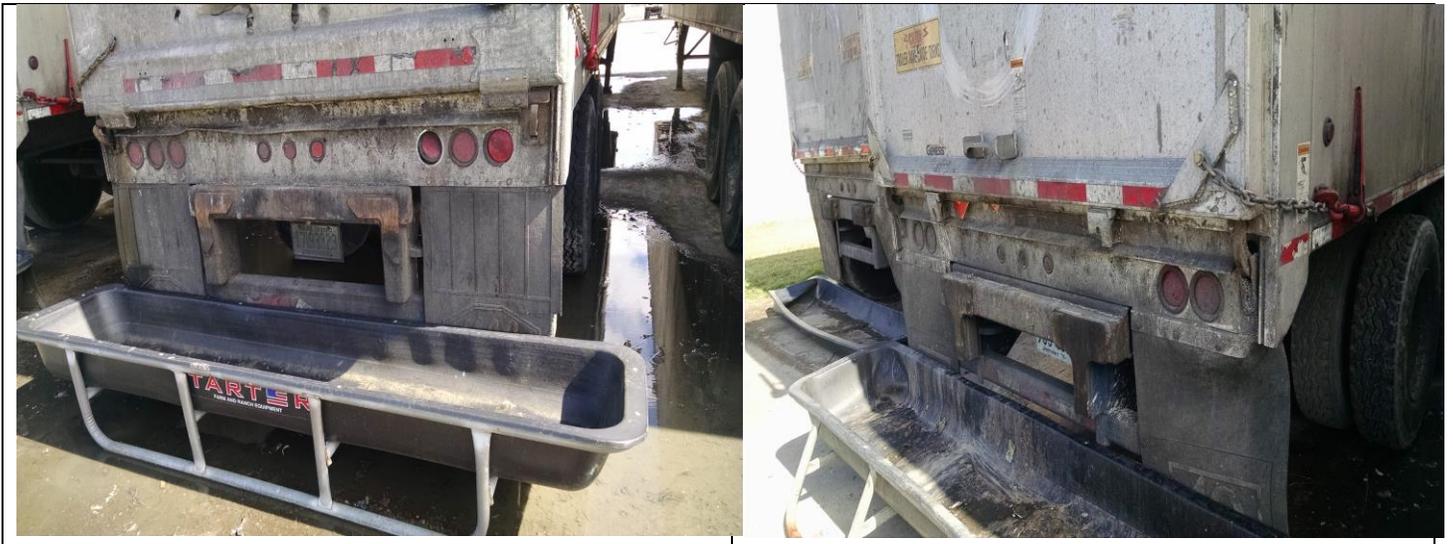
Trailer leak protection:

- 10- Facility has purchased cow waterers to place behind trailers to catch any potential leaks from trailers. Trailer with holes on sides have been taken out of service to this facility.

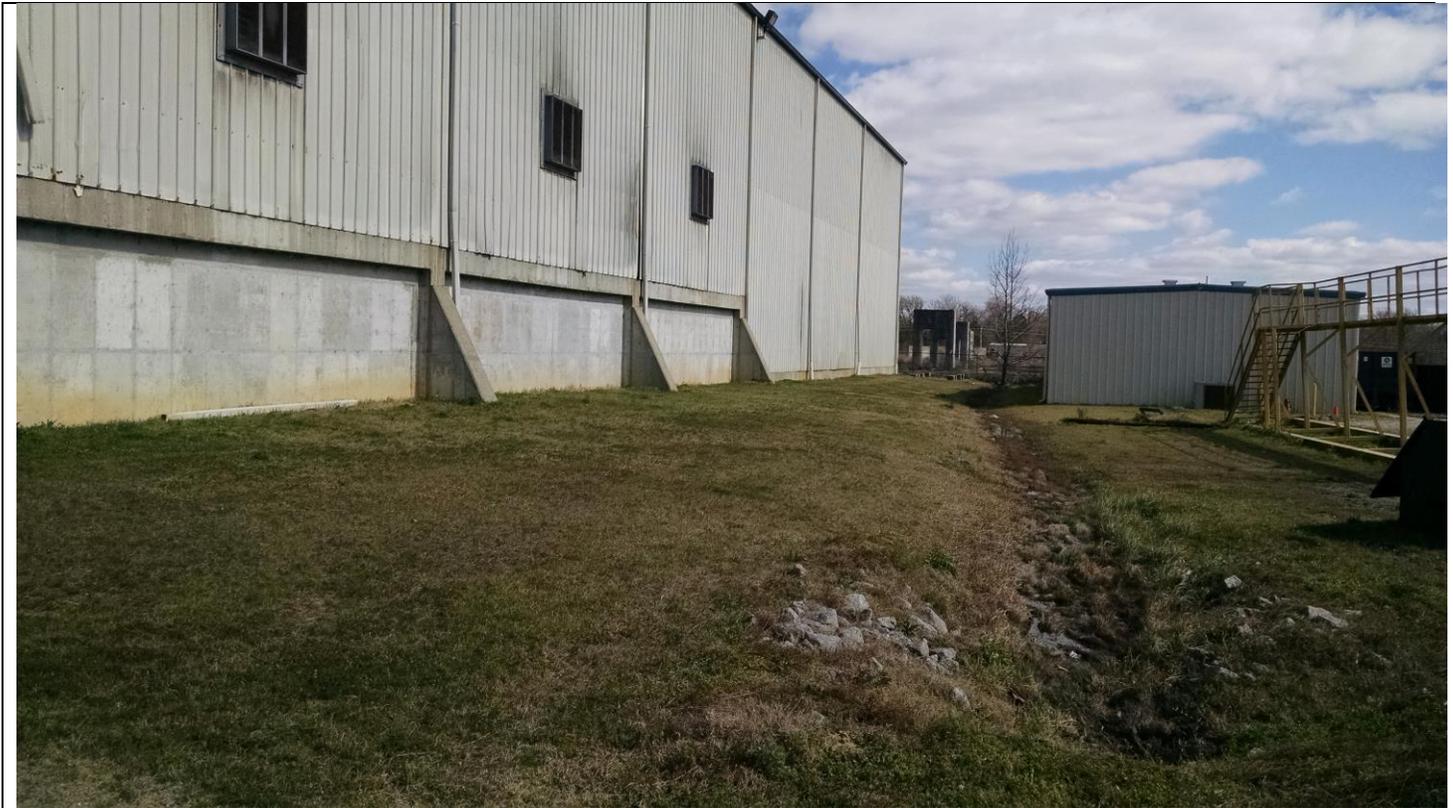
Outside and Surface water swell:

- 11 - Wind blown trash has been addressed.
- 12 - Surface water swell area has been corrected with rip rap to prevent erosion.
- 13 - Digital pictures taken during this inspection.
