**UST CLOSURE
INSPECTION CHECKLIST**

Facility/Site Name: OVERMAN PAINT Co.
 City/Town: 5018 HOOPER ROAD County: GUILFORD
 Owner: RANDY OVERMAN Phone: (910) 697-9203
 Operator: _____ Phone: _____
 Contractor: PETROLEUM EQUIPMENT + SERVICE INC. Phone: (910) 294-3199
 Laboratory: _____ Phone: _____
 Directions: _____

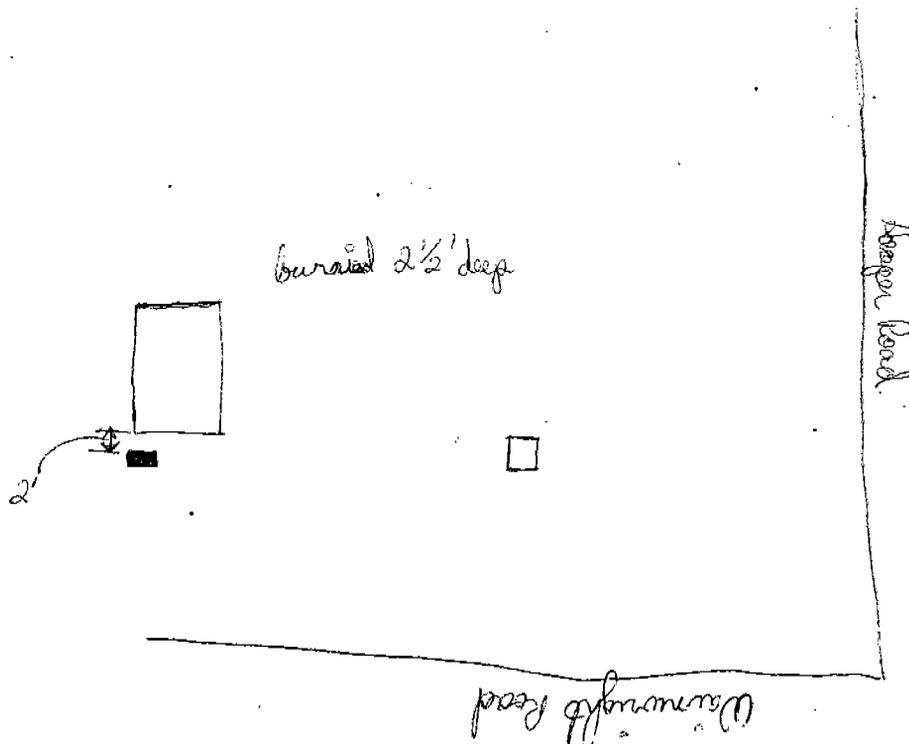
DIAGRAM OF SITE INVESTIGATION AT UST CLOSURE

O₂ < 8% before pulling
tank was corroded and has numerous 1/8" holes in it.
Samples smelled very faintly of gas.

Diagram should include physical structures such as roads, buildings, etc.; former location of USTs, pumps, product lines; soil sampling locations; and location of excavated soil.
