# CORRECTIVE ACTION PLAN MODIFICATION FORMER DUPONT KENTEC FACILITY

Date: October 2005

Project No.: 18984398.00050

RE: Corrective Action Plan Modification, Response to Comments  
Former DuPont Kentec Facility  
Kinston, Lenoir County, NC  
APS Incident 6334

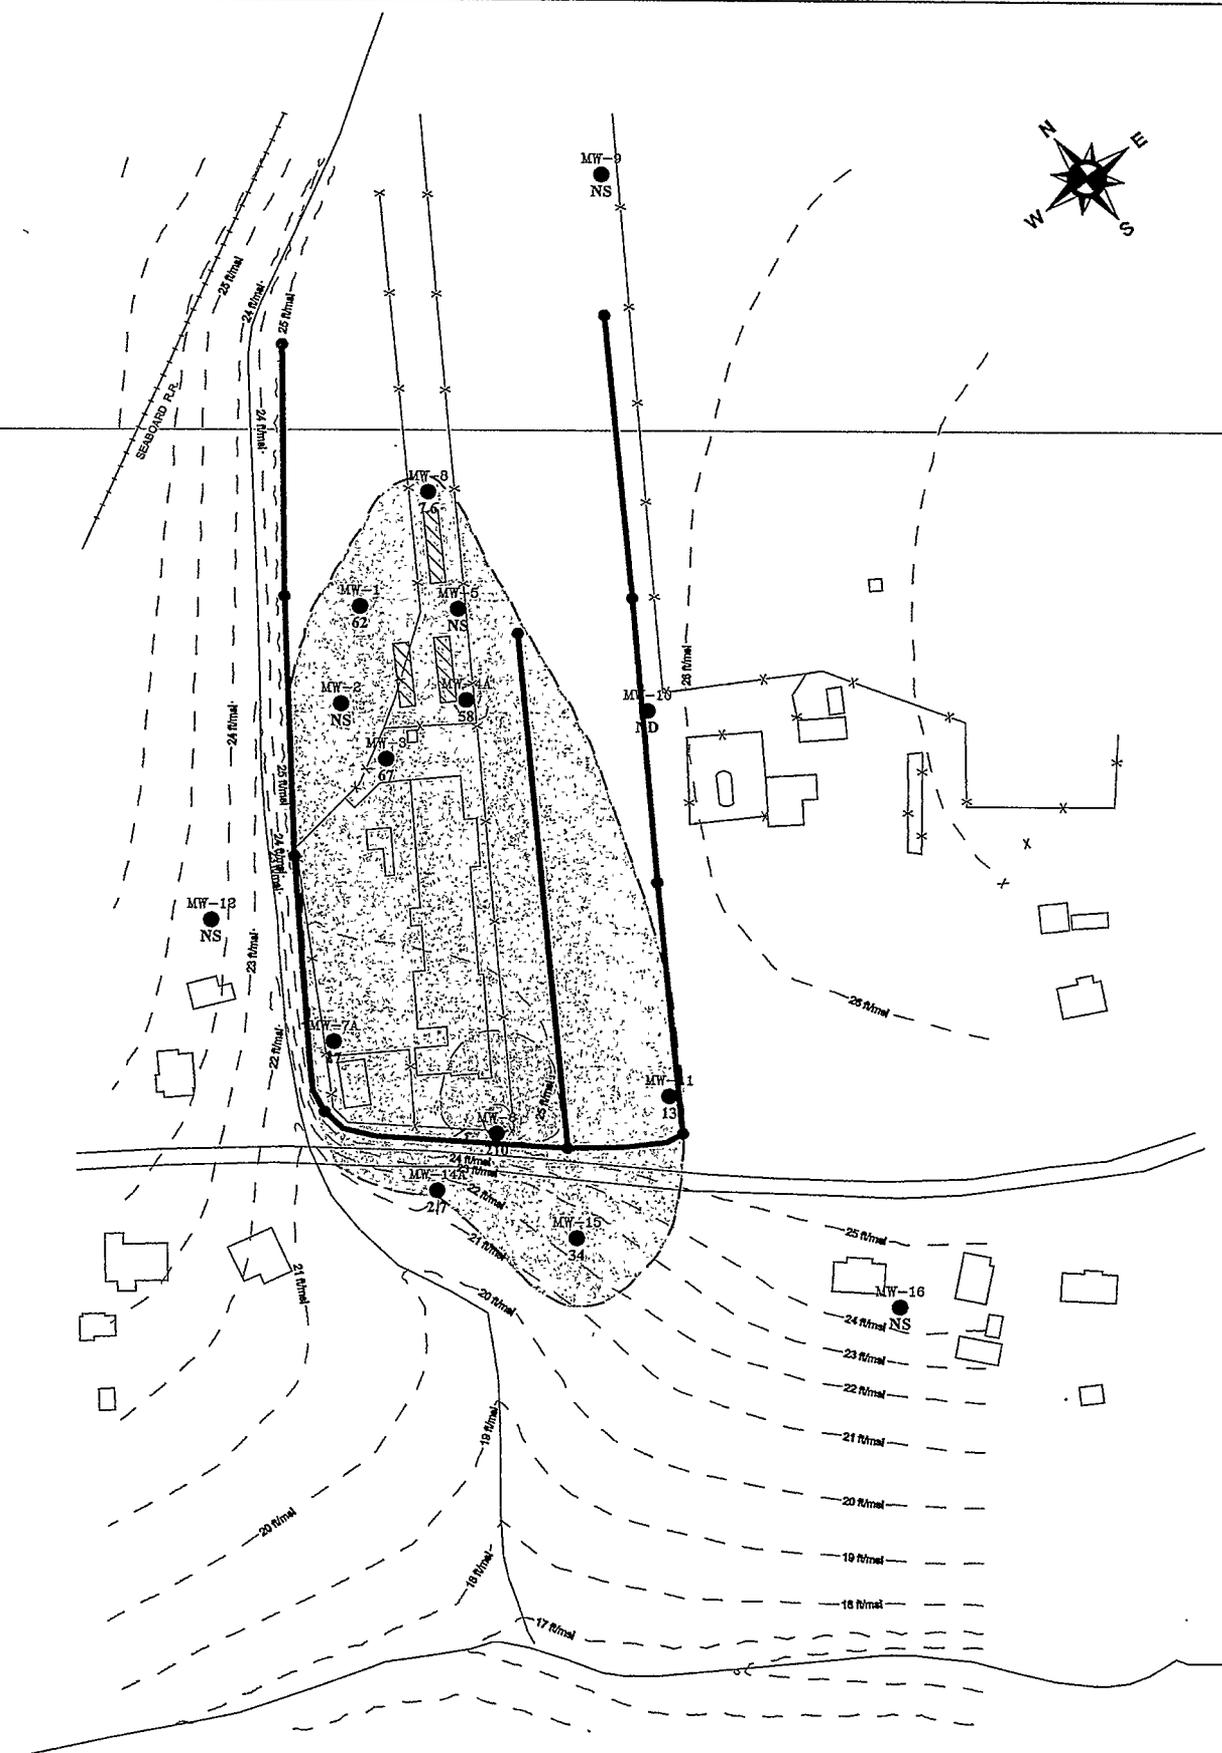
**Figure 3**  
**Groundwater 1,4-Dioxane**  
**Isoconcentration Contour Map (ug/l)**  
**April 2005**  
**Kentec Plant**

In 2002, the groundwater treatment system was modified to discharge to an infiltration gallery located to the north of the site's main building. It was thought that the additional water injected into the upgradient aquifer would enhance the circulation of groundwater through aquifer and accelerate the remediation process. The result of this modification was as expected and monitoring showed a significant decrease in 1,4-dioxane concentrations in monitoring well MW-6 from 2002 to 2004 (1300 ug/l to 230 ug/l); however, since 2004 little reduction in concentrations in MW-6 has been documented. Currently, the infiltration gallery has little affect on the shallow aquifer (Figure 3).

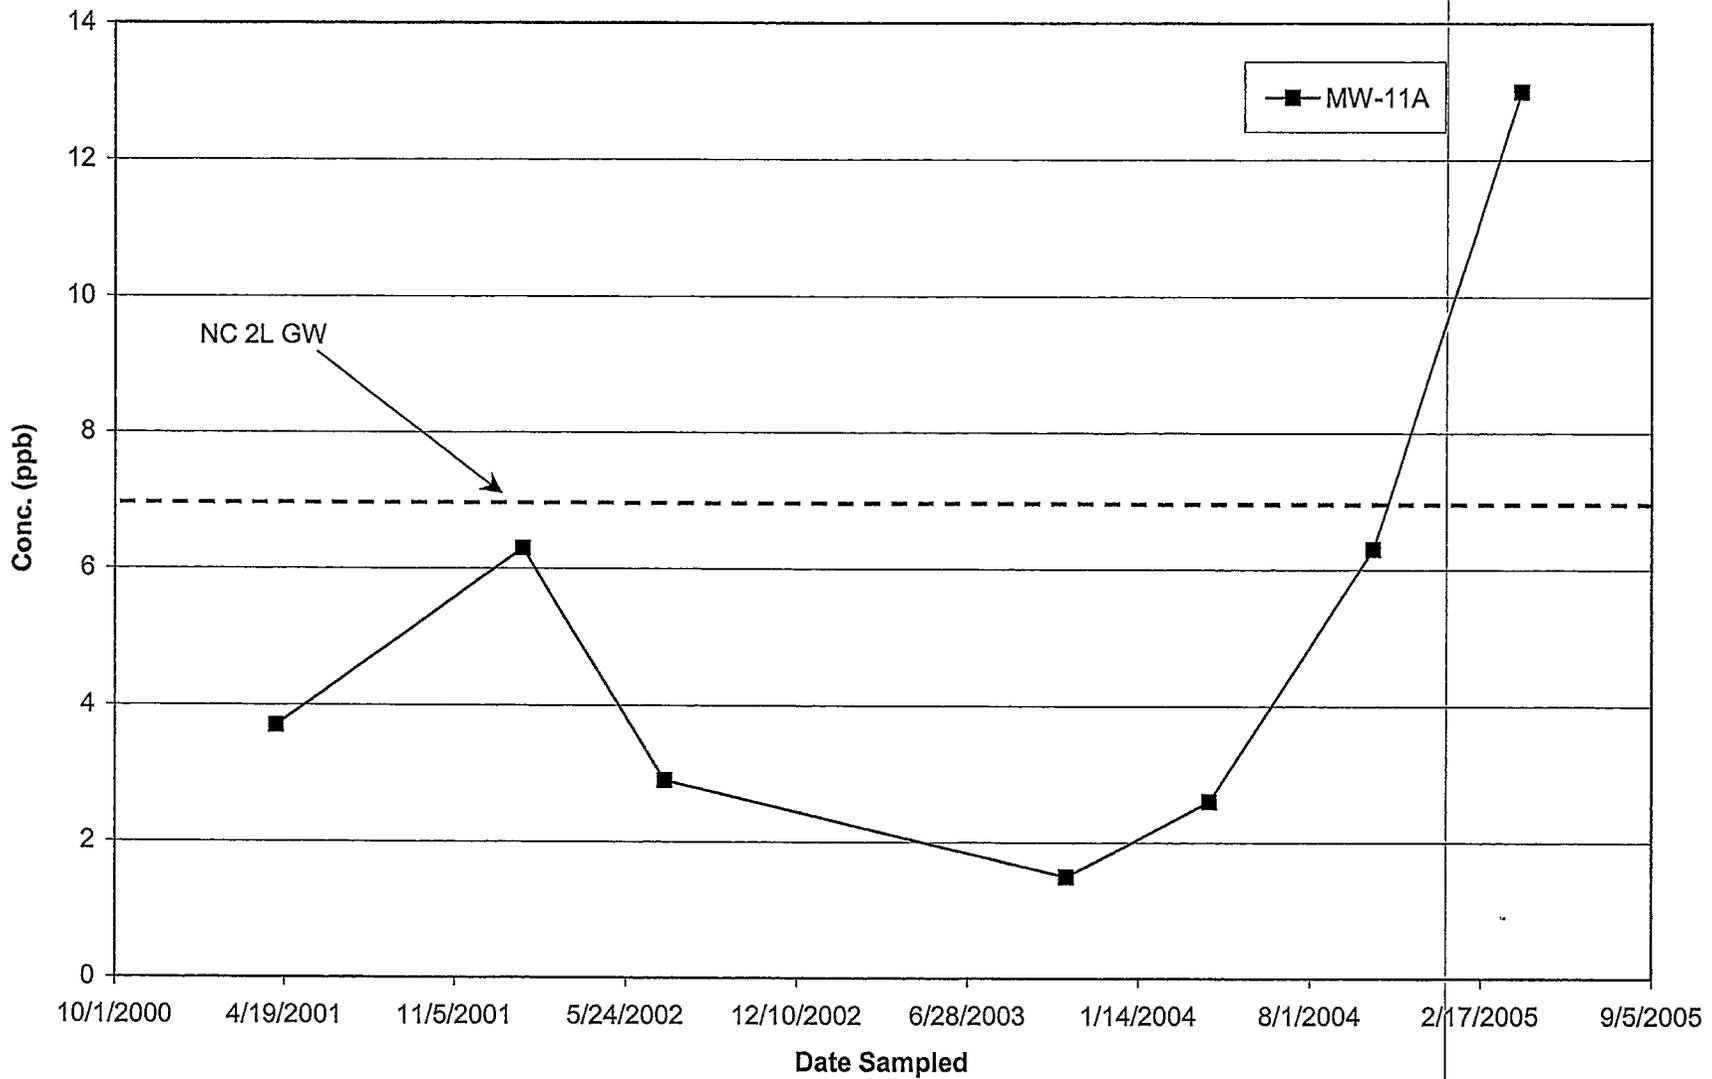
Figure 9. Concentration Trends - MW-11A (1,4-Dioxane)

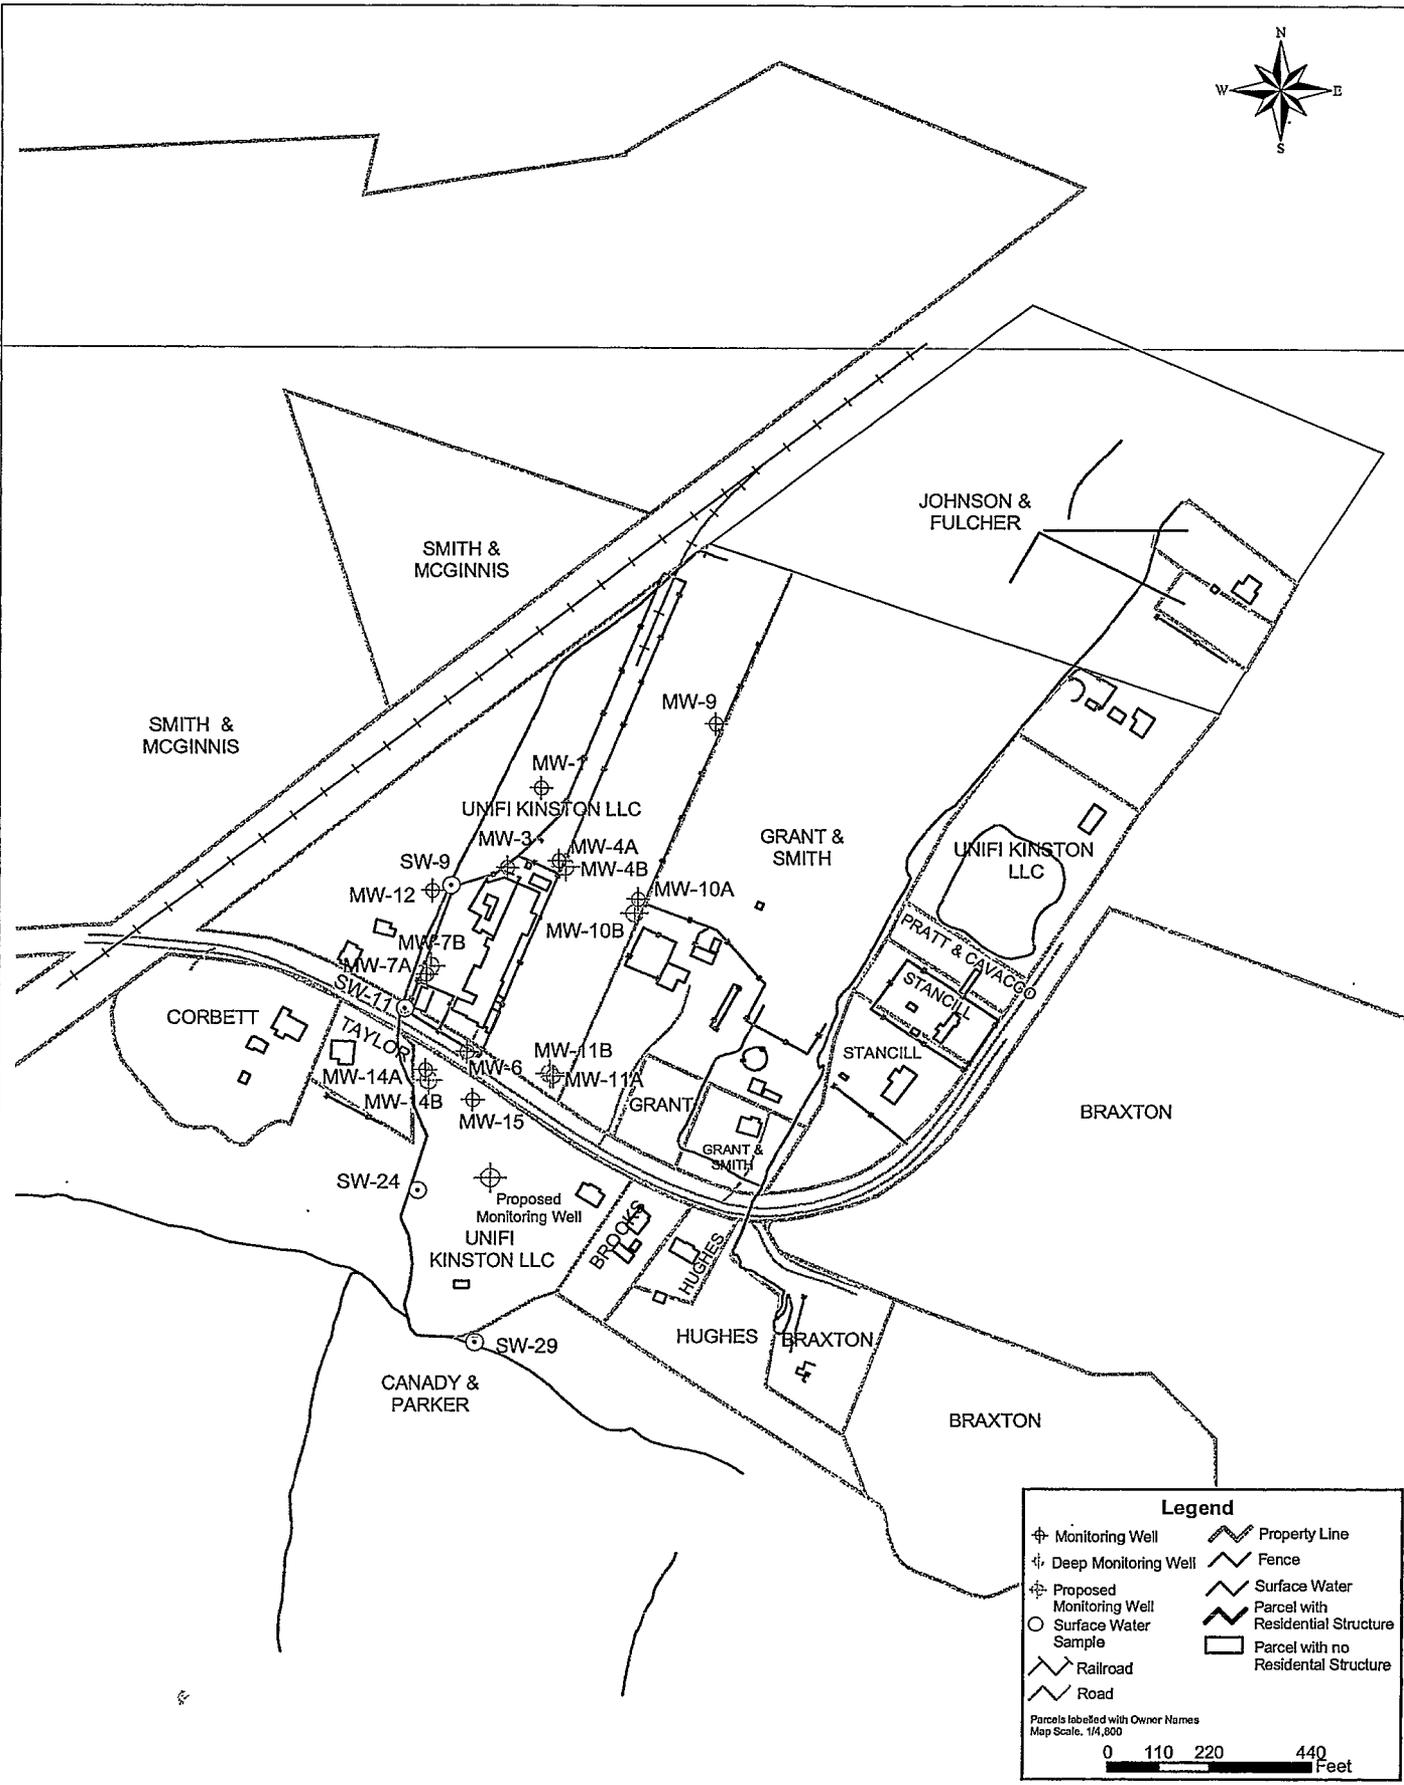
CREATED: ND	DUPONT PROJECT NO.: 4427
DATE: 10/10/05	URSD PROJECT NO.: 18994393
REVISION:	FIGURE NO.: 13
FILE NAME: G:\Kentec\GIS\Project_figures\Ken_Natural_Atten\attenuation_Loc.mxd

TITLE: **Proposed Natural Attenuation Monitoring Locations  
 Kentec Plant**

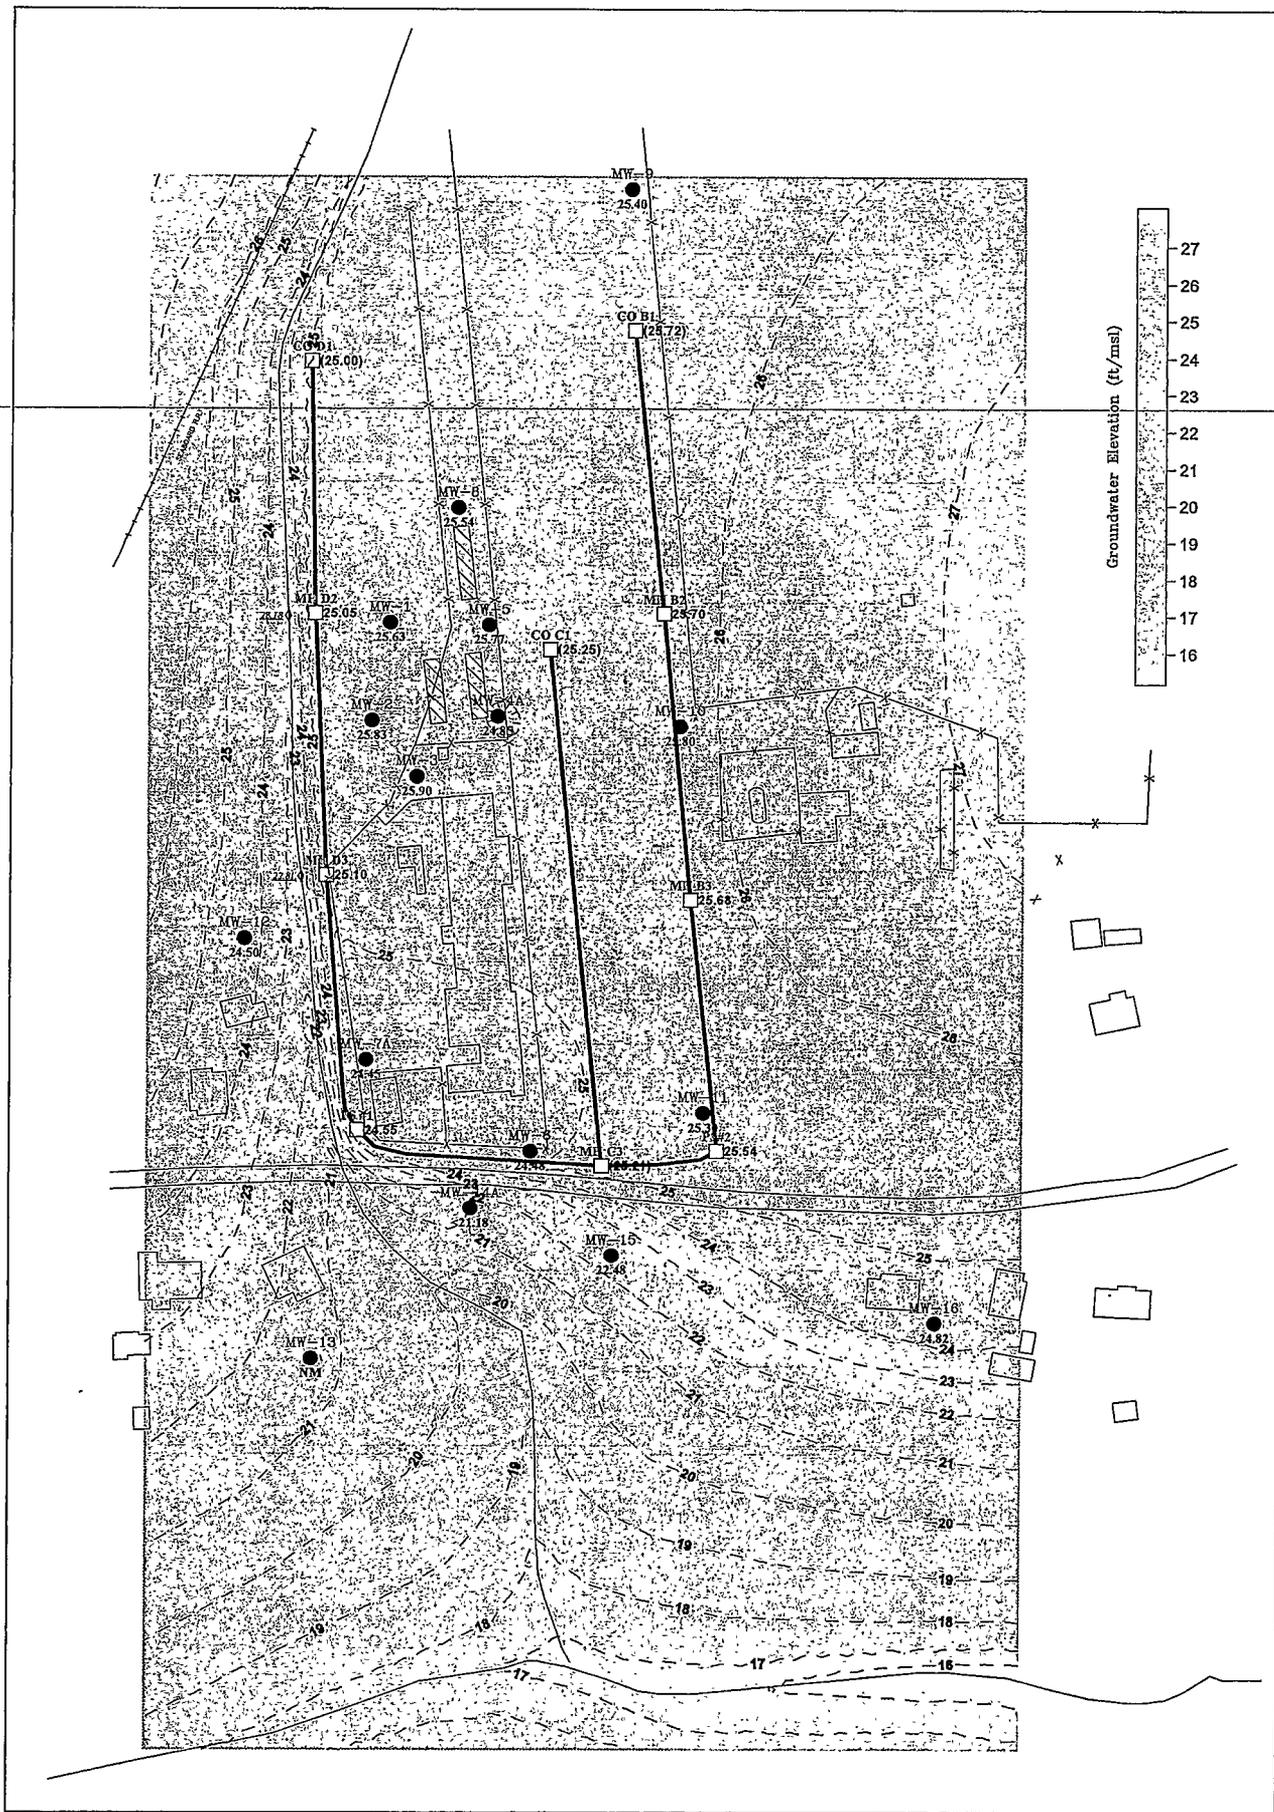
TITLE:  
**Figure 14**  
**June 7, 2005 Potentiometric Surface Contour Map (ft/msl)**  
**Capture Trench Non-Operational**  
**Kentec Plant**

Depth to water elevations were collected from all accessible site monitoring wells, interceptor trench access manholes, and from staff gauge locations installed in the drainage ditch / unnamed tributary and lower creek on June 7, 2005. The extraction system had been non-operational for approximately 57 days prior to these measurements. This data was used to generate a potentiometric surface contour map (included as Figure 14) which depicts static conditions at the site in respect to flow interaction between groundwater, surface water, and water in the interceptor trench. As evident on this figure, even during non-operational conditions, the interceptor trench is a significant influence in respect to groundwater flow beneath the site. A comparison of head elevation differences between monitoring wells and trench access manholes indicates that groundwater is entering the trench in areas where the water elevation in the trench is lower than the potentiometric surface and exiting the trench in areas where conditions are reversed. Specifically, groundwater appears to be flowing into the trench in the northeastern / upgradient area of the site and flowing away from the trench in the south southwestern / downgradient area of the site.
