FACILITY COMPLIANCE INSPECTION REPORT
Division of Waste Management
Solid Waste Section

Currituck County Transfer Station
216 Airport Rd.
Maple, North Carolina 27956

Partial Comprehensive Facility Compliance Inspection.

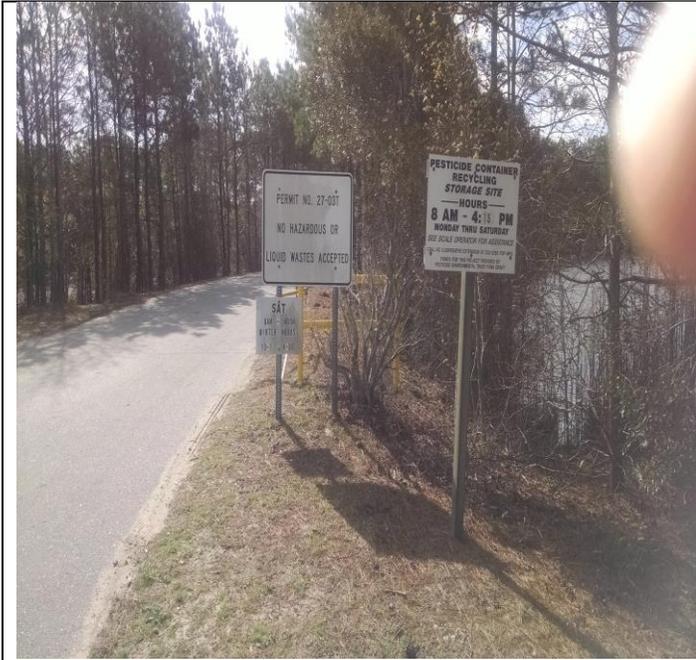
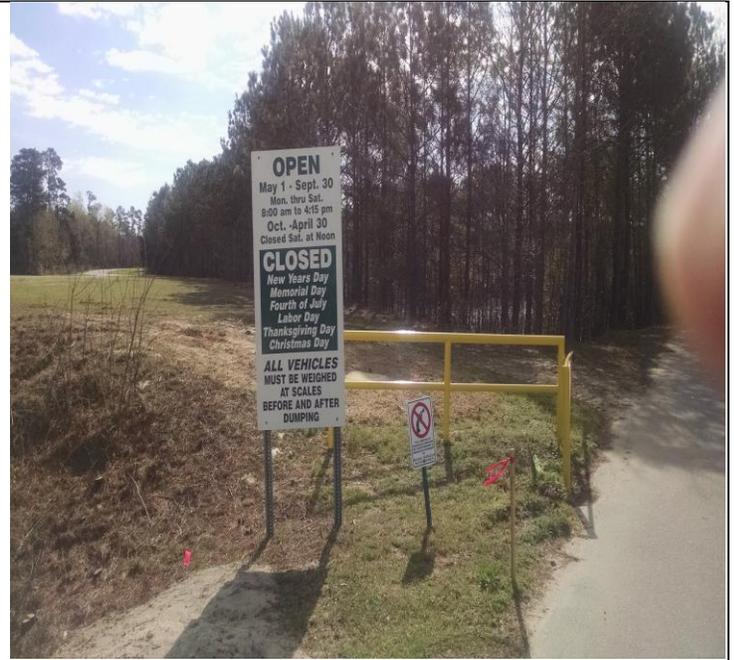
- 1 - This facility is secured well by gates and other security measures.
- 2 - Signs posted and in compliance with permit conditions.
- 3 - Interior roads made for all weather conditions and are well maintained.

- Signs

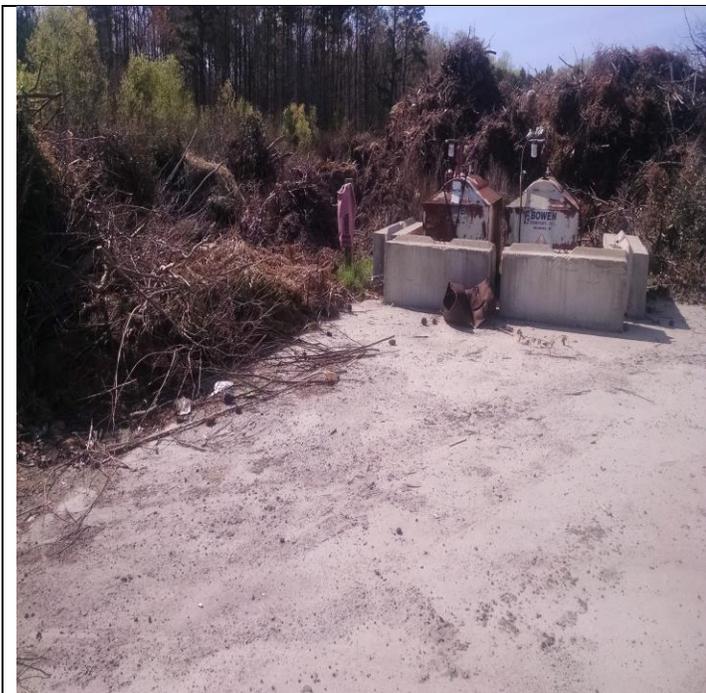
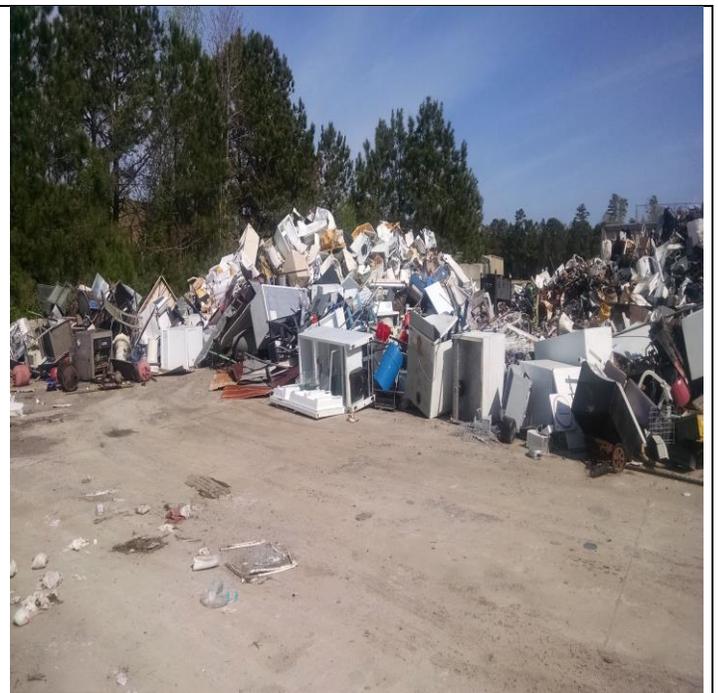
- 9 – This facility is permitted to receive White Goods and Scrap Metal. All is piled up together. Please ensure the Chlorofluorocarbon refrigerants are removed properly from white goods. It is hard to tell today due to the piling of all white goods and scrap metal. Please keep white goods upright so they can be inspected and to ensure that no refrigerants leak out.

- 10 – This facility also is permitted to receive Tires and Scrap Tires. Tires are place in enclosed trailers in front of the scale house.
- 11 – This facility is permitted to receive Yard Waste and Pallets. During this inspection, it was noted that the yard waste piles were within 5 feet from fuel barrels. I would keep further distance due to potential fire danger if piles of yard waste catches on fire this fuel barrel would be a potential liability and safety issue. Also, there were some items mixed into the yard trash that needs to be removed. These items were building material that were of treated materials. Need to screen this better at scale house or where ever you screen these loads of yard trash at.

- Fuel barrels/ Yard Waste area and White Goods / Scrap Metal area.
