Your Name: Spring Allen (061)  
EPA ID: N C 0 9 9 1 3 0 2 6 6 1  
Facility Name: North Star Logistics, Inc.  
Document Group: Enforcement (E)  
Document Type: Immediate Action Notice of Violation (IANOV)  
Description: nov docket #2014-024 issued for storage and disposal issues from citizen's complaint  
Date of Doc: 1/30/2014  
Author of Doc: Spring Allen

IMMEDIATE ACTION  
NOTICE OF VIOLATION  
Docket # 2014-024

Mr. Phil Delp, President  
North Star Logistics, Inc.  
917 Beaverdam Road  
Canton, NC 28716

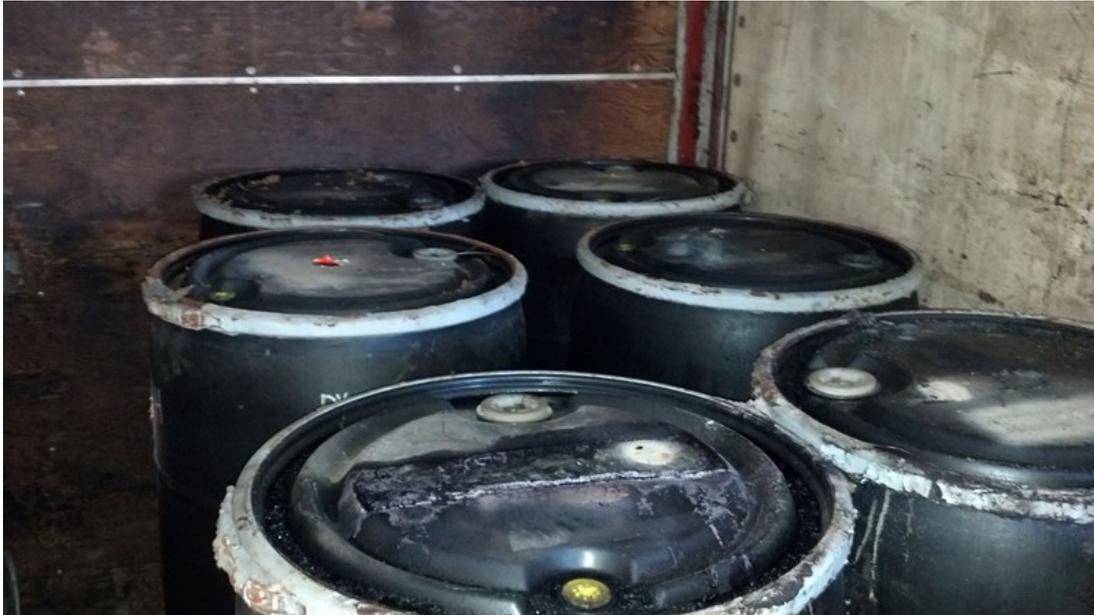
On January 30, 2014 Ms. Spring Allen, and Mr. Johnny Glance, Haywood County Fire Marshal arrived on-site to investigate the contents of the trailer and source of the spill. Facility personnel had already opened the trailer's side door. The trailer was accessible only by ladder into this side door. The trailer contents included two pieces of equipment; a fork truck and a scissor truck as well as eight (8) 55-gallon containers. (photo # 1 & 2) Contents appeared to be releasing around the drum tops, and apparent slight corrosion on the closure rings. Mr. Delp stated that the containers held textile dyes and believed them to be non-hazardous. . When asked about the basis for this statement, Mr. Delp (1) failed to provide an analytical waste profile, and (2) failed to articulate a claim of generator knowledge of the characteristics of the waste.

North Star Logistics – 12-30-2014 Drums inside trailer near back gate (photo #1)

Comply with 40 CFR 262.11, adopted by reference at 15A NCAC 13A .0107. An immediate determination and/or analysis of the contents of the eight 55-gallon containers and of the two 55-gallon lab packs must be completed to ensure proper characterization and disposition. Due to a suspected or known release of hazardous waste, a comprehensive site characterization is required. The characterization must include the area surrounding the storage trailer. This area is currently located on the northwest side of the facility inside the fence.

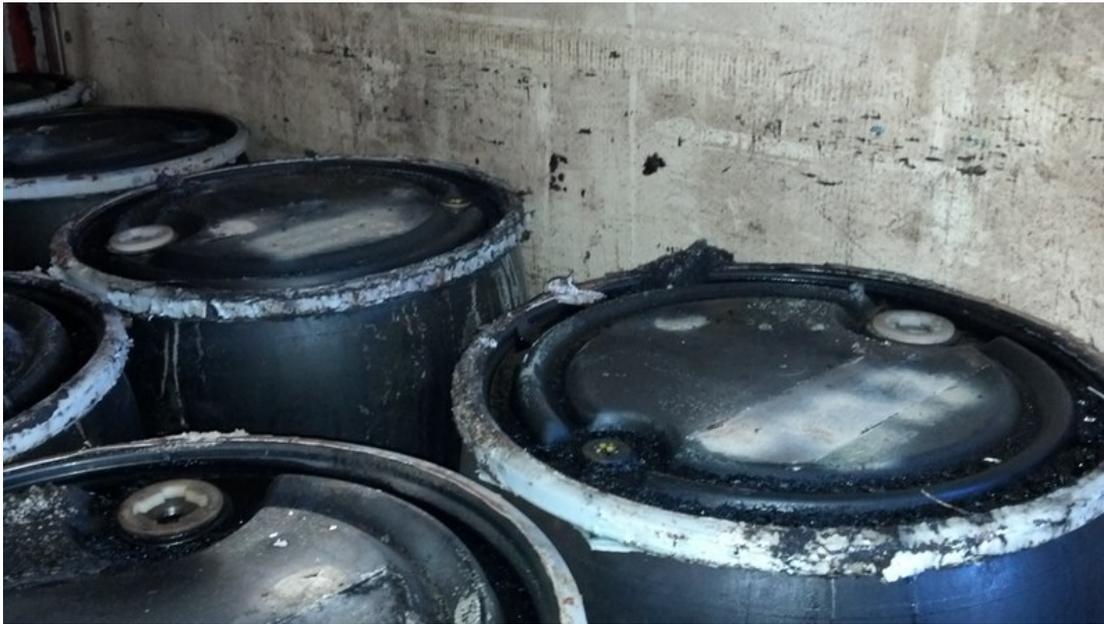
North Star Logistics – 12-30-2014 drum tops – inside trailer near back gate (photo #2)

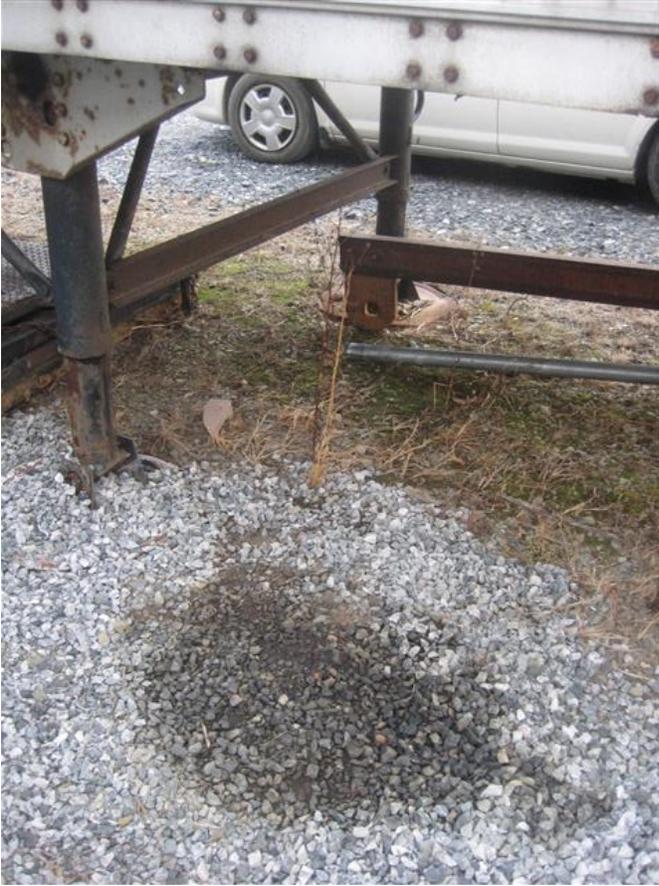
A trailer located inside the rear facility gate on the north side of the fence was observed to have an unknown liquid leaking onto the ground under the trailer. The area discolored on the ground's surface was approximately 1' X 2' in size. (photo # 3 & 4) Facility personnel were unable to open the trailer to investigate the source of the spill.

North Star Logistics – 12-21-2014 - release from trailer near back gate (photo #3)

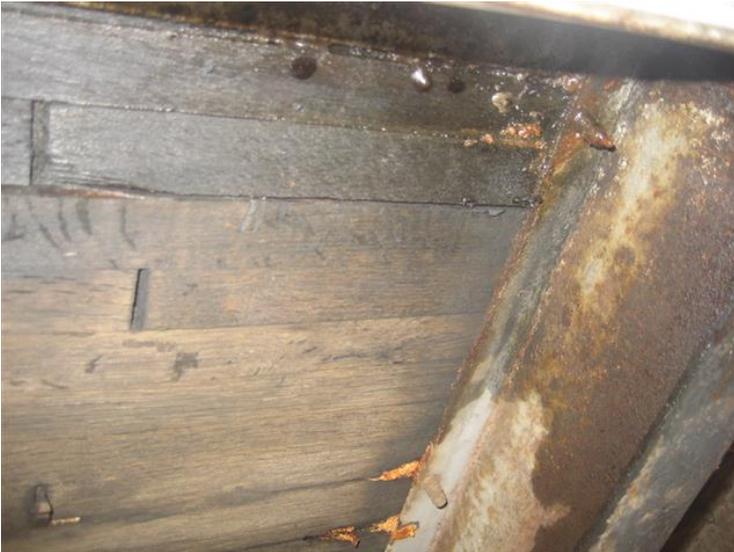
North Star Logistics –12-21-2014 - under side of trailer near back gate (photo #4)

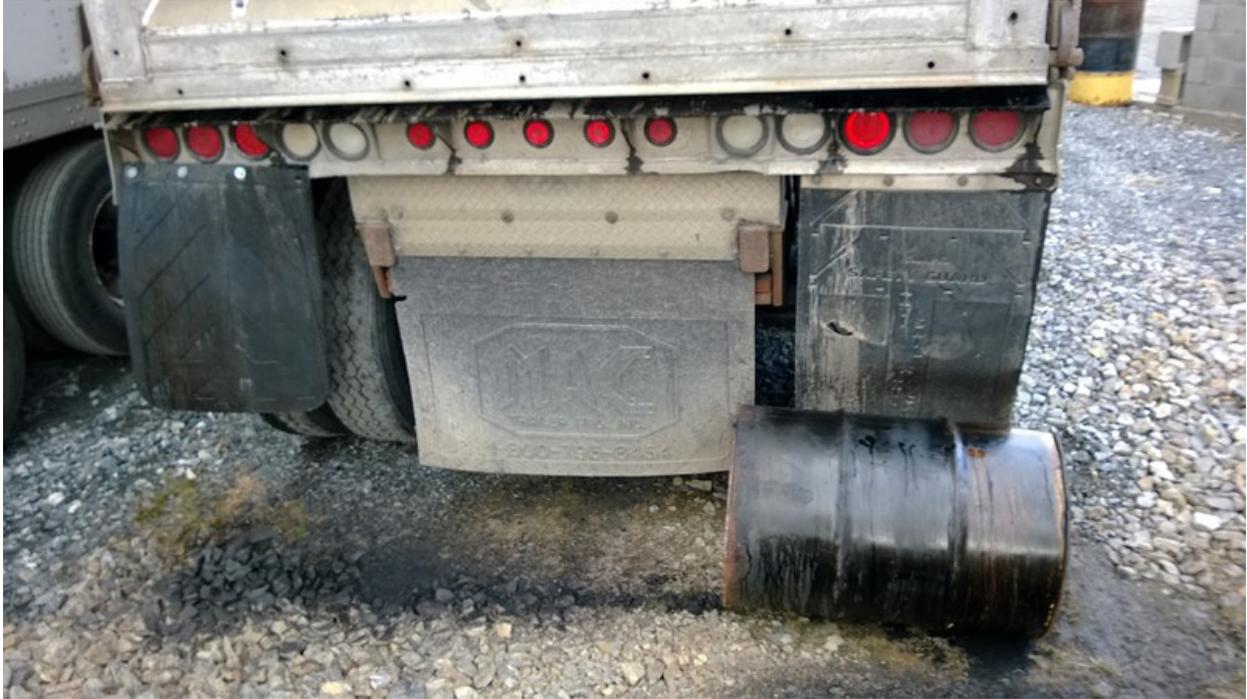
Inspectors also observed a release from a tandem truck near the loading dock on the southwest corner of the building where an unknown black liquid had dripped onto the ground's surface from the rear of the truck. Mr. Delp stated that the truck was presumed empty. (photo # 5) Mr. Delp was not able to provide any information pertaining to the contents of truck or an explanation as to what was being released.

North Star Logistics - 12-21-2014 drips onto ground from tandem truck (photo #5)

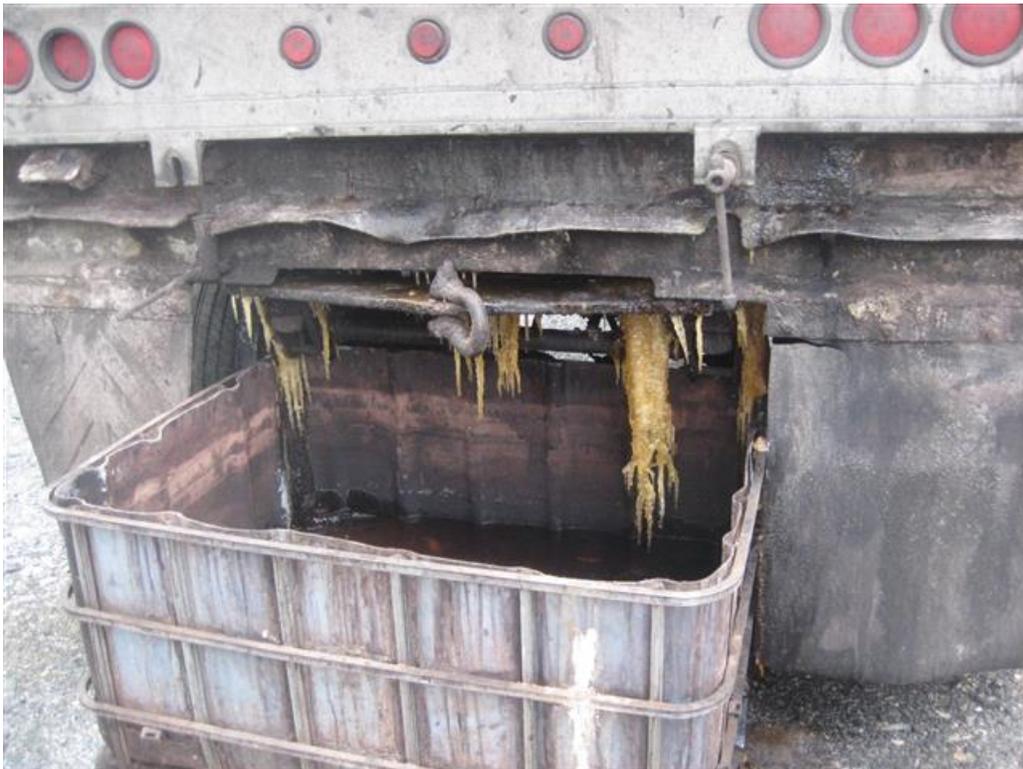
A second trailer located outside of the bay door on the northwest side of the building had an amber colored liquid dripping into an open container. Mr. Delp stated that the trailer was a full trailer from lacquer dust processing and that the drips are water draining out of the saturated dust. When asked about the basis for this statement, Mr. Delp (1) failed to provide an analytical waste profile, and (2) failed to articulate a claim of generator knowledge of the characteristics of the waste. (photo # 6)

North Star Logistics – 12-21-2014 water from wetted lacquer dust (photo #6)

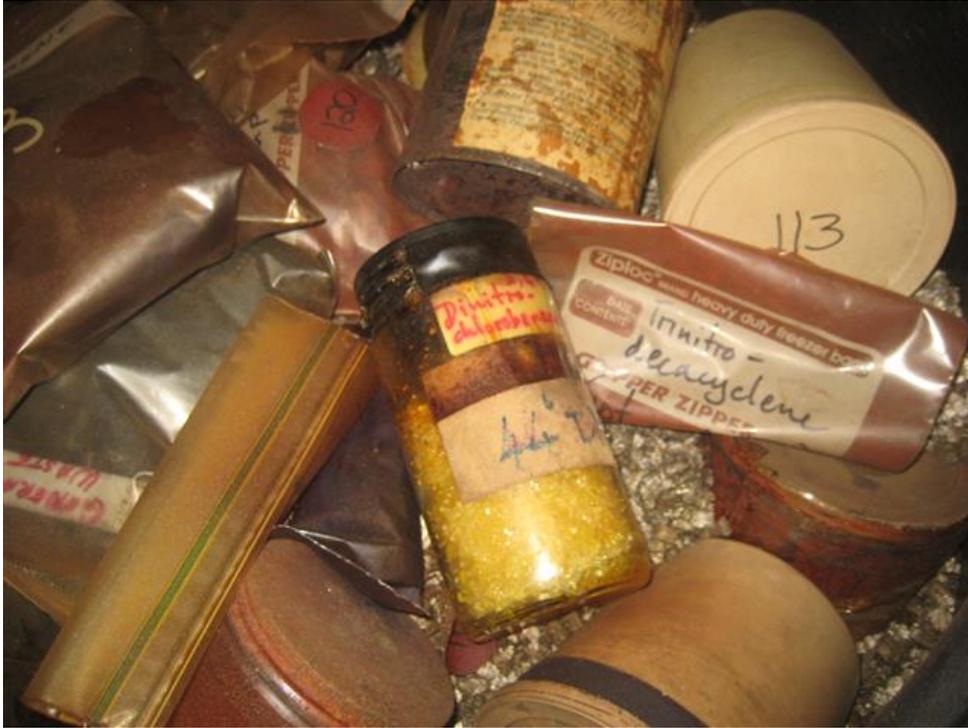
While on-site, inspectors observed two (2) 55-gallon containers near the east wall inside the facility that were not labeled. Mr. Delp stated that to his belief, they held detergents. Observation when the containers were opened indicated they contained lab packed chemicals. Mr. Delp stated that they had been on-site for several, possibly eight (8), years. Mr. Delp stated the containers were brought on-site from the clean out of a Freedom Textile Laboratory when Freedom Textiles closed down several of its Georgia and South Carolina laboratory facilities. Mr. Delp stated that he brought the chemicals on-site with plans to re-sell them. Mr. Delp stated

the lab pack waste was non-hazardous. When asked about the basis for this statement, Mr. Delp (1) failed to provide an analytical waste profile, and (2) failed to articulate a claim of generator knowledge of the characteristics of the waste. Additionally, when asked, Mr. Delp stated that no Material Safety Data Sheets were available for the various lab chemicals (photo # 7 & 8)

North Star Logistics – 12-21-2014 Lab pack #1 contents (photo #7)

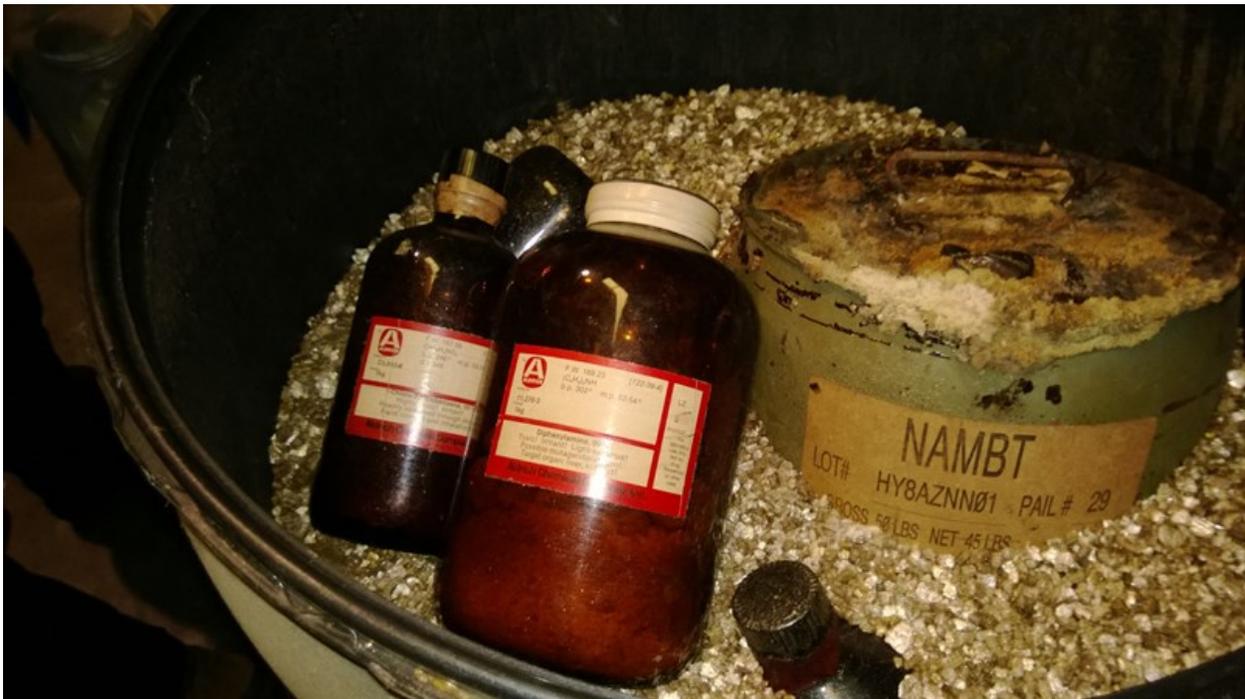
North Star Logistics – 12-21-2014 Lab pack #2 contents (photo #8)
