**HAZARDOUS WASTE SECTION - COMPLIANCE BRANCH  
FILE TRANSMITTAL & DATA ENTRY FORM**

**COMPLIANCE EVALUATION INSPECTION (CEI) REPORT**

Name of Facility: Smithfield Packing Co Inc. - Tar Heel Div.  
EPA ID Number: NCR000149666  
Type of Facility: Small Quantity Generator  
Facility Location: 15855 Hwy 87 W, Tar Heel, NC 28392  
Bladen County  
Mailing Address: P.O. Box 99, Tar Heel, NC 28392  
Telephone Number: 910-862-7675 ext. 605  
Facility Owner: Smithfield Foods Inc., 111 Commerce St., Smithfield, VA 23430  
Property Owner: Smithfield Packing Realty, 2800 Post Pak Blvd, Suite 4200,  
Houston, TX 77056

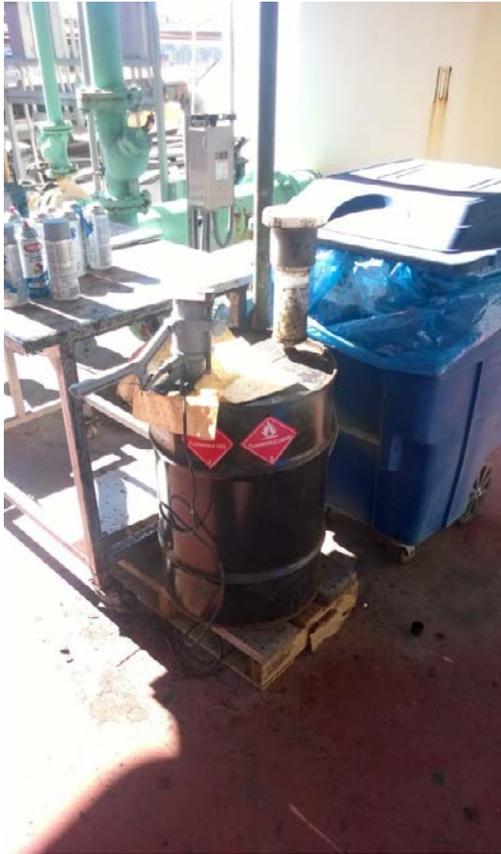
Picture 1: Aerosol can puncturing drum

Hazardous waste is also generated from the puncturing of aerosol cans (see Picture 1 on page 3). The cans are punctured under a covered area which is convenient for maintenance personnel. Mr. Musselwhite and I discussed the location of the drum. I expressed concern due to its proximity to potential electrical ignition sources and its accessibility to anyone who happened by. I recommended that a better and more controlled location be identified for the container.

- Update the facility's EPA Form 8700-12 to reflect the name change and new facility contact.
- Relocate the aerosol can puncture drum to an area away from ignition sources and in an area in which access can be controlled.
- Address the housekeeping in the used oil storage area.
- Organize all manifests and be certain signed copies from previous years are obtained for the facility's records. Also be certain to organize Land Disposal Restriction (Land Ban or LDR) forms associated with manifests.
- Address all issues noted above regarding the management of universal waste.

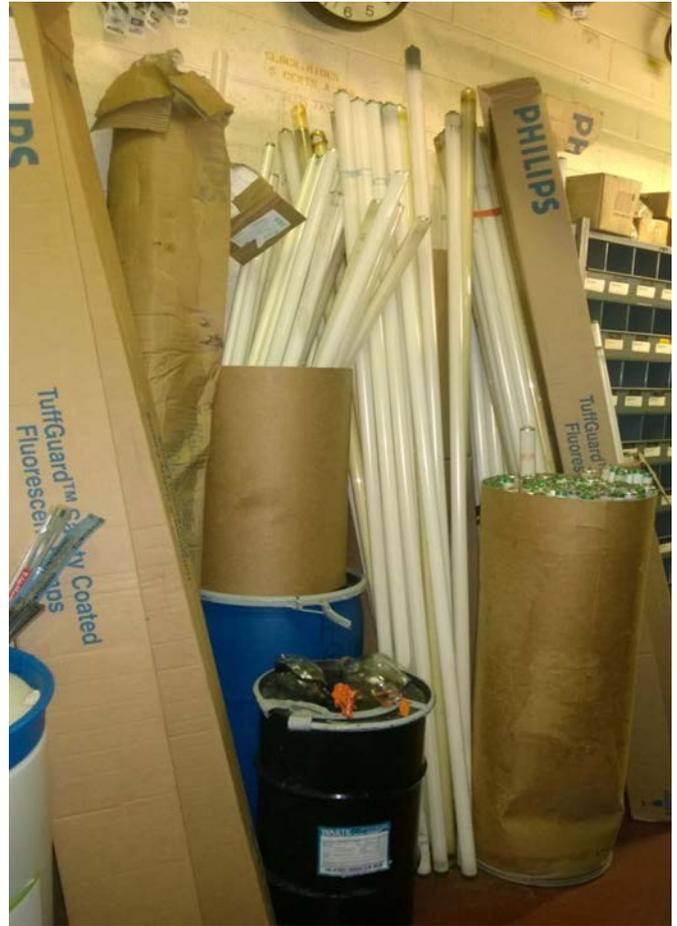
Picture 2: Universal Waste Storage Area

The universal waste storage area was located in the main building and access was controlled via a locked door which accesses a parts room (see Picture 2, above). I observed approximately six open boxes of universal waste lamps as well as several lamps which were not in containers and/or broken. The lamps were not labeled properly and the facility could not demonstrate that the used lamps had not remained on site for more than one year. Additionally, I observed four buckets which were used to contain universal waste batteries. The buckets were all properly closed, labeled, and dated.

*Smithfield Packing Co Inc. is in violation of 40 CFR 273.13(d) in that used lamps were observed not in containers and the used lamps that had been placed in boxes were not closed. Additionally, any broken lamps must be managed as described in 40 CFR 273.13(d)(2).*

*Smithfield Packing Co Inc. is in violation of 40 CFR 273.14(e) in that none of the containers of universal waste lamps were properly marked.*

*Smithfield Packing Co Inc. is in violation of 40 CFR 273.15(c) in that the facility could not demonstrate the length of time that the universal waste had been accumulated at the facility.*
