FACILITY COMPLIANCE INSPECTION REPORT
Division of Waste Management
Solid Waste Section

Date of Site Inspection: April 29, 2016 Date of Last Inspection: May 8, 2014

Wake Transfer Station
9220 Durant Road
Raleigh, NC 27616-3159

Comprehensive Inspection

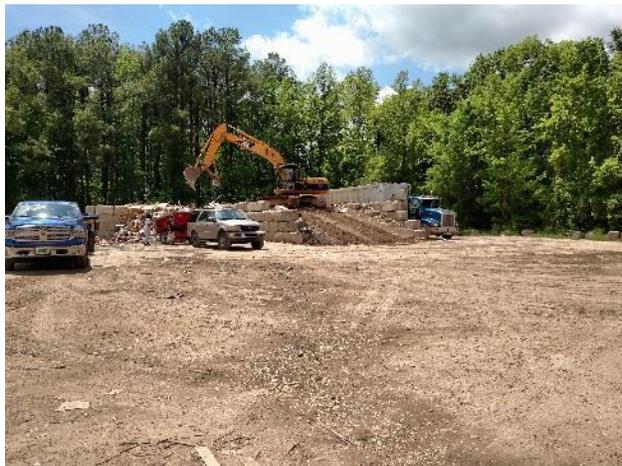
- 12. The tipping area was neat and clean with waste quickly sorted and loaded into outgoing trucks and containers. Waste that accumulates outside the tipping floor barrier during loading of the transfer trailer is cleaned up after each transfer truck is loaded. The tipping floor is concrete and is being well managed.
- 13. Concrete barriers are being used to create unloading bays for different types of vehicles to improve safety and vehicle flow.

Tipping floor

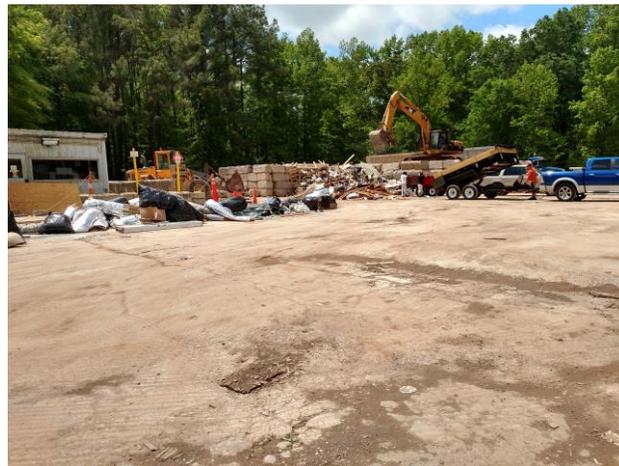
Unloading bays.
